Information Request – Tapu te Ranga Marae, 44 Rhine Street, Island Bay, Wellington

FIRE INVESTIGATION REPORT

44 Rhine Street, Island Bay, Wellington City

F2786311

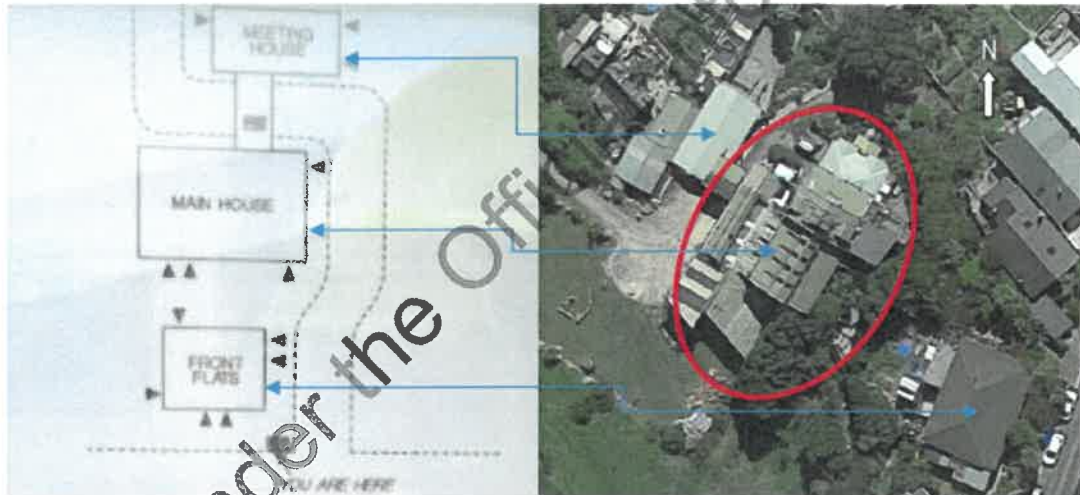
Photo1 showing diagram image from main fire panel.

Photo 2 showing corresponding aerial view alarm including main house (Google Maps)

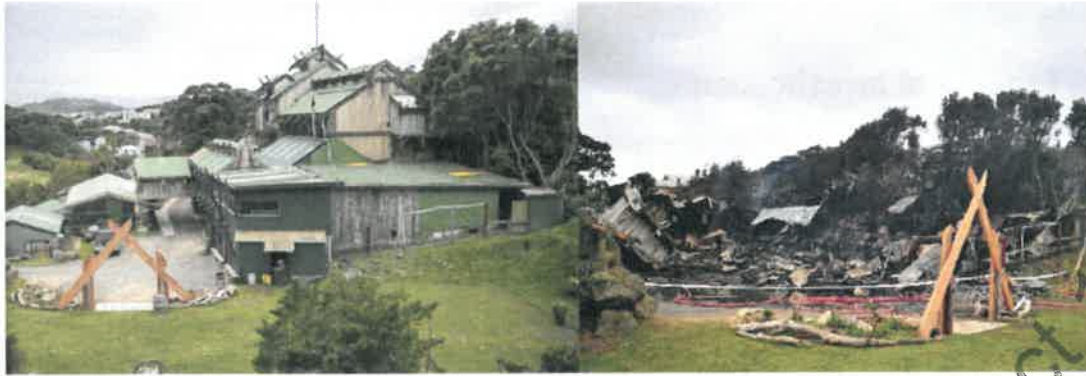
The 'main house' consisted of multiple areas built at different stages and was up to five levels in some places. It ran in an approximate north – south alignment with various elements added onto the original build at later stages. The total structure of the 'main house' was destroyed by the fire. All the upper levels had collapsed onto the ground level during the fire.

Photo 3 shows a pre-fire image of the main house.

Photo 4 shows the main house the morning after the fire.

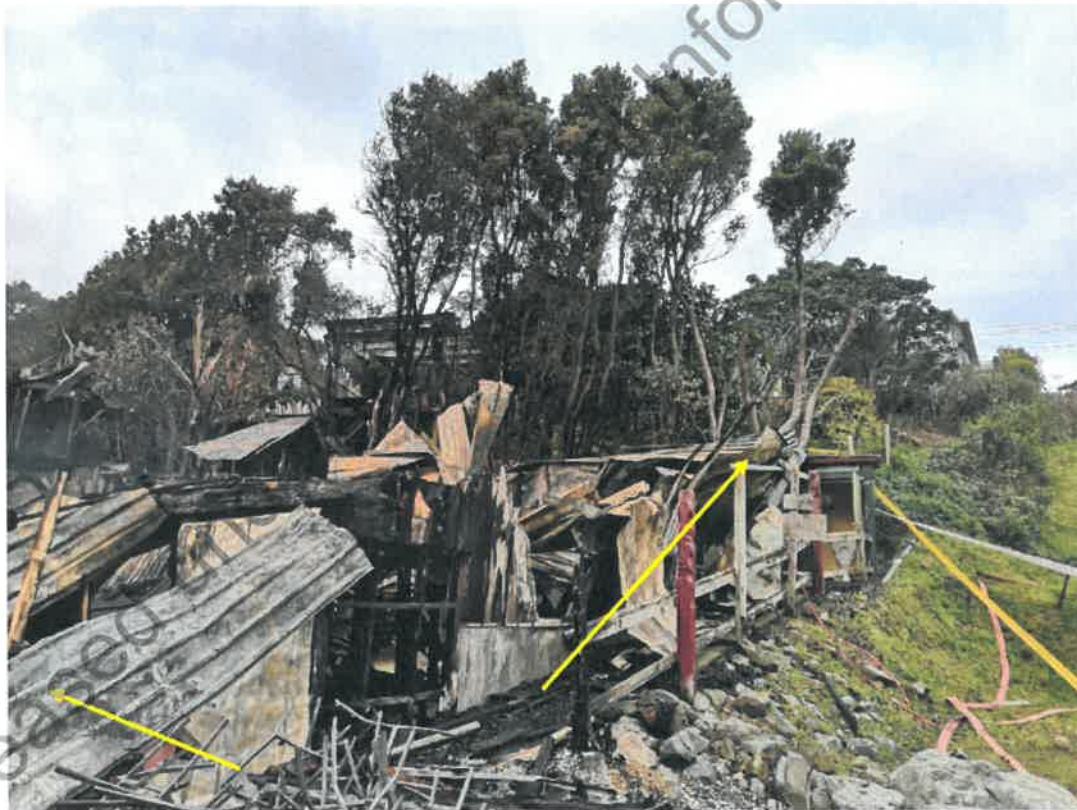
An external examination was made walking in a clockwise direction starting from the southern end of the building. A distinctive vee pattern could be identified emanating from the southern corner of the building along the southern face to the eastern side of the building suggesting fire had travelled in north and easterly directions.

Photo 5. The arrow shows the directions of fire travel from southwest corner of building (location of a storeroom).

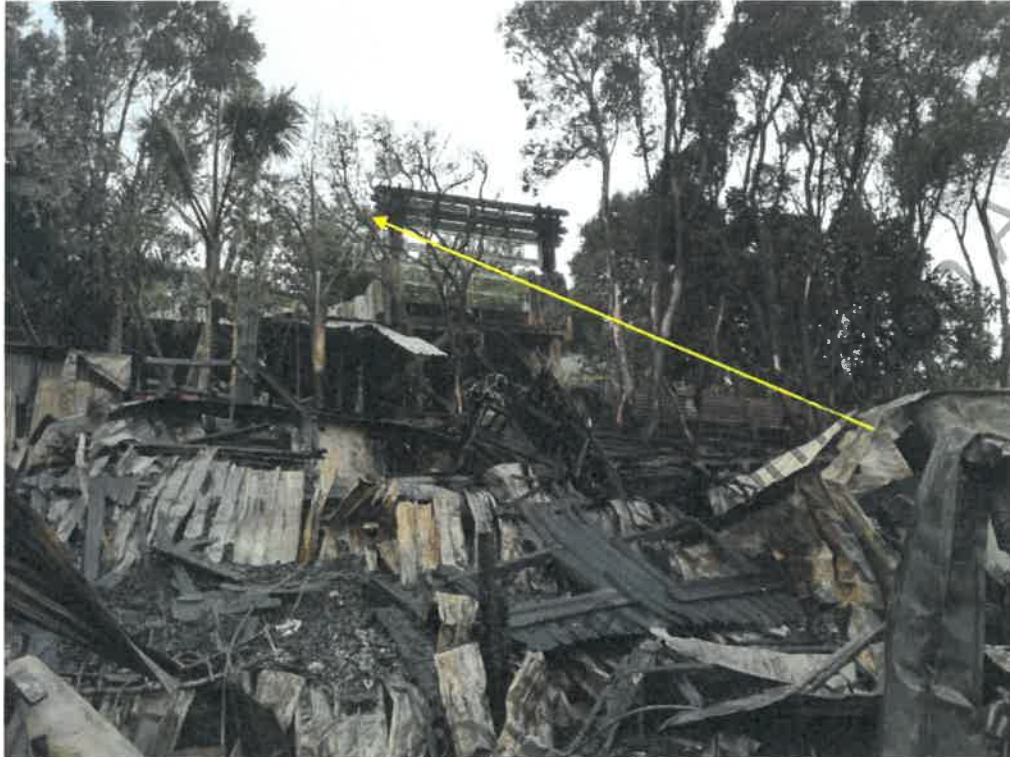
Viewing across the building from the western face, fire patterns could be identified on the eastern side showing greater damage and lower burning towards the southern end of the building, again suggesting the fire travelled from the southwest area of the building towards the east indicated by the arrow in photo 6 below.

Photo 6 looking across the main house site from the west to the east side of the building, burn patterns show fire travel from the right to left of the photo (southern side of the building towards the north).

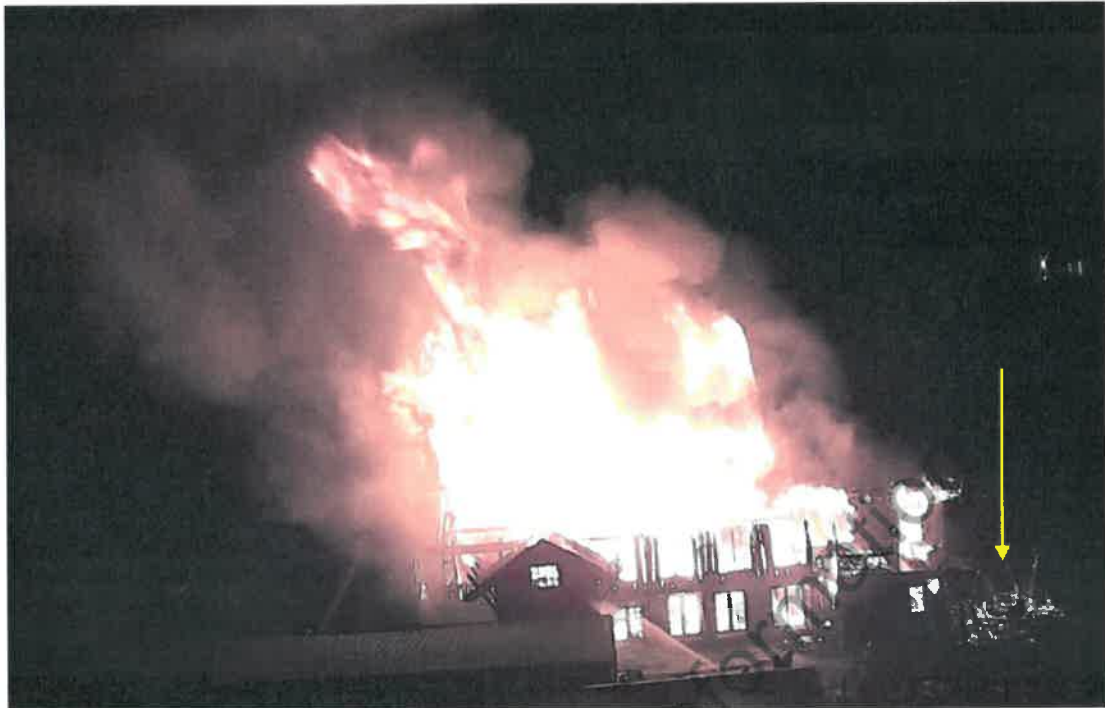
Photo 7 is a screen shot from the Incident Command Unit video camera showing the effects of wind on the flame and smoke. South is to the right of the image. At this point, the store room (indicated by arrow) has been completely consumed by the fire.

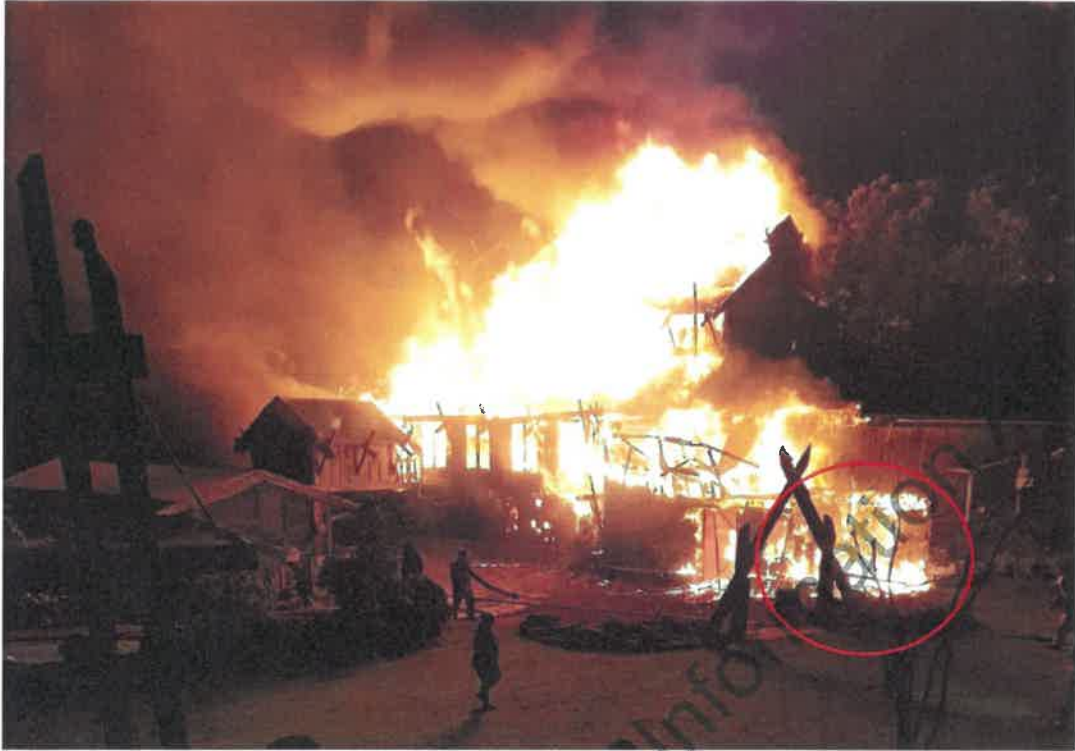
These findings were consistent with early reports from witnesses [REDACTED] who saw fire initially in the southwest corner of the building and from photos taken during the fire and supplied to the fire investigator team.

Photo 8 showing very low level burning in southwest corner (circled) before significant firefighting attack is made.

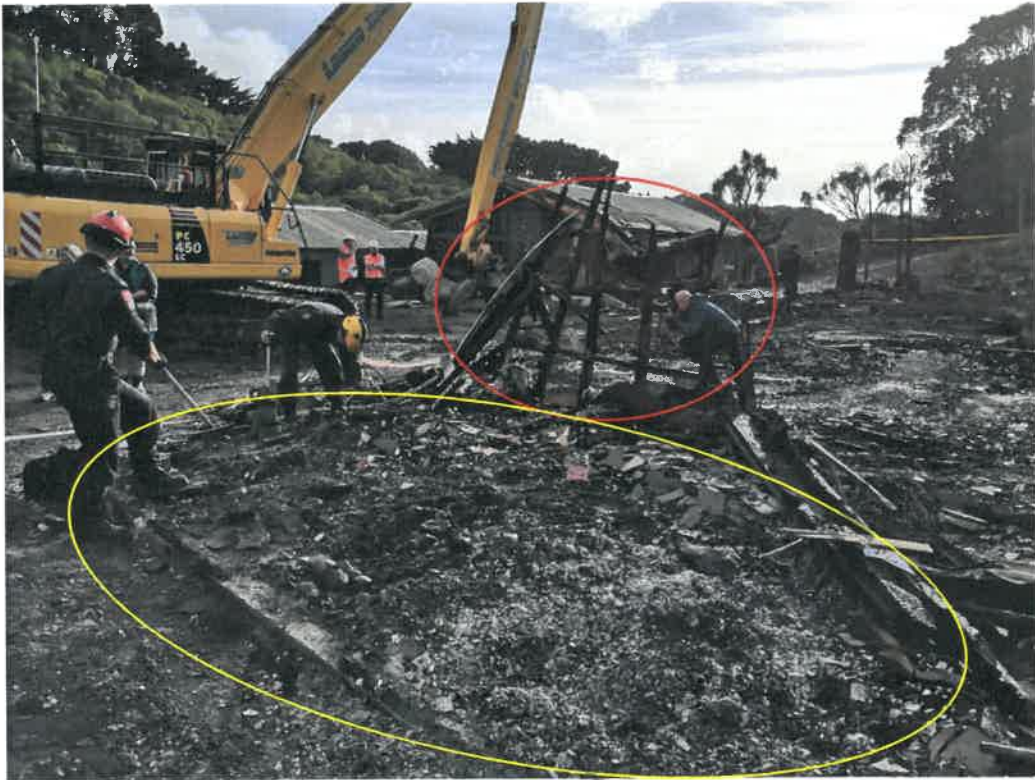
A narrow walkway ran between an adjacent bedroom on the ground floor and the storeroom on the southwest corner of the 'main house'. The bedroom wall had some remaining timbers that showed greater damage to the side of the timbers facing the storeroom. The wall cladding of both rooms (a cement type board) were examined and showed less damage on the bedroom wall than on the storeroom wall. This indicated fire travelled north from the storage room towards the bedroom.

Photo 9 showing remaining wall (circled red) of adjacent bedroom. While the rest of the site had been cleared by an excavator, the area around the storeroom (circled yellow) had been preserved for further inspection.

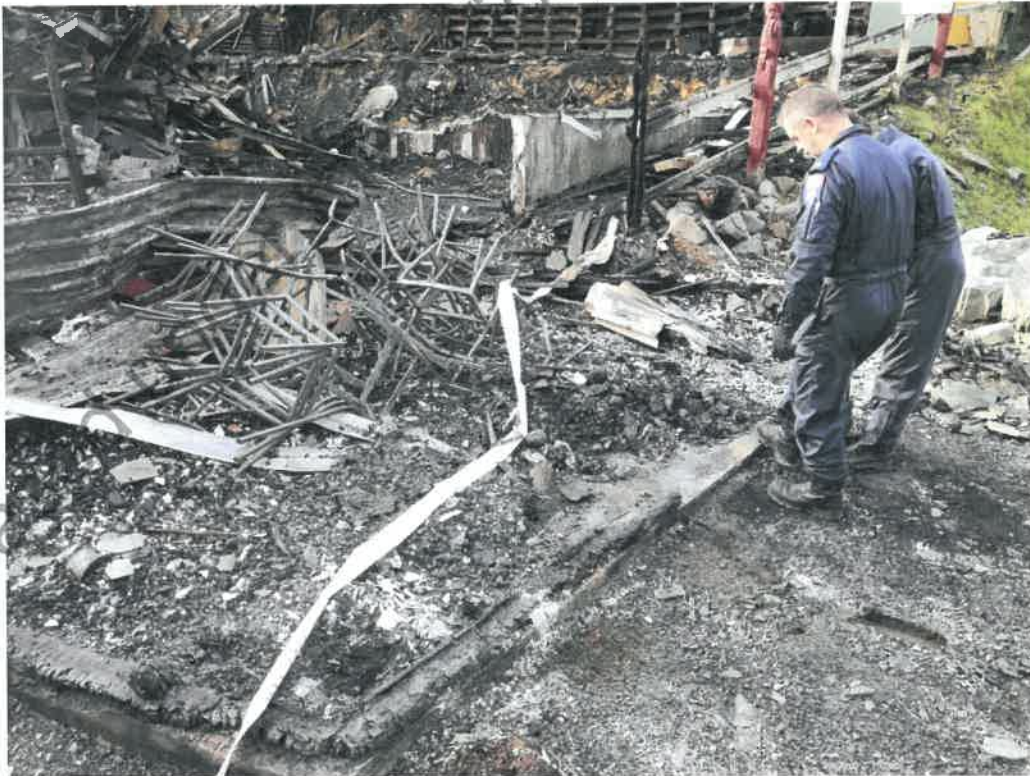
Photo 10 showing storeroom during early excavation.

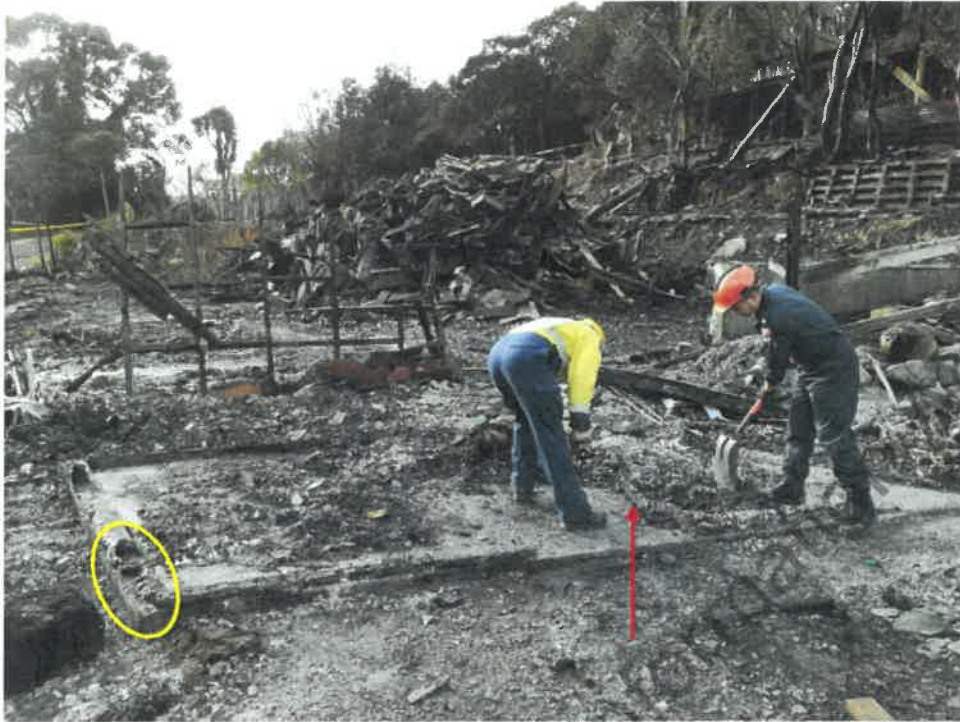
Photo 11 showing storeroom during continuing excavation. The red arrow indicates the remains of the door showing it was in the open position at the time of the fire. Witnesses stated the door was always left open.

The timber base plates were intact around the storeroom except for the area immediately around the southwest corner of the room where a section of the timber base plate (refer photos 11 & 12 yellow circles) had been burnt away indicating very low intense burning. The damage was on the outside of the plate suggesting the heat source was external rather than from within the room.

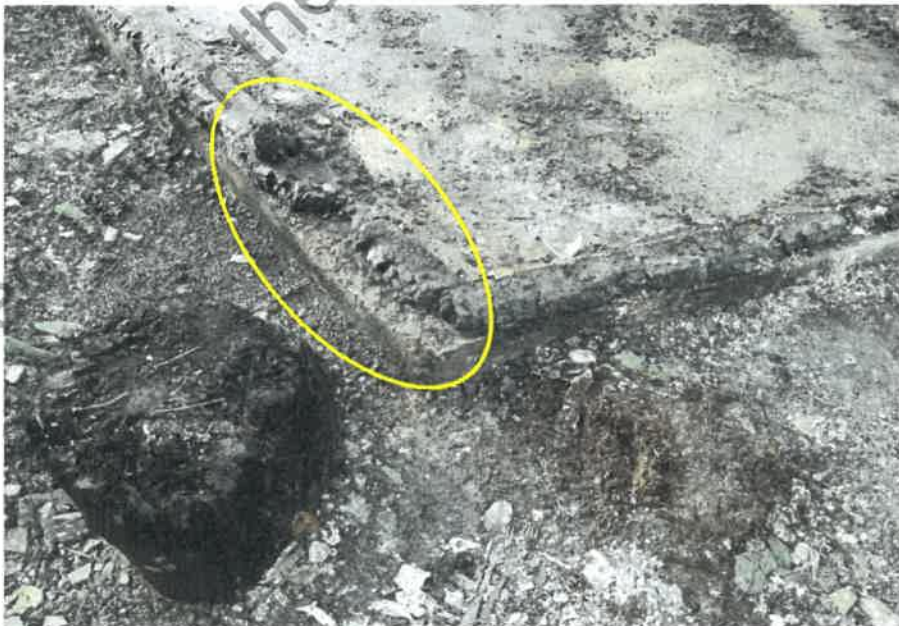
Photo 12 showing deep level charring of base plate on the south western corner of the storeroom.

Investigations revealed the point of origin where the fire started in the building was in the region of the bottom plate of the wall framing on the southwest corner of the store room.

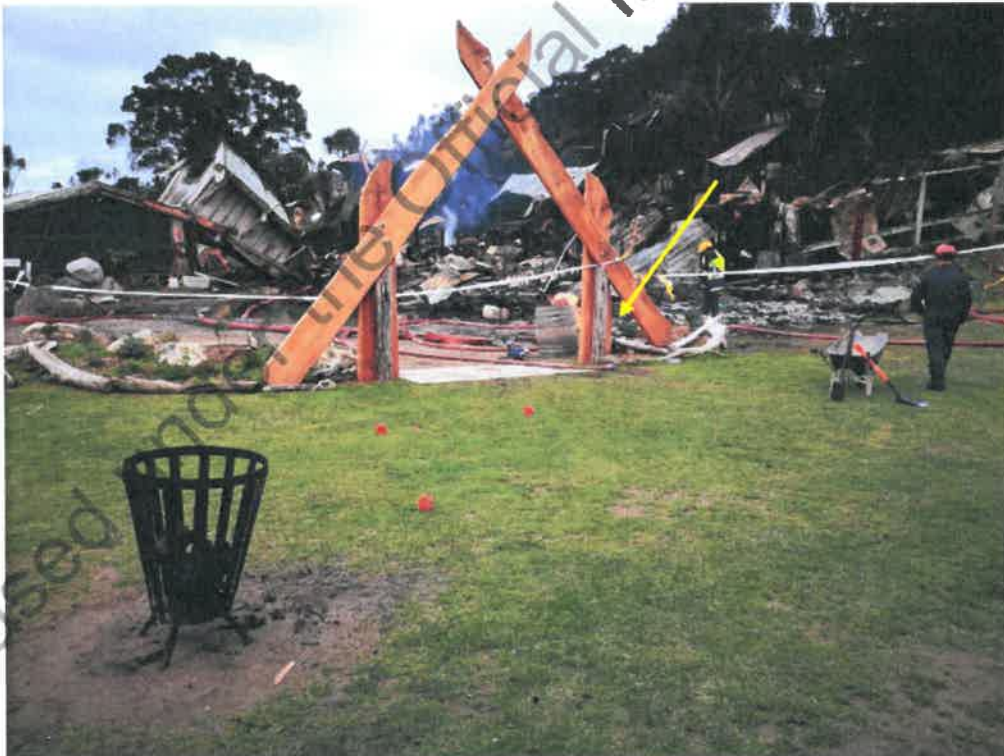
Examination of the immediate surrounding area identified a brazier located 14.8 metres southwest from the building. The brazier contained the remains of burnt wood and examination of the grass between the brazier and the 'main house' revealed a number of areas of scorched grass and remains of embers.

Photo 13 showing brazier location with embers spilled immediately on the northern side of the burner and orange markers showing location of further ember locations. The location of the storeroom wall believed to be point of origin of building fire is indicated by yellow arrow.

The probable cause of this fire² is believed to be the accidental ignition of combustibles in and around the southwest wall of the storage room. The source of heat is believed to have been embers that had travelled from the brazier and had been kindled by a gusting prevailing wind from the southwest until ignition occurred in or around the base of wall of the storage room.

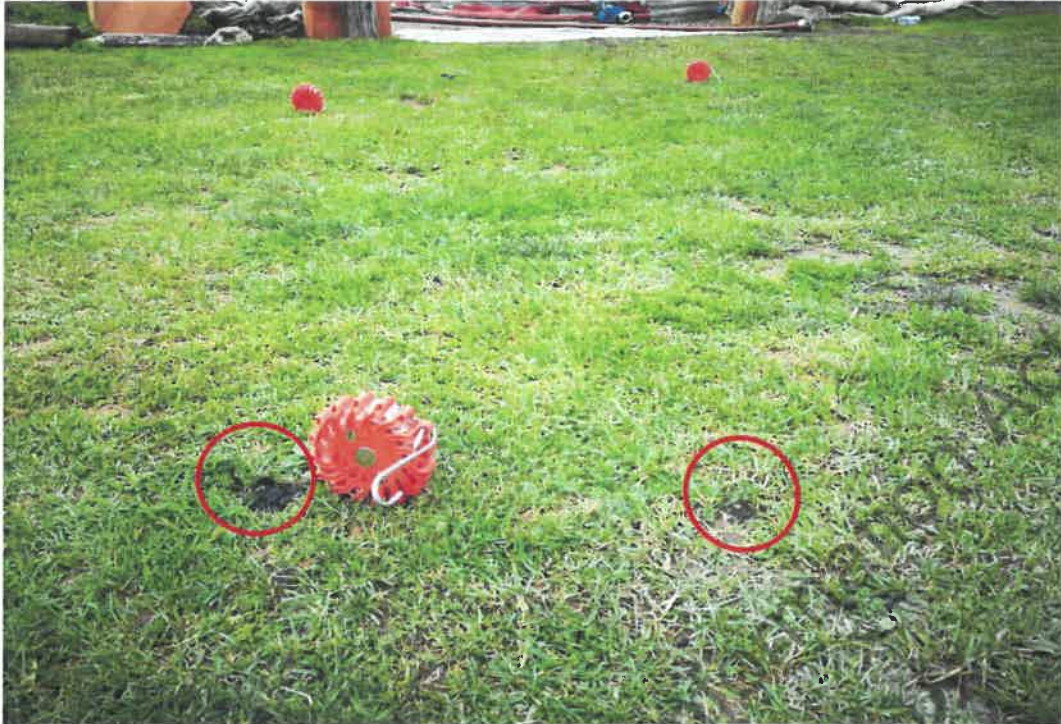
Photo 14 showing burnt grass from embers.

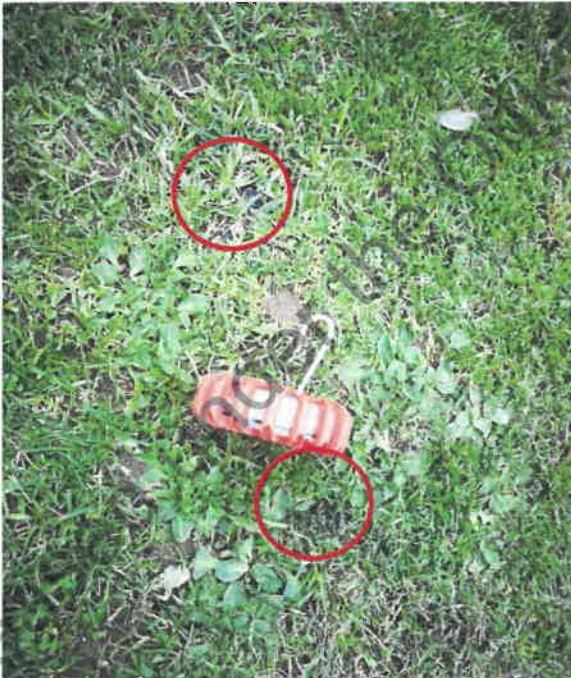
Photo 15 showing burnt grass from embers.

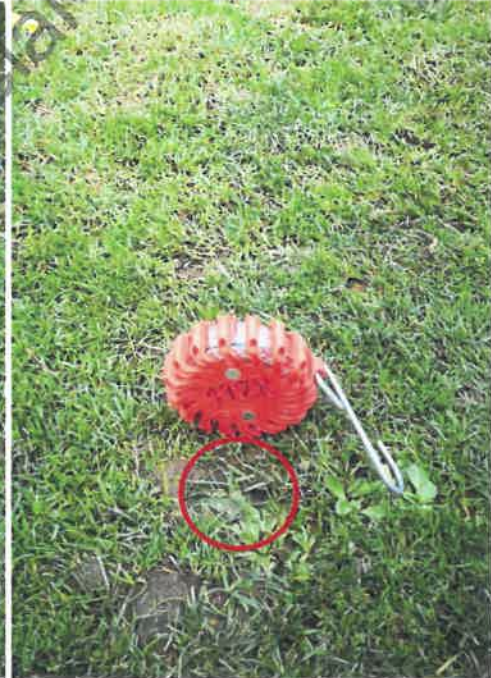
Photo 16 showing burnt grass from embers.
