## Fire Research & Investigation Unit

# Heads Up

### BACKGROUND

During May 2006 a fire occurred in a Rest Home and Hospital complex in Auckland that could have led to a loss of life or lives. This document summarises the findings of the Fire Investigation and Post Incident Audit that were carried out on the incident.

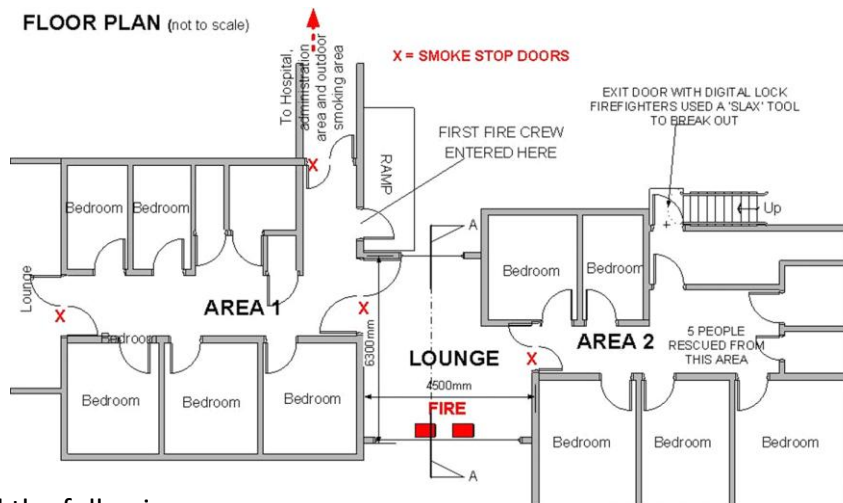
Just before midnight a fire started in a lounge area between two sleeping areas as shown on the floor layout on the next page.

During the evacuation, fire-fighters were unable to open the exit door from area 2 due to it being locked with a digital combination lock.

While it was later discovered that the code for the lock was displayed on a notice on the top left of the door, this was not visible due to the smoke haze. During the evacuation fire-fighters used a 'slax' hand tool to force their way out.

The locked exit door was an issue and highlights the need to have doors that can be easily opened in an emergency. One method of complying with the requirements of the Building Code is to install electronic digital locks that will release automatically when the fire alarm system activates.
