Fire Research & Investigation Unit

Heads Up

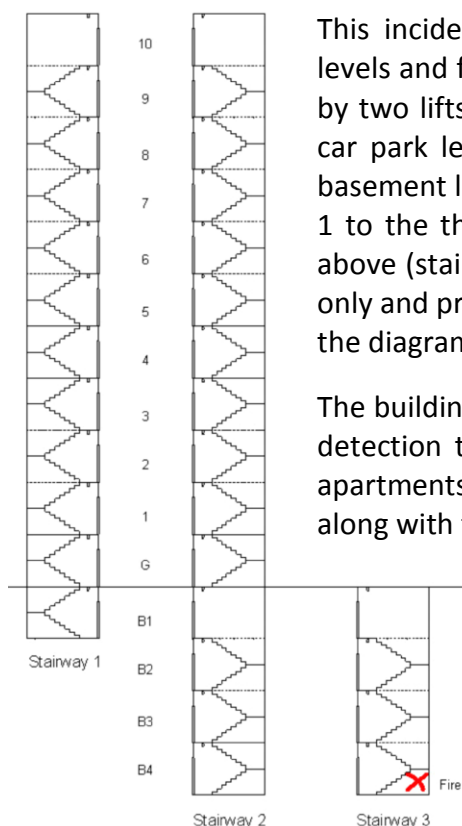
This incident was in an up market apartment building, with eleven residential levels and four basement car park levels. The eleven residential levels are serviced by two lifts, and two separate stairways. The lifts also service the four basement car park levels. In an unusual design configuration, one stairway terminates on basement level 1 (stairway 1), while the other provides access from basement level 1 to the three basement levels below, but not back up to the residential floors above (stairway 2). A third stairway (stairway 3) is dedicated to the car park levels only and provides access from basement level 1 through to basement level 4 as per the diagram to the left.

The sprinkler coverage within stairway 3 did not extend to the under side of the concrete stairs. This is concerning on the lowest level of a stairway, because this area often gets used for storage. In this instance the sprinkler (located over the landing on each floor level) did not activate because it was positioned too far away from the fire. Even if it had operated it would have been ineffective in any event due to shielding by the stairs. The fire did cause the activation of the stairway smoke detection, which initiated a building wide evacuation.

As it happens, stairway 3 is not a vertical safe path because it opens on to the car park firecells on each level. In this case then no exception is permitted, and the underside of the stair should have been covered by sprinklers. However sprinklers were not included under the stairs in the other two stairways serving the residential levels either, and these would have to be safe paths. Had the fire been set in one of these stairs, this incident would have been significantly more serious.

This incident also highlighted that correct sprinkler system design is critical to the safety of all buildings, and in particular multi-storey buildings with limited escape options.
