Fire Research & Investigation Unit

Heads Up

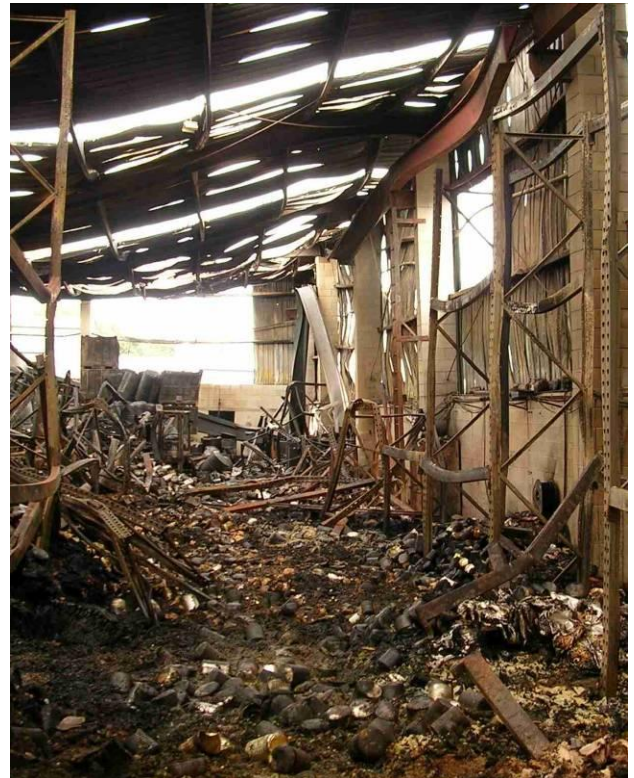
This fire grew quickly through the heavily loaded high stack shelving. The fire was very hot and the roof structure was distorting. The roof light panels had failed although the long run iron was remaining in place.

Photo showing distortion of steel structure and spillage of product from high rack shelving.

- This business indicated that they proposed to rebuild and that they would take appropriate fire engineering advice while planning for this. Business operators do not need to wait for a major event like this to occur, all business and commercial building owners should consider installing suitable fire protection systems to minimise the risk of huge losses and interruption to business as usual from fire.
