Fire Research & Investigation Unit

Heads Up

INFORMATION SOURCE F2683642 Commercial kitchen fire

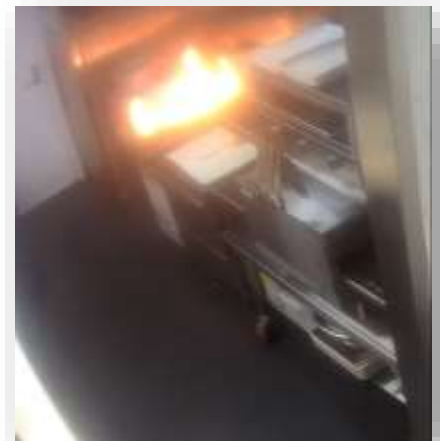
The oil in an overheated deep fat fryer of a commercial Kitchen ignited. The lack of combustible materials in the vicinity prevented fire spread so the fire was contained to the fryer. Café staff promptly turned off the fryer and isolated the power source, but attempts to attack the fire with a fire extinguisher were unsuccessful as the type of extinguisher used was not suitable for an oil fire. Eventually, the automatic sprinkler system activated and extinguished the fire.

Figure 1 - Fire contained to the oil surface

- Where it is possible to do it safely, any appliance involved in a fire should be isolated from gas and/or power supply.
- Portable fire extinguishers of the appropriate type should be provided in commercial kitchens. Not all types of extinguishers are suitable for these spaces. Refer to the Fire and Emergency position on fire extinguishers (<https://fireandemergency.nz/business-and-landlords/commercial-use-of-fire-extinguishers/>).

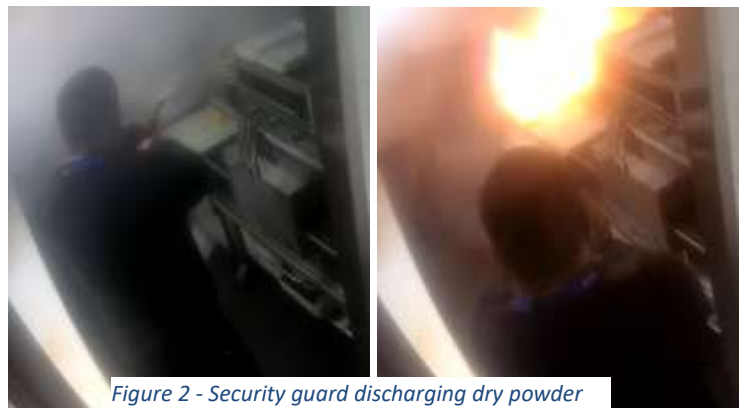
As the fire developed, a security guard entered the kitchen to retrieve a fire extinguisher located there. He used it to attack the fire with a short burst which initially extinguished the flames but the flames re-ignited immediately. A second, longer burst of the extinguisher produced the same result and the security guard was forced to retreat. During the investigation, the fire extinguisher was found to be a dry powder type. Approximately half of the contents had been discharged.

Figure 2 - Security guard discharging dry powder extinguisher, followed by immediate re-ignition

Whilst the dry powder was effective at extinguishing the flames, the residual heat in the oil was sufficient to re-ignite the oil surface immediately. This is because the powder stops the combustion reaction but does not form a stable layer on the oil surface to isolate the hot oil from the air. As the discharge of powder stops, the oil, already above its ignition temperature, encounters oxygen in the air again and the fire re-ignites.

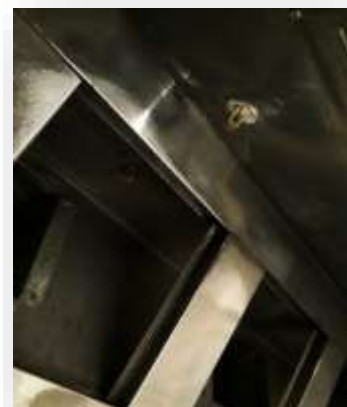
The building was fully sprinklered. The sprinkler coverage in the kitchen included two standard heads over the circulation / preparation area, one high temperature head directly above the cooking area and one standard head in the exhaust system (obscured by tape). The high temperature head above the fire activated eight minutes after ignition, discharging water directly onto the fire. The initial discharge caused additional flaming due to the boil-over phenomenon. This resulted in the activation of a second sprinkler head and the fire being extinguished. This demonstrates that standard sprinkler systems can deal with fires involving deep frying oil although there may be additional damage due to flaming oil expansion.

Figure 3- Sprinkler above fryer

- Sprinkler heads should never be left covered or altered in any way (this includes painting or attaching objects).
- When works must be carried out which present a risk of damage to sprinkler heads, appropriate process should be followed, which may include using an approved capping device for the duration of the works only, or isolating (part of) the system. Refer to the relevant standard for more information and isolation procedures (NZS 4515, NZS 4541).

- Where sprinkler heads are positioned in locations that are likely to expose them to accidental damage, approved protective features such as metal cages should be permanently fixed.
