## Fire Research & Investigation Unit

# Heads Up

Concentrated radiated heat from reflected sunlight ignited timber cladding and caused damage to the upper level and roof of a house.

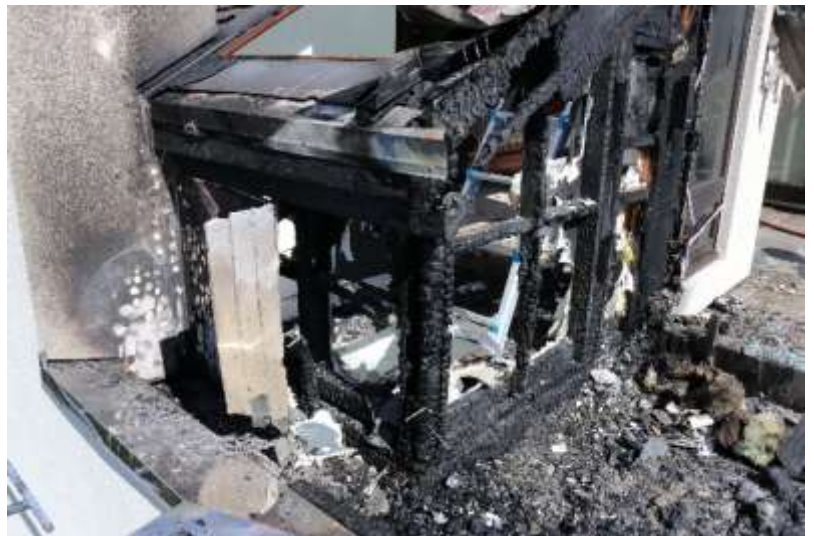
*Photo 1: Shows damage to the upper level of the house.*

Fire and Emergency NZ was called to a house on fire at 11:55am on April 14th. A developing fire was discovered in the top level of the house with the timber framing well alight when firefighters arrived. Examination of the scene showed no electrical sources or other viable ignition sources in the area of origin.

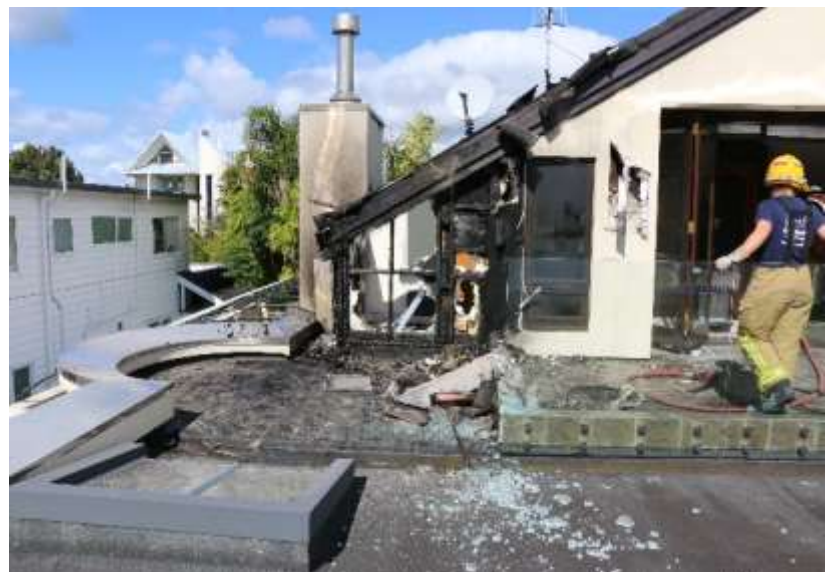
The fire investigator concluded sunlight reflected from the nearby stainless steel capping had been concentrated on the black coloured barge board of the roof structure.

At the time of the fire the sun would have been in a position to reflect heat energy directly onto the barge board. A combination of concentrated sunlight, lack of cooling due to still wind conditions and a black painted timber board absorbing the heat coincided leading to ignition conditions.

The capping had been added to the home approximately 1.5 years previously.

*Photo 2: shows stainless steel capping which reflected sunlight onto timber cladding.*

- Designers should take into account the effects of reflected sunlight when recommending reflective surfaces for use on external building surfaces
- Consider use of non-combustible materials immediately adjacent to highly polished or reflective surfaces.

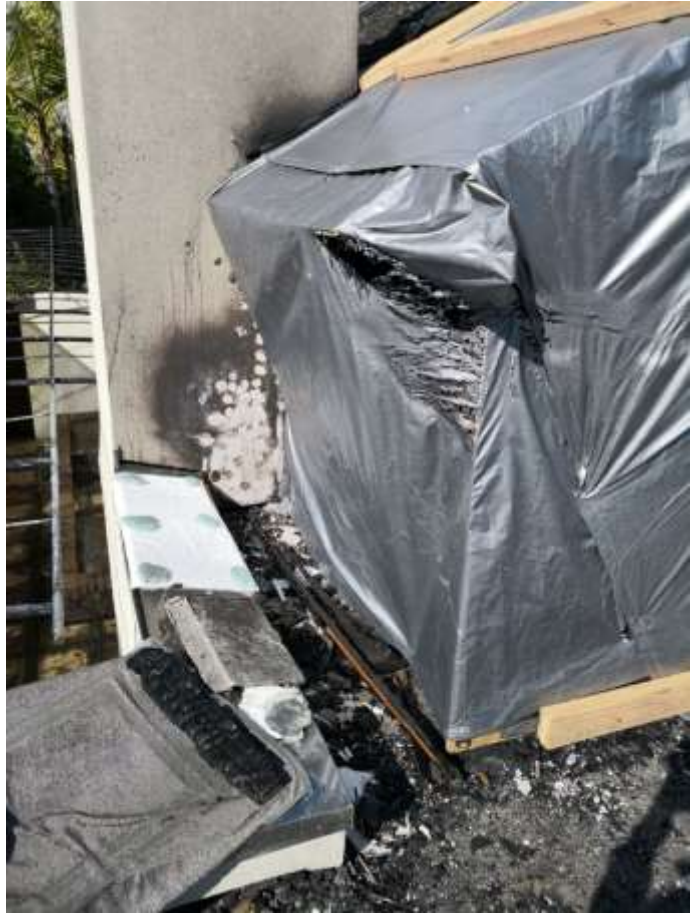
The damaged structure was wrapped with a tarpaulin sheet for weather protection, however two days later the building occupant observed that the tarpaulin sheet had also sustained heat damage.

This finding supported the earlier conclusion that the reflected sunlight was the source of the initial fire.

*Photo 3 – shows damage to tarpaulin that had been used to protect the house after the initial fire.*
