OPERATIONAL REVIEW

F3200236
Vehicle Fire
Stanley Road, Dromore
Ashburton
15-03-2021

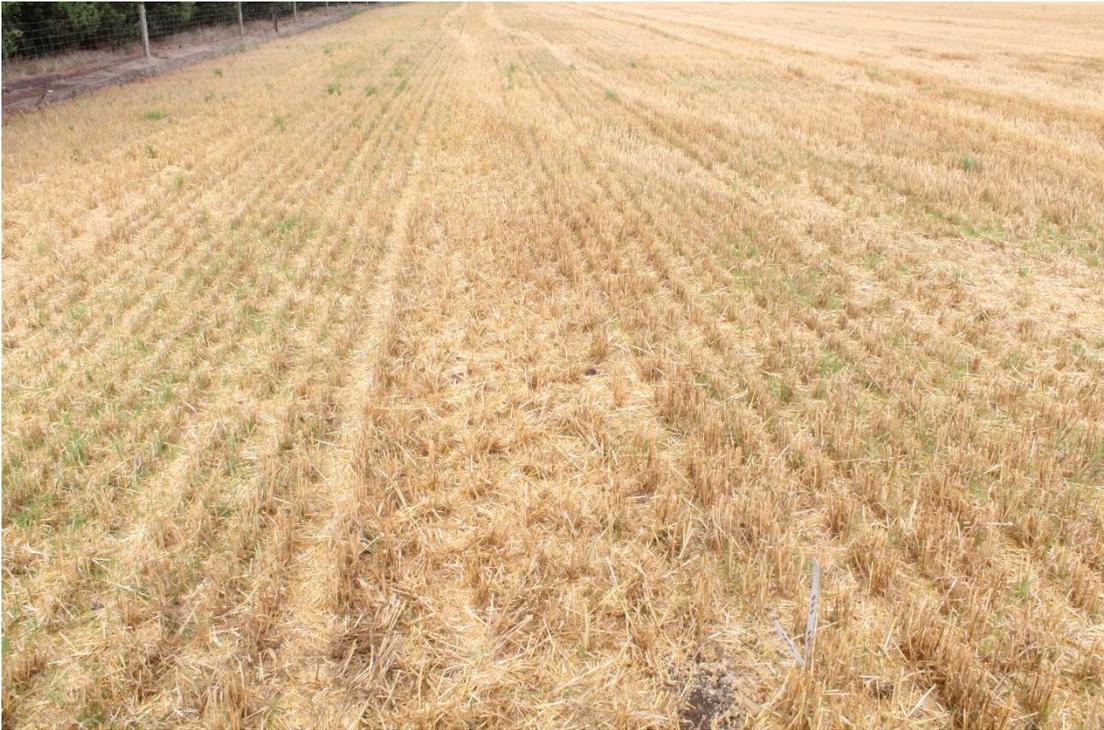
- The quantity of unburnt material in the stubble paddock was not known or recognised as being significant. Figures supplied by the farmer from the harvester's computer indicated approximately 10-12 tons of cured fuel per hectare. The maximum loading amount in fire behaviour outlined in the *Manual for Predicting Fire Behaviour in New Zealand in New Zealand Fuels* is "not measured" as t/ha at 0.105m height ^{Fig 1.0}. The review team noted that the maximum reference on D6 was for 7.4 t/ha. The following pictures show the fire behaviour manual calculations, the paddock the appliance drove into, and a paddock harvested unbaled in windrows taken from the same farm.

The paddock the Ashburton appliance drove into

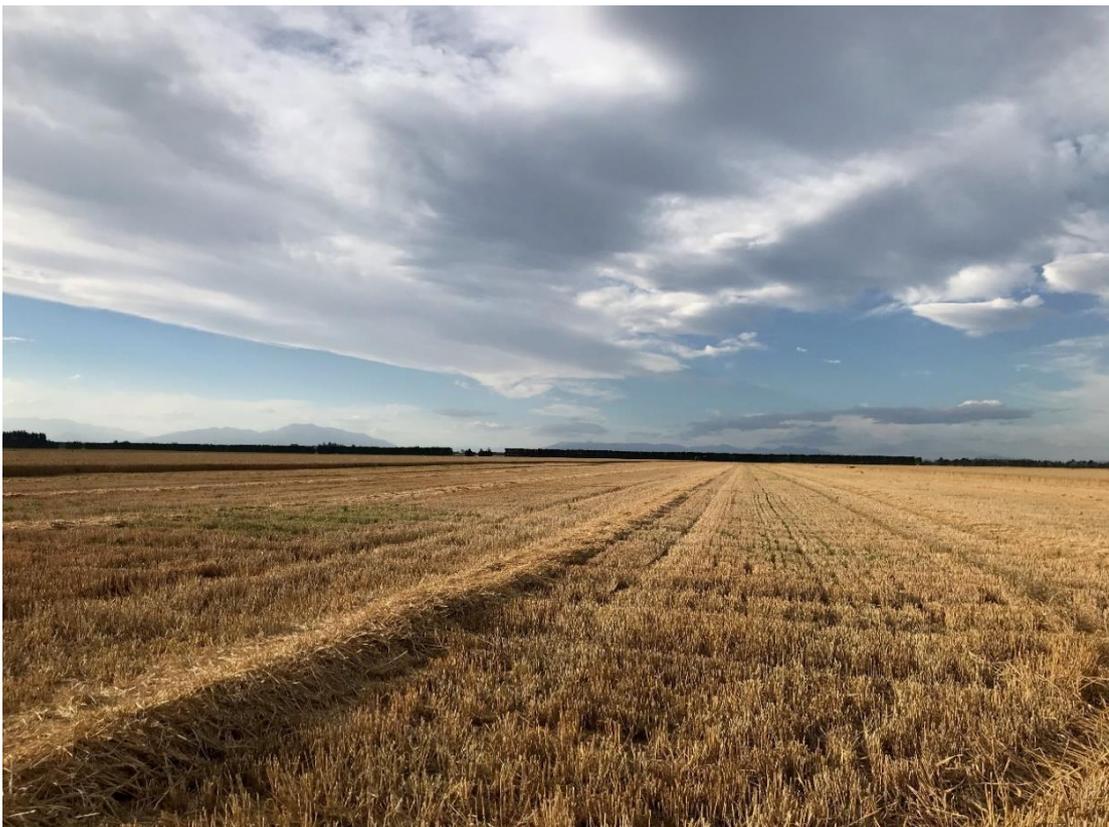
Example of a paddock harvested unbaled in windrows on the same farm

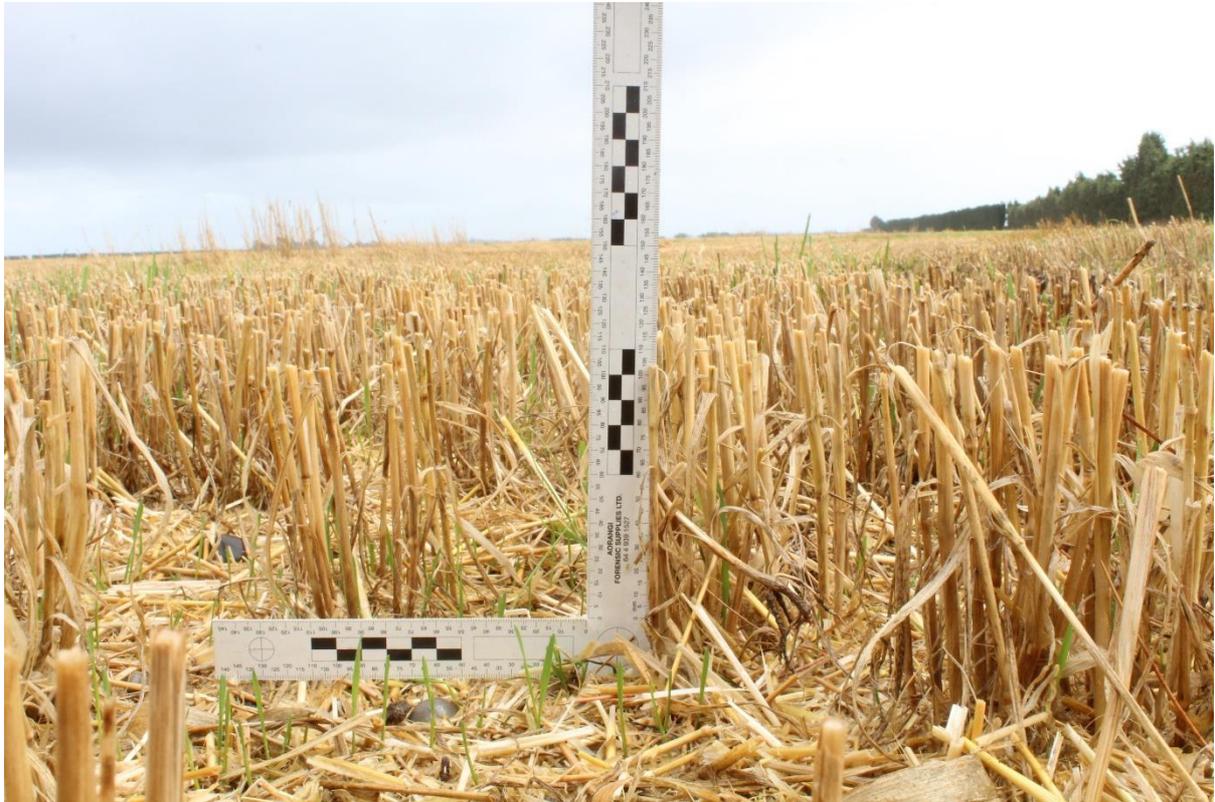
Fig 1.0

During the ASHB622 OIC's initial size-up, he believed the head of the fire had passed his position and the crew dealing with the harvester. His next tactic was to attack what appeared to be the right flank. The OIC also noticed the stubble on the ground and noted that in his experience of stubble fires, this paddock looked somehow different. However, he felt it was safe enough to enter based on his view of available fuel, as the stubble had been cut so low. *Fig 1.0*

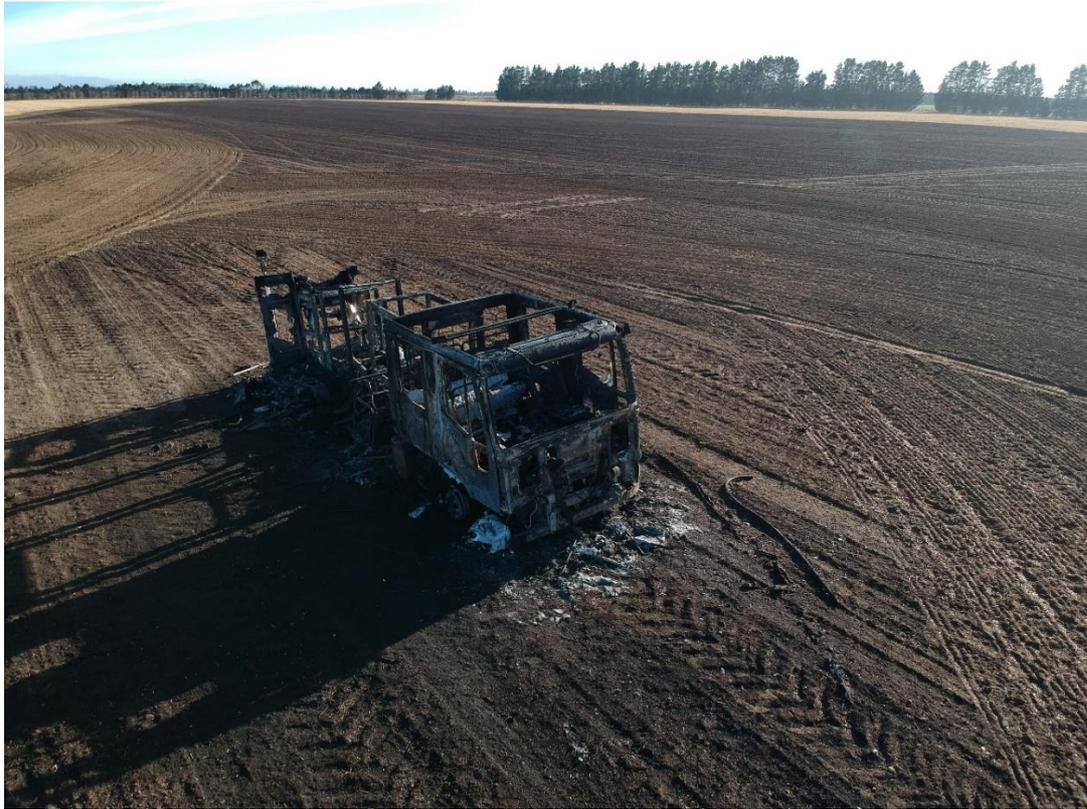
Fig 1.1

With the harvester now extinguished, the OIC ASHB622 directed the crew into the paddock to attack the flank. He asked the crew to relocate the appliance into the paddock on the flank and instructed the driver to face the appliance in the direction the fire was travelling and near to the gate they had entered. *Fig 1.1*

1. Review procedure outlining the parking priorities at rural incidences for urban appliances.
2. Fire behavioural specialists to work with federated farmers and Scion to gain information around the farming practices undertaken when re-cultivating very fine mixed crop dry matter back into the soil instead of the typical routine of burn-offs.

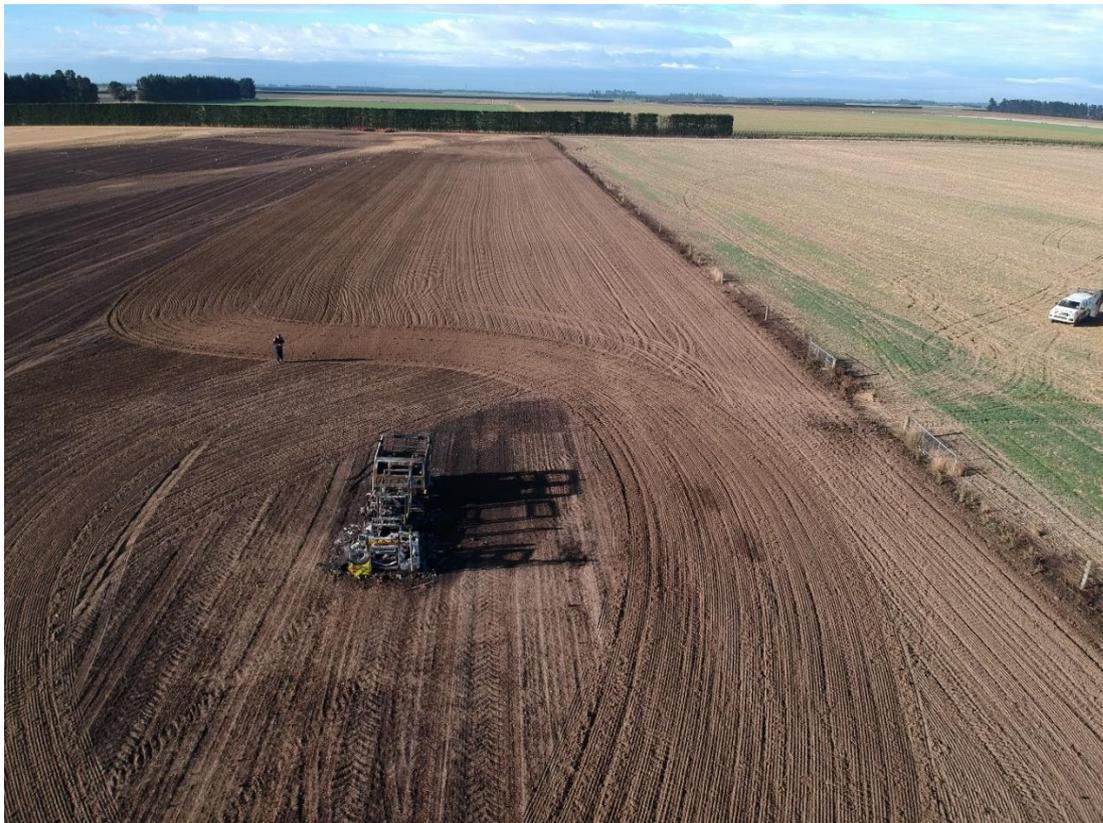
The ASHB622 OIC's priority was to focus on the extinguishment of the combine harvester, as the stubble fire did not pose an immediate threat to any property. The OIC directed the appliance into the connecting cultivated paddock adjacent to the stubble fire and drove up to the combine harvester located approximately 94 metres from the entry gate and accessway. *Fig 1.2*

The farmworker present in the adjacent paddock Fig 1.2 with the combine harvester stated he witnessed the fire advancing up the paddock behind the appliance. The fire investigator's findings indicate the appliance was situated inside a large curved fire front, created by the farmers' initial extinguishment attempts, the oscillating moderate wind and coalesce burning.
