Investigation into a fire appliance loss in Ashburton, March 2021

Fire and Emergency New Zealand

Date of Report: 26 April 2022

Prepared by: *Stacey Rees, HSE Global*

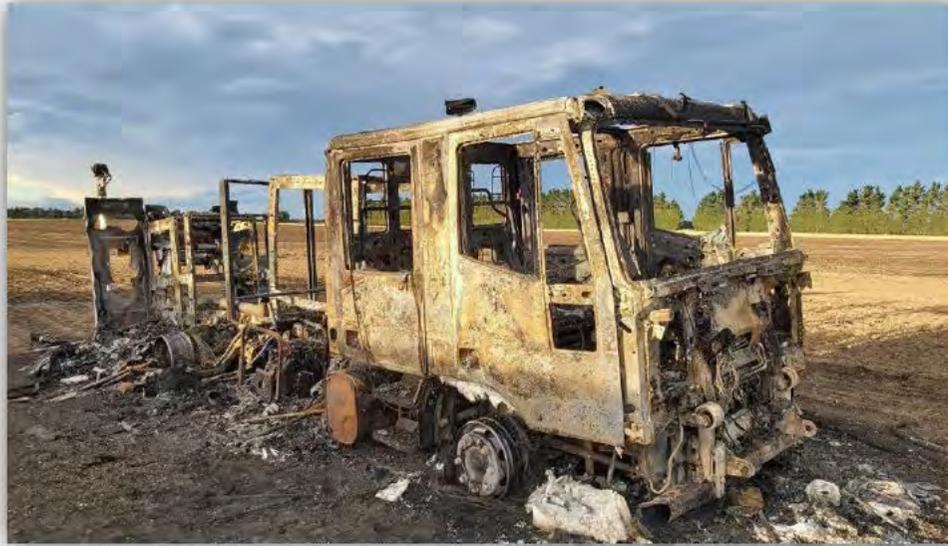
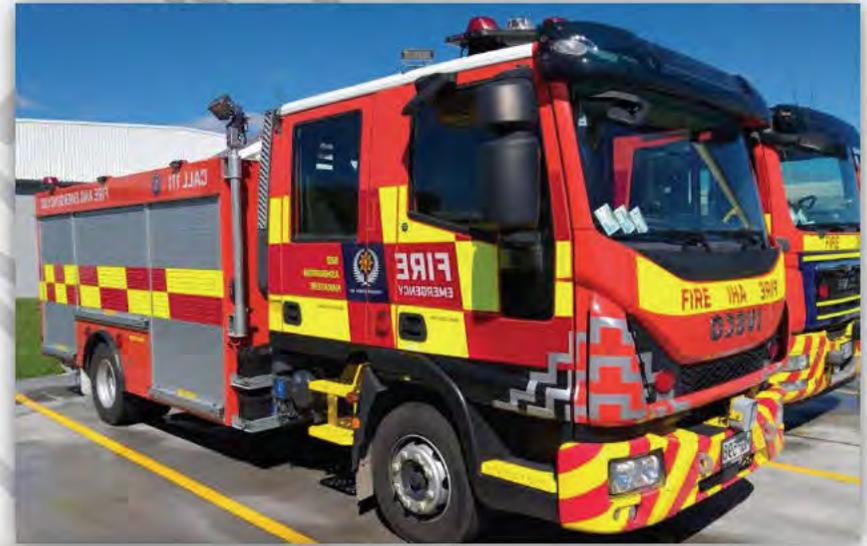
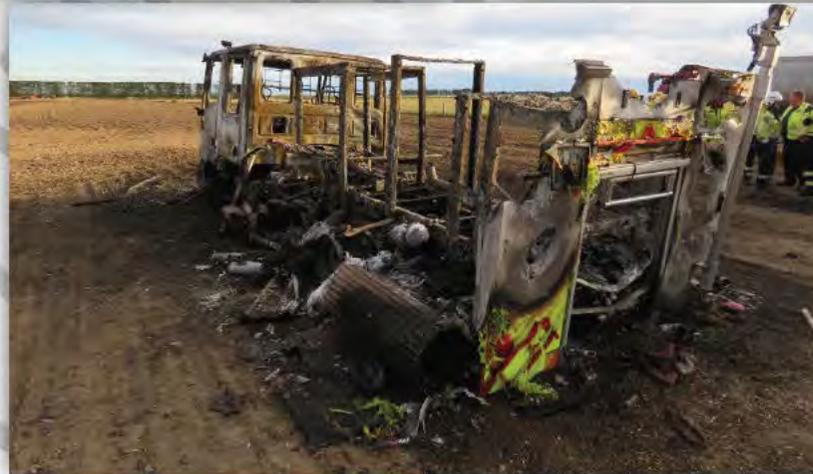
Photographs of the appliance involved

The below images reveal the ASHB622 state following the events detailed above, and of a 2019 Iveco EuroCargo ML120 the kind that was lost during the incident.

Following an event, the immediate cause is often apparent (the tip of the iceberg). In this case, the immediate cause was parking an urban vehicle on unburnt fuel at a rural fire.

14. Considering the weather conditions, fire travel, and stubble condition in the paddock, the appliance was not parked in an optimal position.
15. There are gaps and inconsistencies in respect of the rules regarding working on unburnt material during vegetation fires in the red book, green book, online training and R\$-143/2020 (see insert). There is no risk assessment available for this critical risk and no clear definition of controls, specifically critical controls. Therefore, monitoring and audit practices cannot be complete nor give assurance of risk control effectiveness.

17. The late realisation of the proximity of flames to the appliance was a major contributing factor to its loss. Due to the rapidly changing conditions, the location of the fire appliance and the late realisation of the situation, a rural appliance with higher ground clearance and the ability to move whilst pumping water would have suffered fire damage, but not been a total loss. The potential for other consequences of moving a fire appliance on unburnt stubble material whilst flames were on and around the appliance includes fatal harm to personnel. Communication is critical.
