# Fire and Emergency NZ

Accident investigation into fatal landslide incident at Muriwai  
on 13 February 2023

Incident Number F3667912

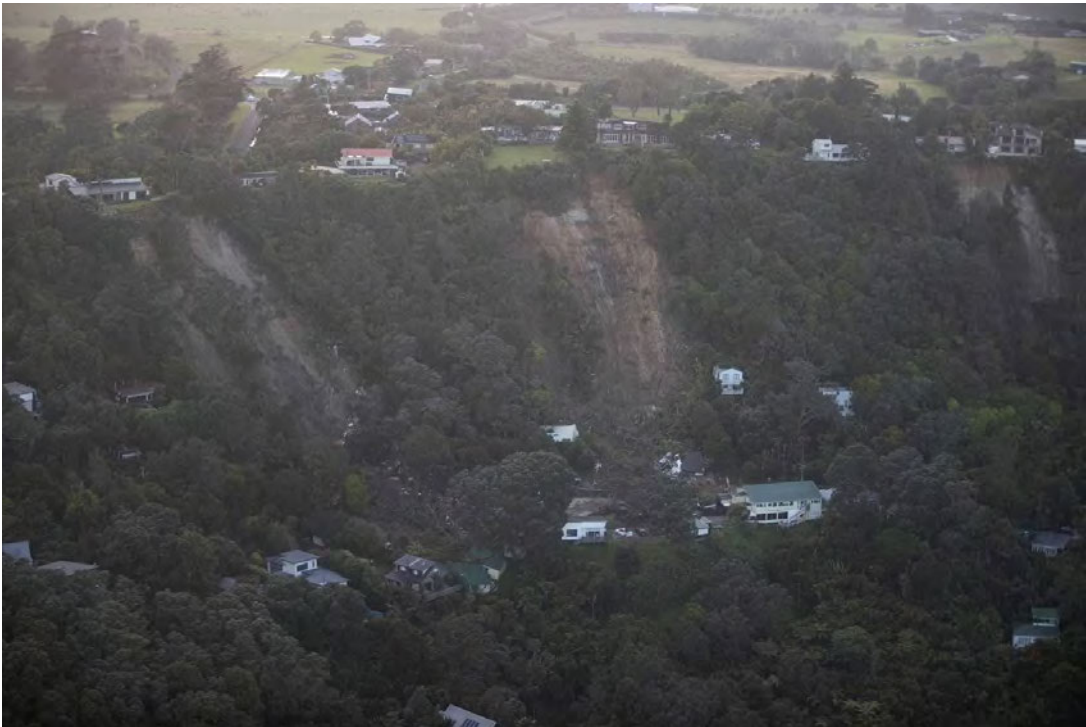
**Figure 1** above. Several slips above Motutara Rd. Firefighter rescue site at bottom of centre slip. Oaia Road houses along top of hill. (NZ Herald)

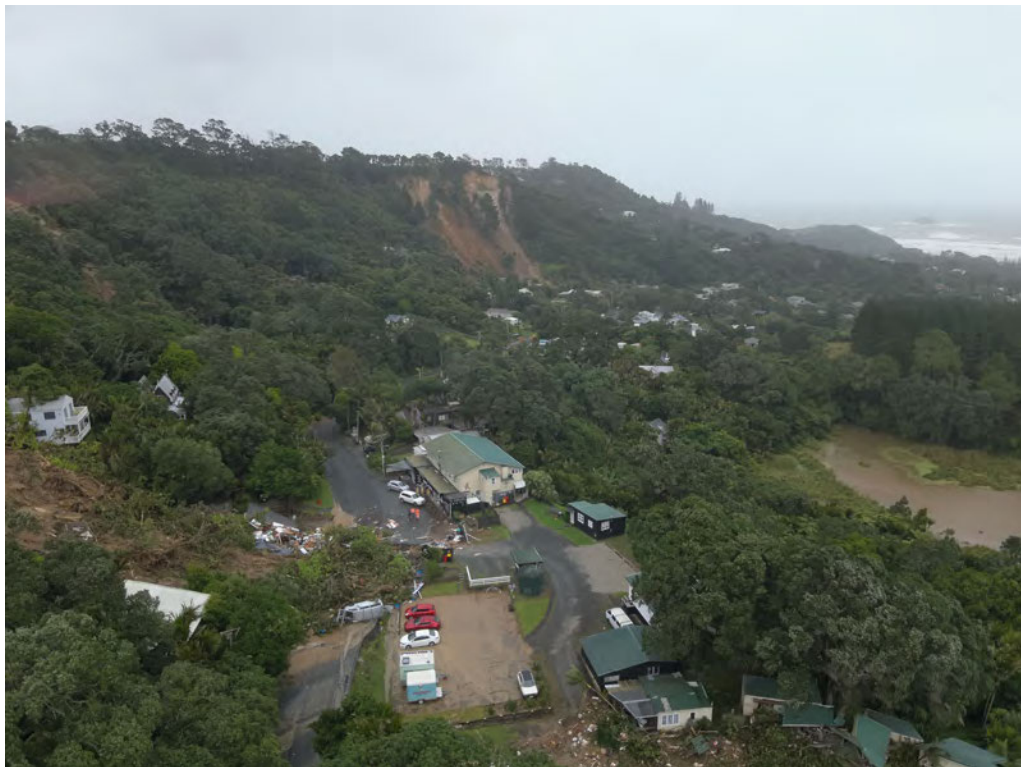
**Figure 2** above. Rescue site in foreground where debris covers road. Lodge café is the large building in the centre past the rescue site. (USAR photo taken 14:00 hrs on 14 Feb)

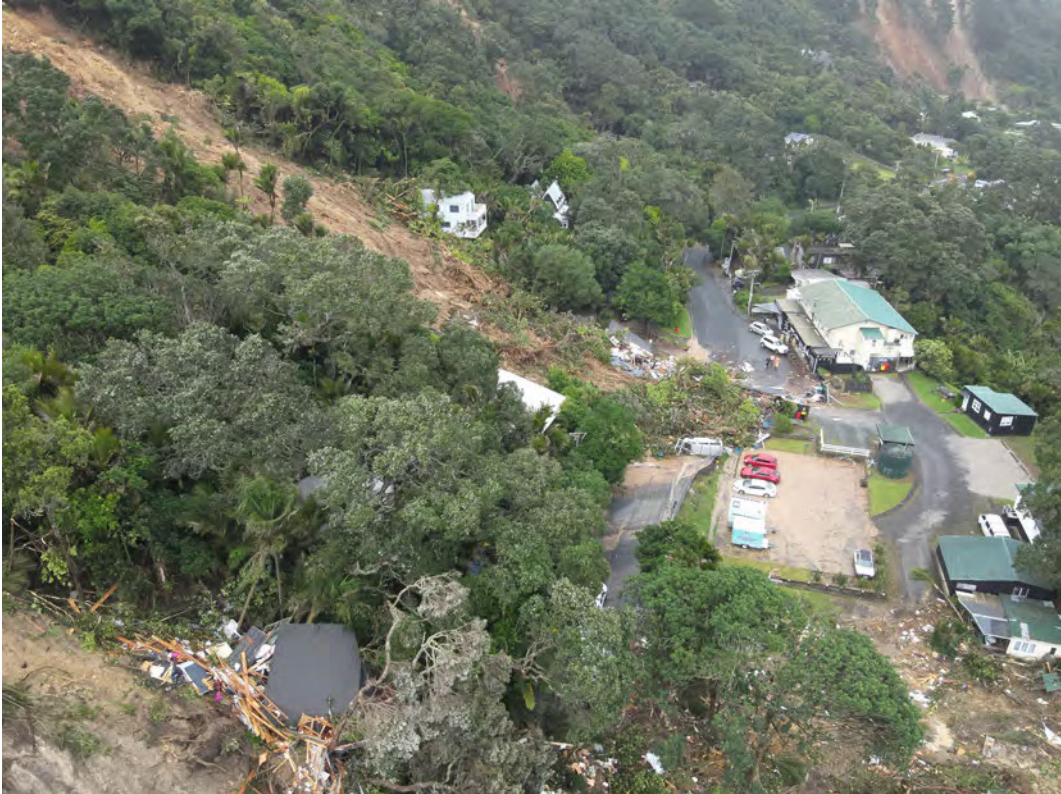
**Figure 3** above. Rescue site in centre right where debris crosses the road. The landslide in foreground happened during the rescue approx. 1 hr 50 mins after the first landslide occurred. (USAR photo taken 14:00 hrs on 14 Feb)

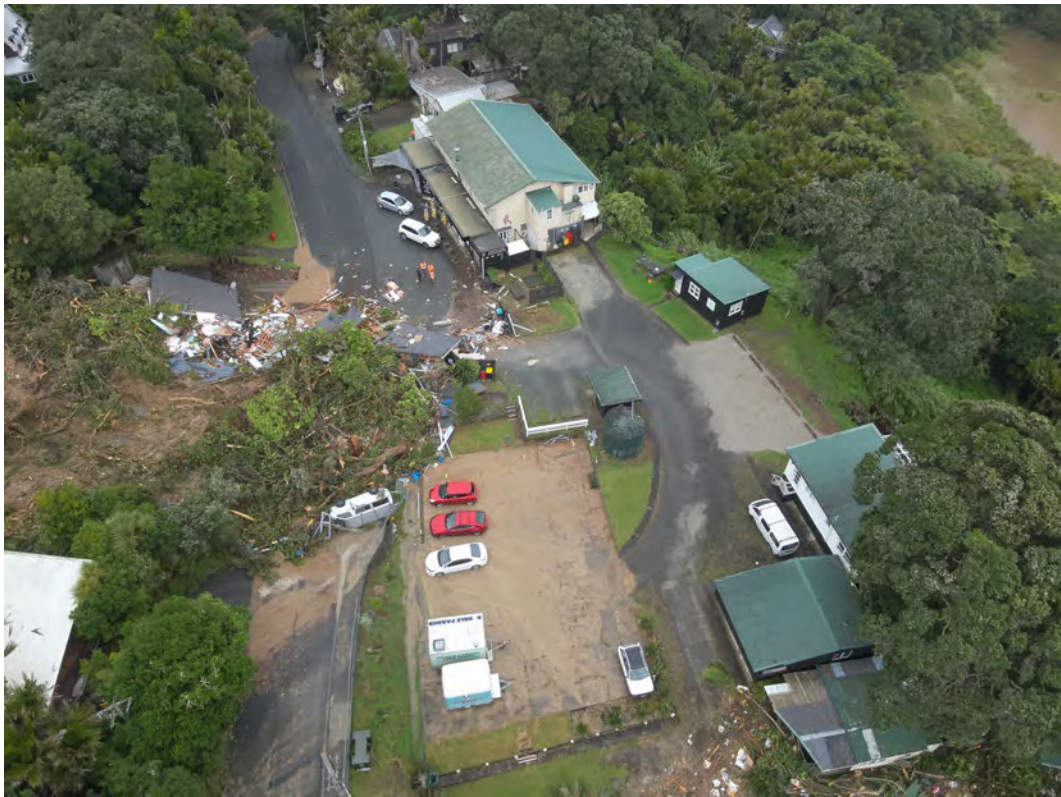
**Figure 4** above. Close up of rescue site on roadway. (USAR photo taken 14:00 hrs on 14 Feb)

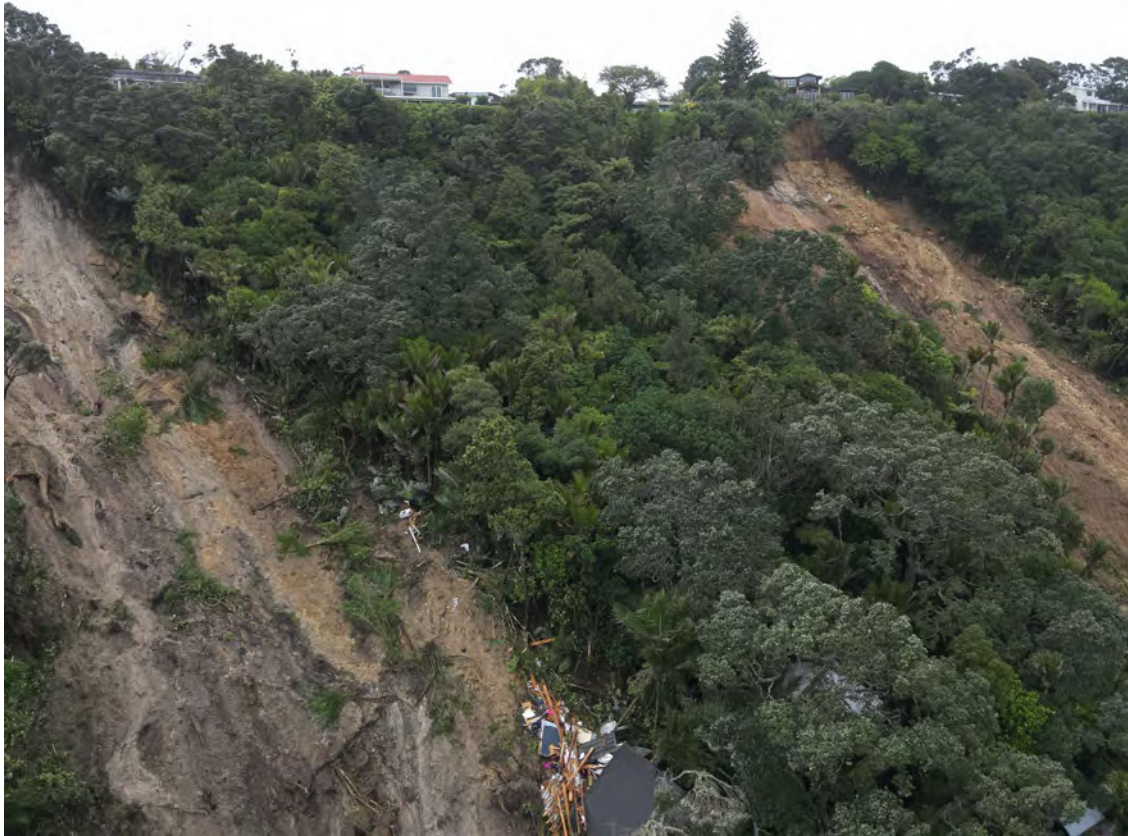
**Figure 5** above. Hillside above Motutara Rd with Oaia Rd houses at top of hill. The far slip is the first slip involving the firefighters with the second slip in foreground. (USAR photo taken 14:00 hrs on 14 Feb)

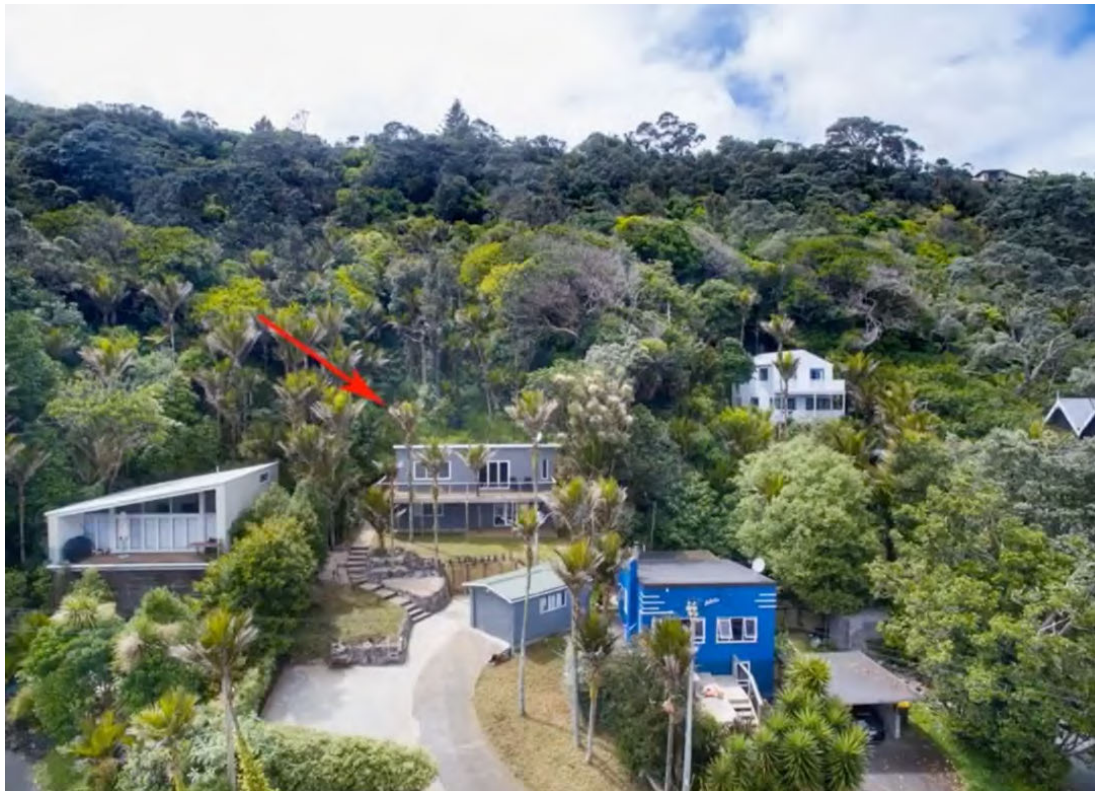
**Figure 6** above. Firefighters were working at the centre house indicated by the arrow before the landslide. (Real estate photo)

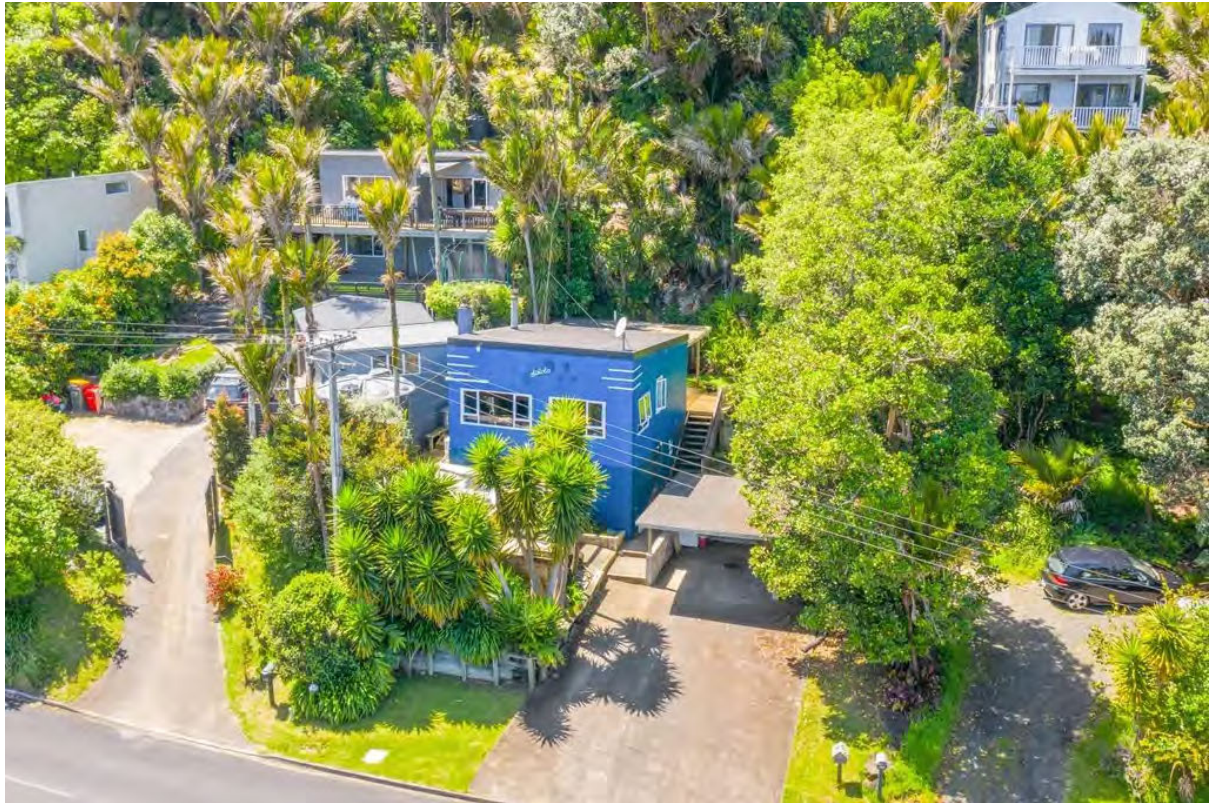
**Figure 7** above. Firefighters were working at centre rear house before the landslide. CFO rescued a person from roof section of centre front house shown after the landslide in figure 8 below. (Real estate photo)

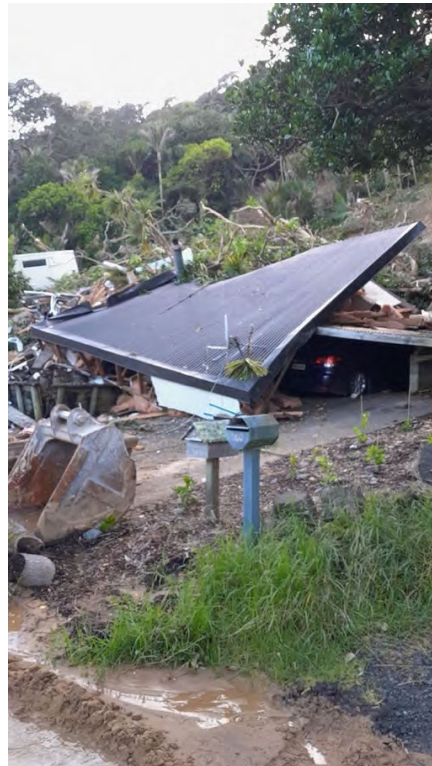
**Figure 8** above. CFO rescued a person from underneath the roof section shown above. This is the roof of the centre-front house shown in figure 7 above. (USAR Photo)
