Fire Research Report

The Adequacy of Existing House Foundations for Resisting Earthquakes: Effect on Service Reticulation and Ignitions

a Report Submitted to the New Zealand Fire Service
by Dr G.C. Thomas and J.D. Irvine
School of Architecture
Victoria University of Wellington

16 August 2007

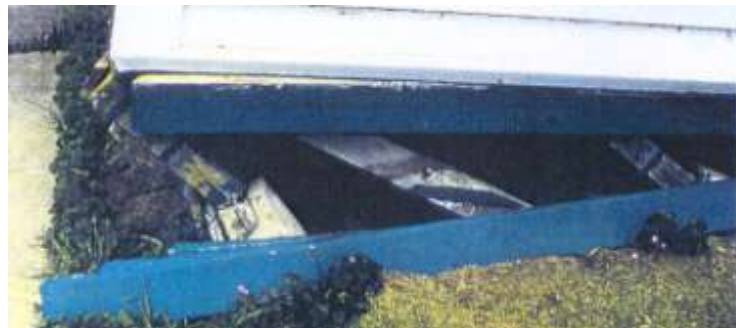
In past earthquakes, these dwellings often swayed sideways, especially if a dwelling had been repiled and replaced with only shallow pile footings [Figure 3.2]. Many dwellings of this age bracket usually have weatherboards covering the sub-floor area, however this form of cladding cannot be assumed to provide any significant sub-floor bracing potential.

Figure 0-2 Corner of Foundation showing Piles swayed to one side (Source: BRANZ 2003)

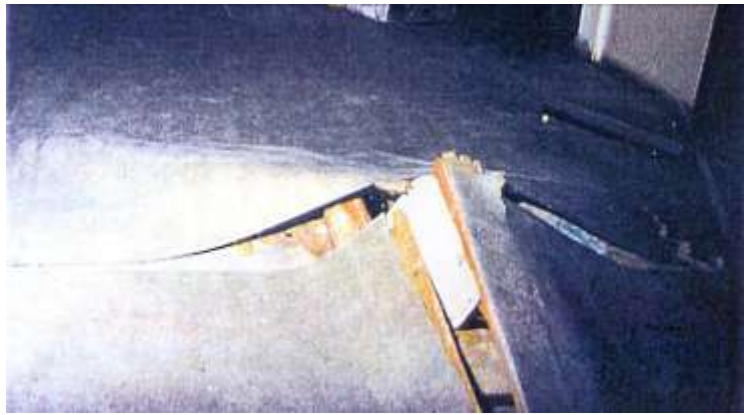
Observations of Piled Foundations with sheet bracing attached to exterior piles have shown good bracing performance in past earthquakes (Norton et al. 1994). However, much of the extensive damage to dwellings during the 1989 Loma Prieta earthquake was attributable to pre 1940's piled dwellings with unbraced exterior piles (Norton et al. 1994). Similarly, dwellings with walings or weatherboards on exterior piles also performed poorly and slipped from piles, which can result in the piles being punching up through the floor [Figure 3.3].

Figure 0-3 Example of Piles punching through the Floor due to Sub-floor Framing slipping off Piles (Source: BRANZ 2003)

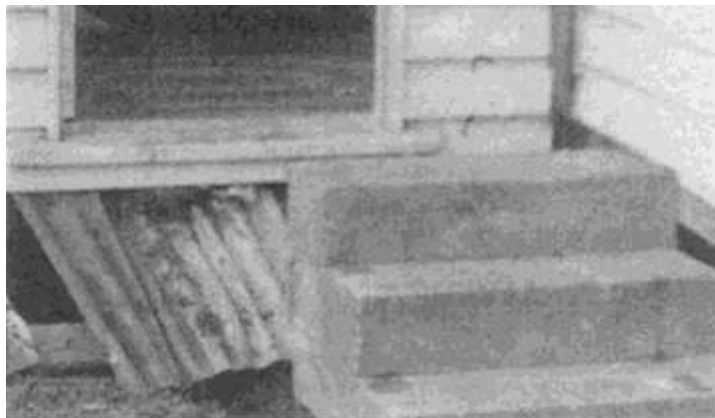
Anchors such as concrete steps, chimney bases and porches are commonly integrated into the piled foundation sub-floor, which provide a significant amount of lateral resistance [refer Section 5.1]. However, if these ‘anchors’ are not adequately connected to sub-floor framing smashing between the piles and concrete could also potentially occur damaging the vertical load sustaining system (Norton et al. 1994) [Figure 3.4].

Figure 0-4 Full Piled Foundation slipped off Foundations, with Concrete steps remaining in place (Source: Cooney 1979)

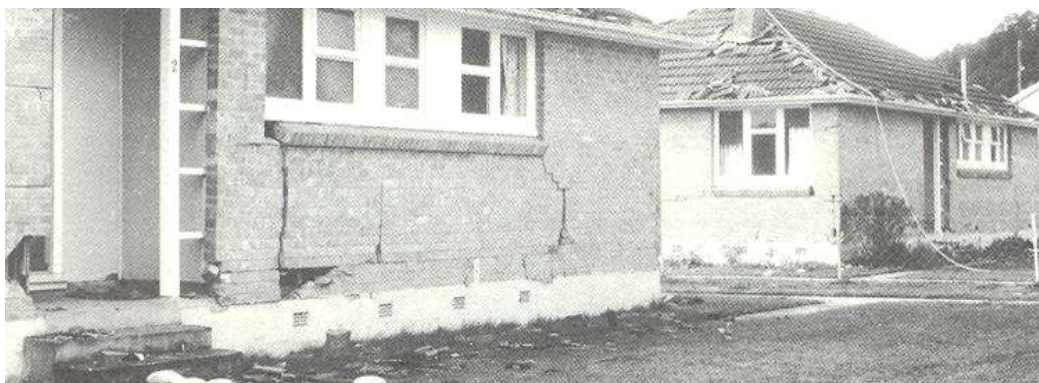
Figure 0-6 Superficial Damage to brick veneer on State Dwellings, however no damage to the Foundation Wall is evident (Source: Eiby 1980)

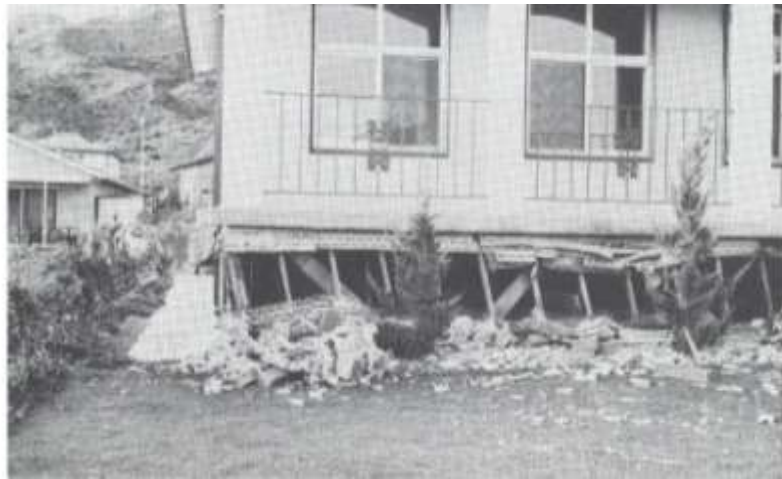
Other foundation types that are also considered as Partial Foundation Walls are foundations with jackstudded sub-floor walls, where short timber studs span between the wall bottom plate and the concrete foundation wall below. As evidenced in past earthquakes, unbraced jackstudding can cause full or partial collapse to the foundation and therefore requires sheet bracing fixed to the interior or exterior of the jackstudding (Norton et al. 1994) [Figure 3.7].

Figure 0-7 Jackstudded Sub-floor showing Cladding broken off and a slumping to one side (Source: Jennings and Housner 1971)

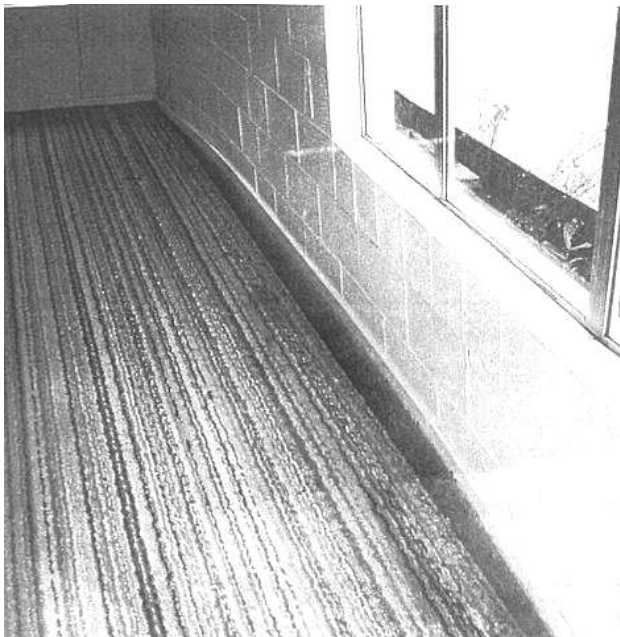
Figure 0-8 Wall separating from Exterior Foundation wall (Source: BRANZ 2003)

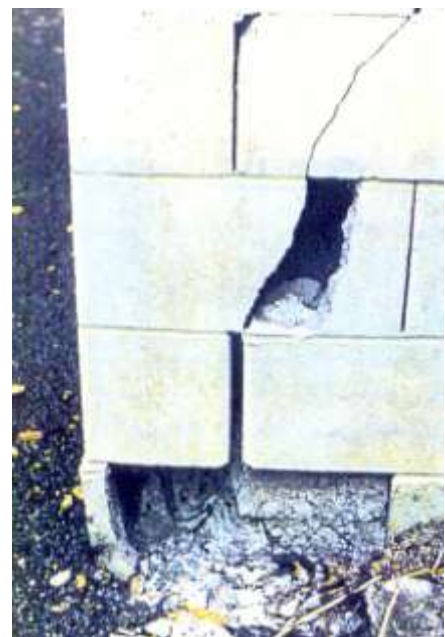
Figure 0-9 Extensive damage on the Lower Courses of Block in a Full Foundation Wall / Internal Piled Foundation (Source: BRANZ 2003)

This type of damage could also cause cracking to appear in mortar lines and blocks if the movement is severe. However, this damage can usually be easily repaired and would not cause the collapse of a dwelling.

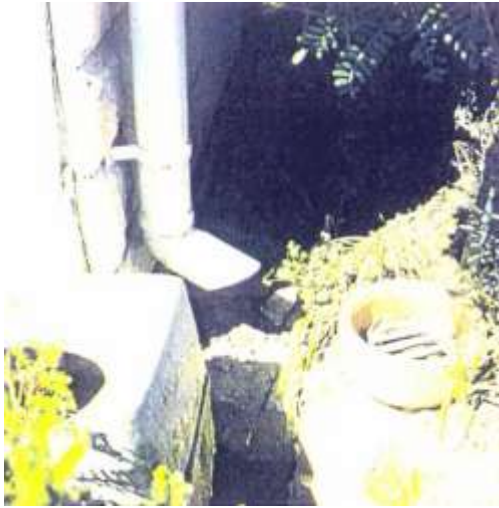
Figure 0-11 Slab on Ground showing relative sliding difference between the Dwelling and Ground; note the prior location of Services (Source: BRANZ 2003)

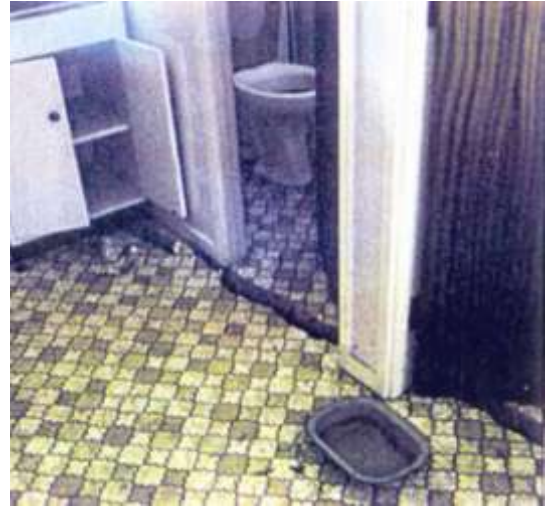
Figure 0-12 Severe Cracking through a Concrete Slab (Source: BRANZ 2003)

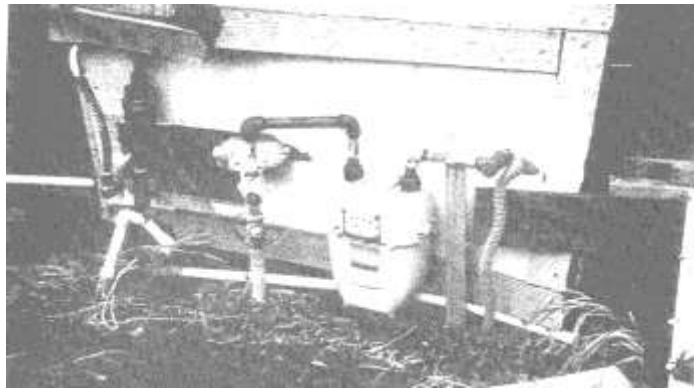
Another development and significant cause of post-earthquake fires, is the rupture of reticulated gas services between the dwelling and the gas mains in the street, which are usually buried. These failures were common where ground deformations were larger than a few inches. A rupture of such a pipe may not be immediately obvious, however may still cause fires in and around dwellings (Chung et al. 1995). Natural gas piping on the customer side of the pipeline showed that service connections and meter sets are more vulnerable when a structure falls off its foundation and crushes or shears the attached service connection (Chung et al. 1995) [Figure 4.1].

Figure 0-1 Damaged reticulated Gas meter next to a dwelling with distorted foundations (Source: Todd et al. 1994)

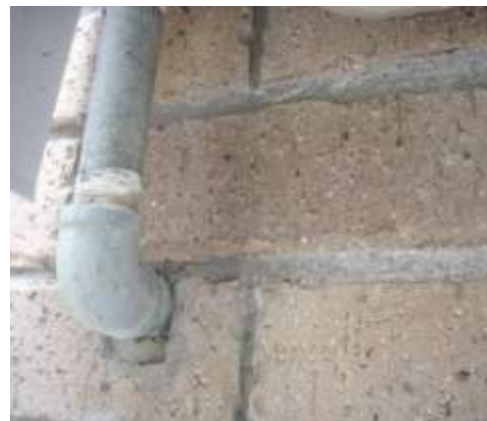
Figure 0-3 Rigid Gas Connection into Brick Veneer

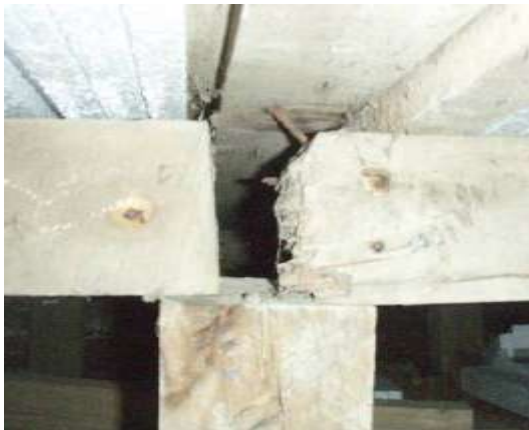
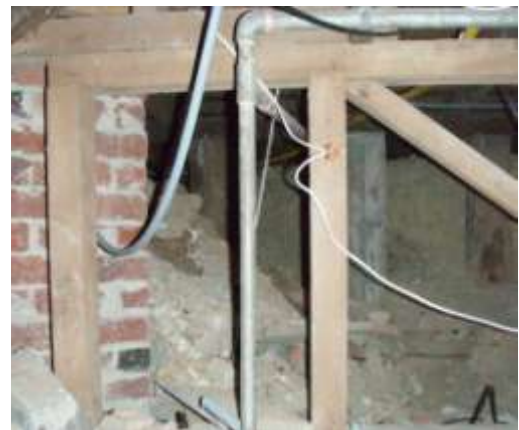
The gas distribution system may also be at risk if the gas network in the sub-floor space is connected over major structural joints which could move excessively or deflect beyond the ductile capacity of the gas pipe work. This could be an issue where pipe work is directly connected to structural framing members, which could potentially move off their supports [Figure 4.4] or move prying apart pipes and breaking electrical cabling [Figure 4.5].

Figure 0-4 Structural Connection likely to move apart in an Earthquake
Figure 0-5 Pipe work interweaving within the Structure

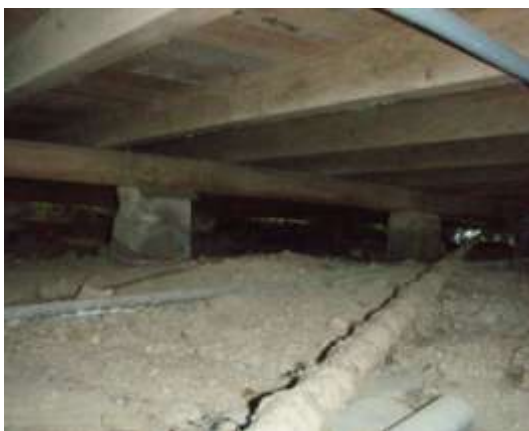
Figure 0-6 Gas Pipe work laid on the Ground under Dwelling
Figure 0-7 Copper Gas reticulation with reserve flexibility of tubing

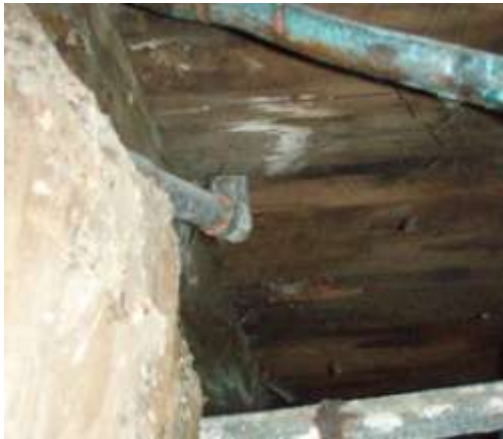
Perhaps the most crucial connection for all dwellings is the connection into the flooring [Figure 4.8] and whether or not flexible connections exist between the gas mains and the appliance it is serving [Figure 4.9]. If this connection is not flexible, any significant movement of the foundations, including even slight swaying, could shear off the gas connection into the dwelling causing a gas leak (Scawthorn 1987).

Figure 0-8 Rigid Gas Connection into Flooring of dwelling
Figure 0-9 Flexible Gas Connection into Gas Appliance
