Fire and Emergency New Zealand Wildfire Investigation Report

| Fire Name: | Lake Ōhau Fire, Lake Ōhau Road |
| Fire Date: | Sunday 4 October 2020 |

Classification of Fire Cause: Accidental

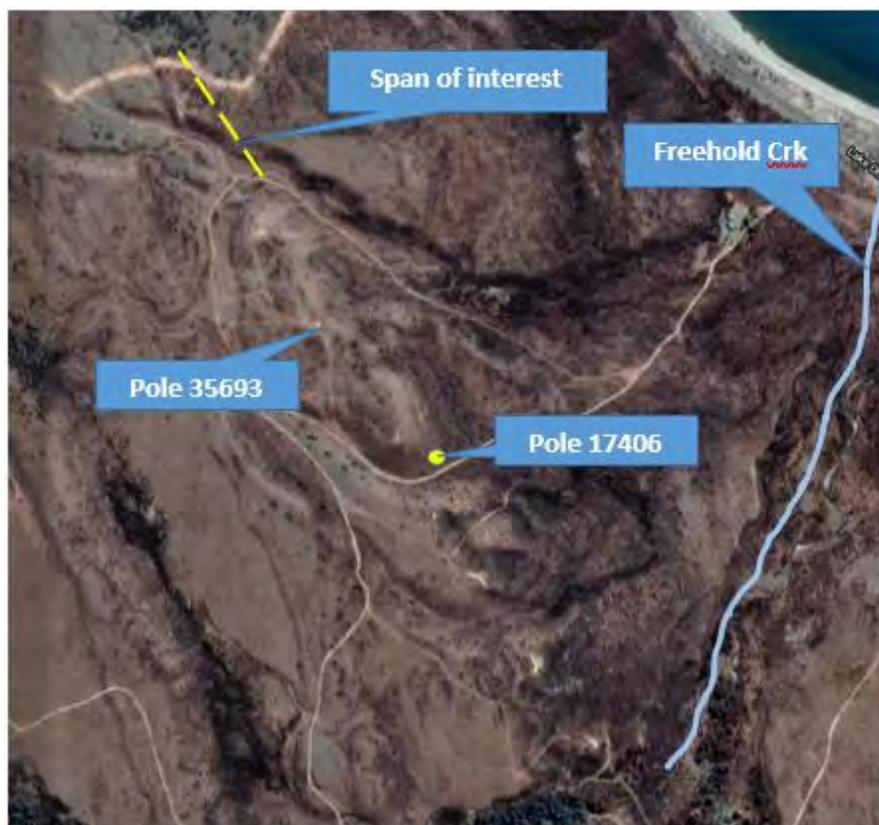
Following the fire pattern indicators back in a northerly direction, we came across pole 35693 that appeared to have arc or heat damage on both metal stay arms. Other than the arc marks the pole appeared in good condition.

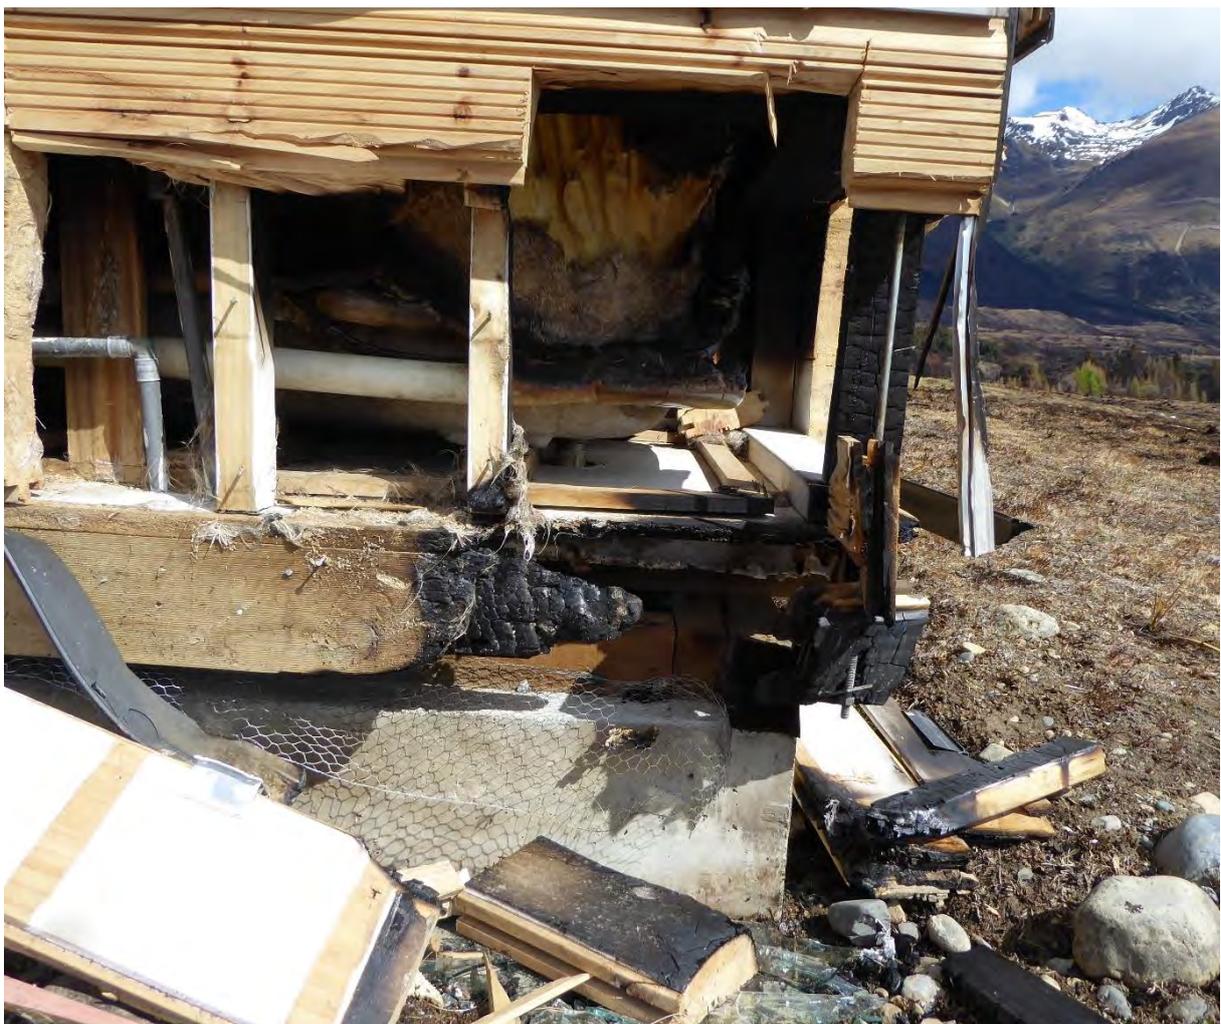
Fig. 20. An example of a partially damaged building due to ember transfer.

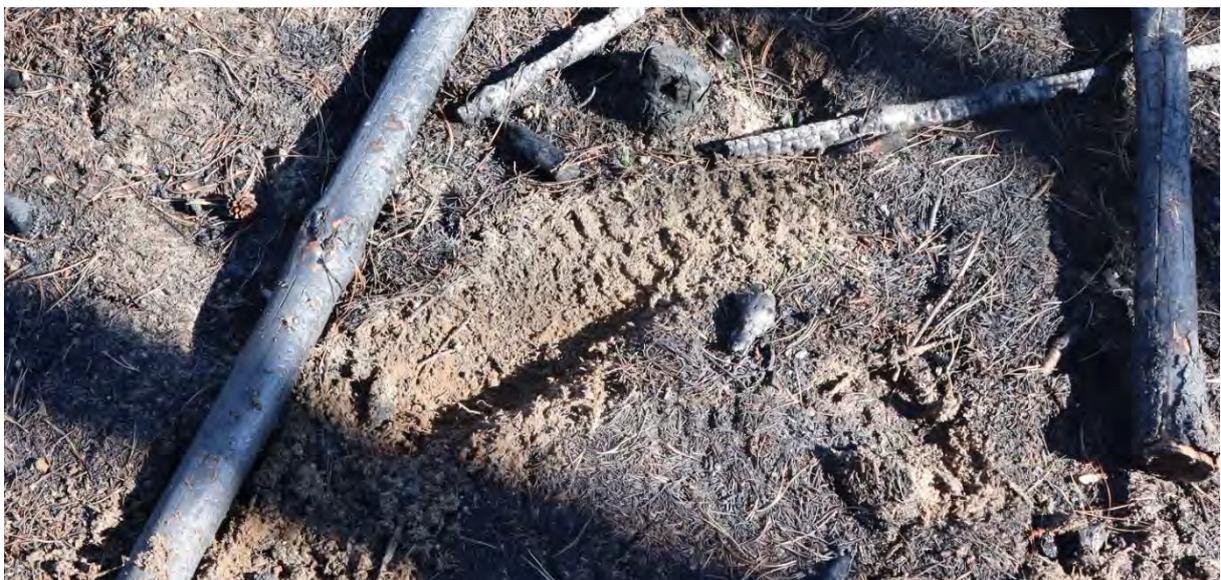
Fig. 35. Above, boot mark in the duff layer, fire has only consumed the top layer of pine needles and not become deep-seated as the Drought Code was recorded at 59.2.

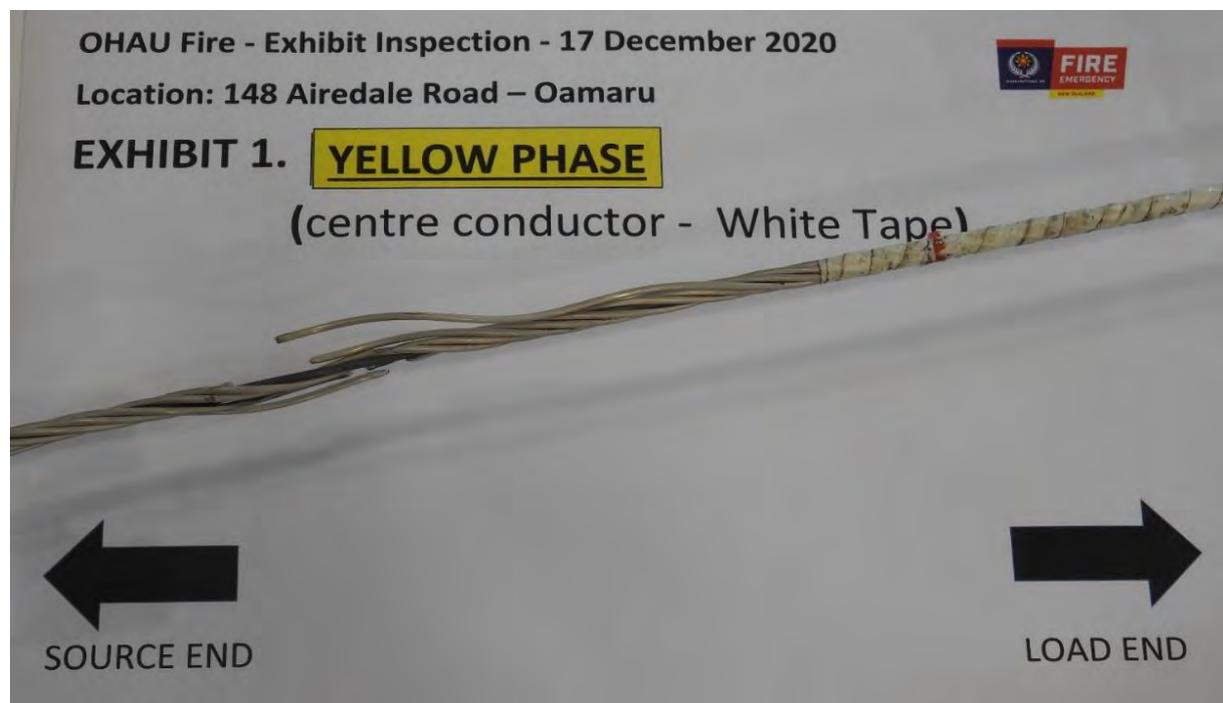
Fig. 37. Damage to Yellow Phase conductor (White tape).

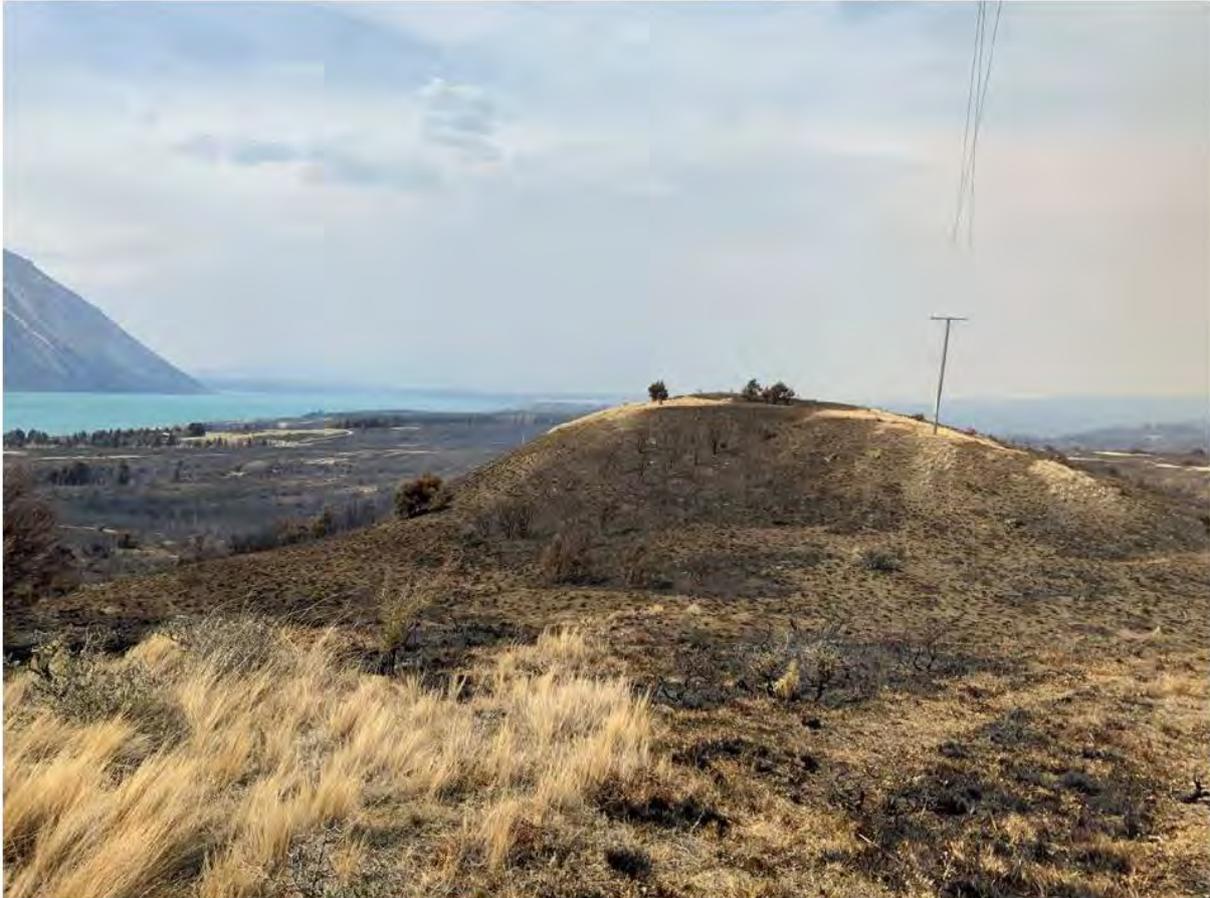
Fig. 40. Above shows lines that had have twisted but may not have made contacted each other. These lines are attached to pole 35693 spanning down to pole 17408 in the background.

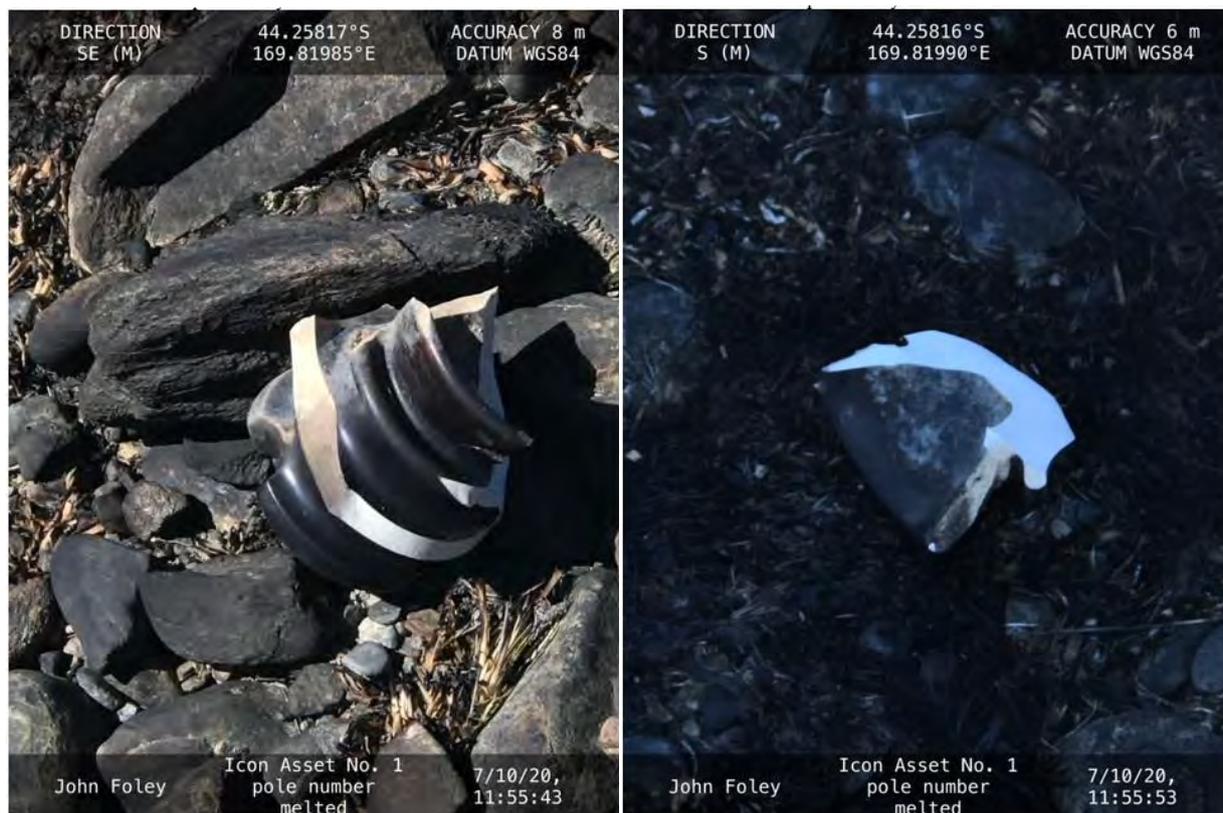
(A3) Pole 40456 (old pole number 17406) broken insulator on the ground.

- A broken insulator was located on the ground and appeared to be freshly broken (refer to Fig's 41 and 42). (Photographs only)

Fig. 41. and Fig. 42. Above, broken insulator located near pole.

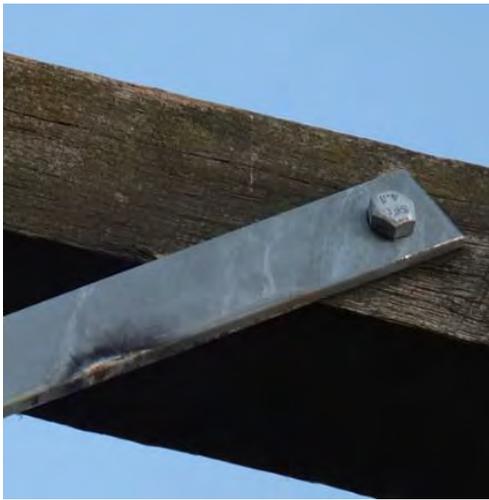
Fig. 45. Photograph (DSCF9361) above left identifies an arc mark to the lakeside metal stay arm on the upper section close to where it is secured to the wooden cross-arm with a double nut.

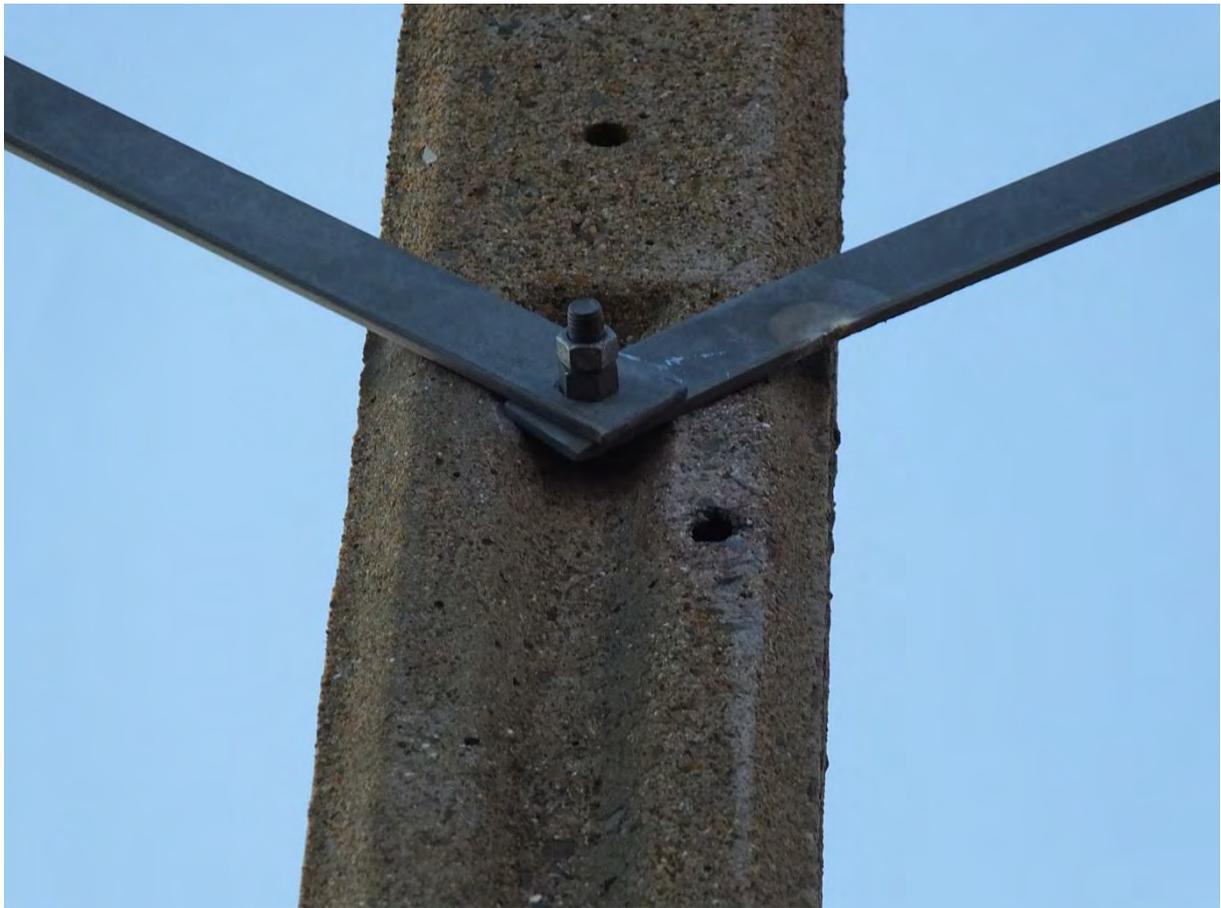
Fig. 48. Photograph (DSCF9365) above shows the lower arc mark on the hillside metal stay arm, a hole below the stay arm and what appears to be a scrape mark on the right-hand side of the pole below the metal stay arm.

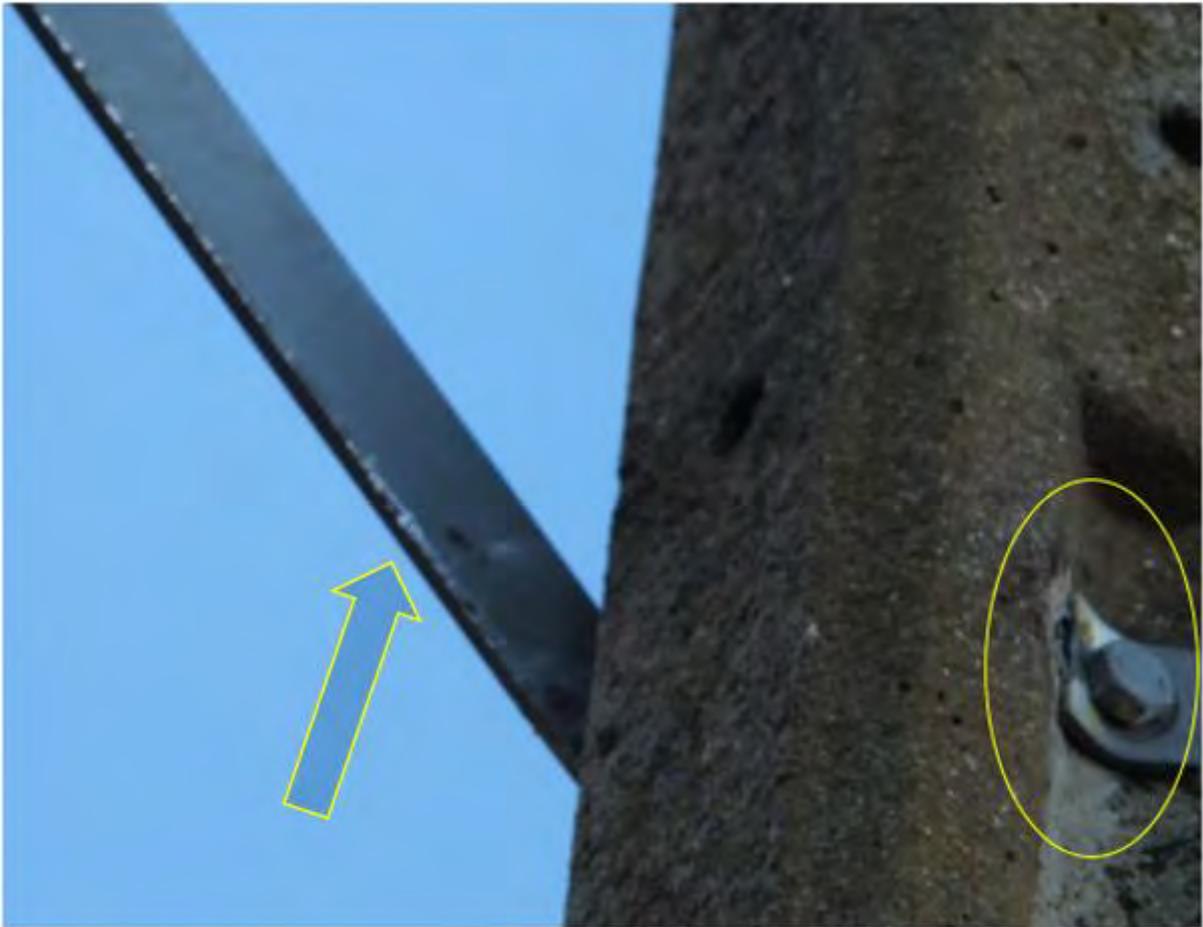
Fig. 49. Photograph (DSCF9369) above identifies location of damage to centre bolt, washer, and damage to edge of metal stay arm.

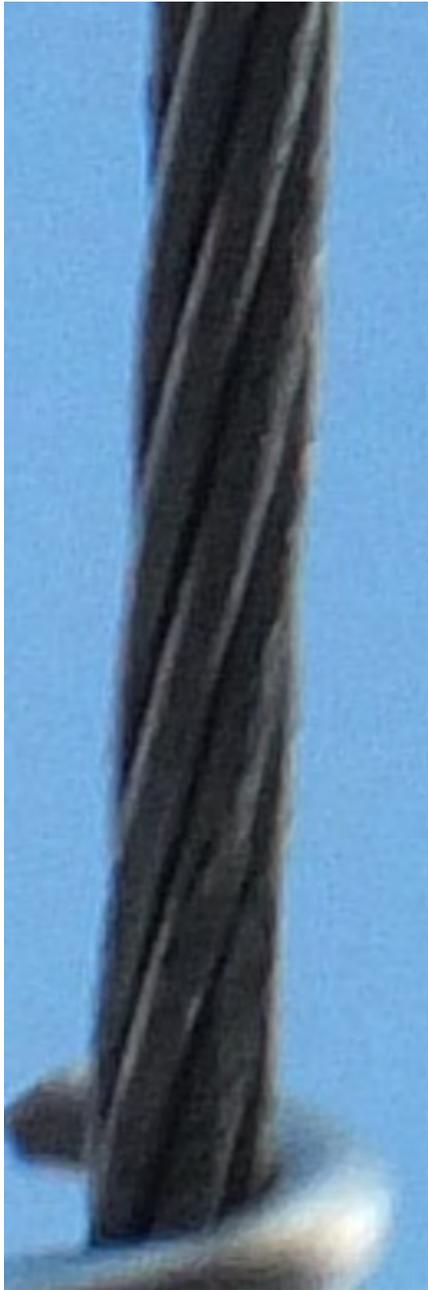
Fig. 50. Photograph (DSCF9362) to the left has been zoomed in and cropped, the strands appear to have a rough edge to them.

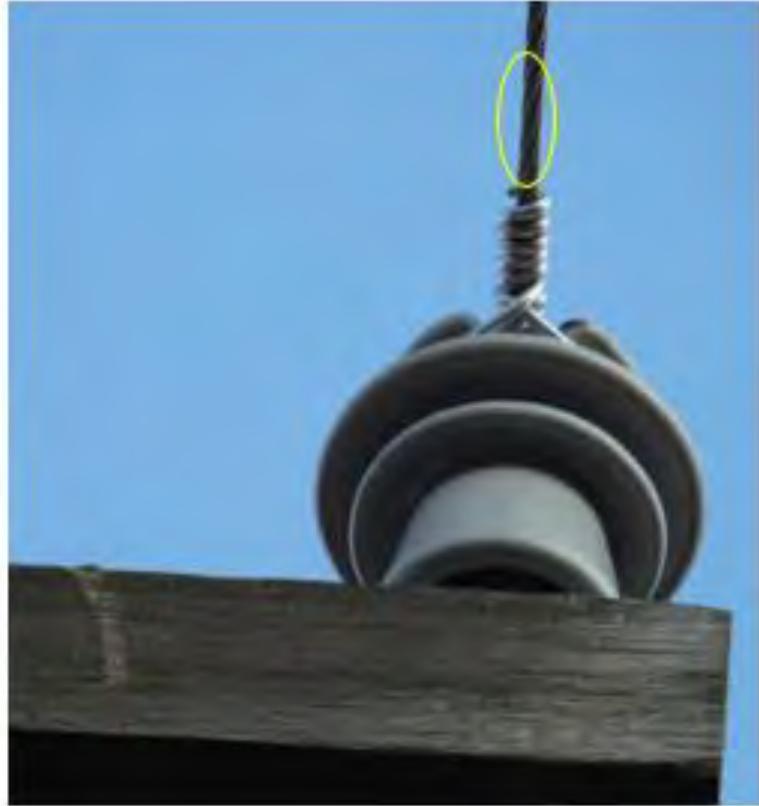
Fig. 51. Photograph above is a zoomed-out image of photograph (DSCF9362) the area within the yellow ellipse shows a rough edge that appears to be damaged.

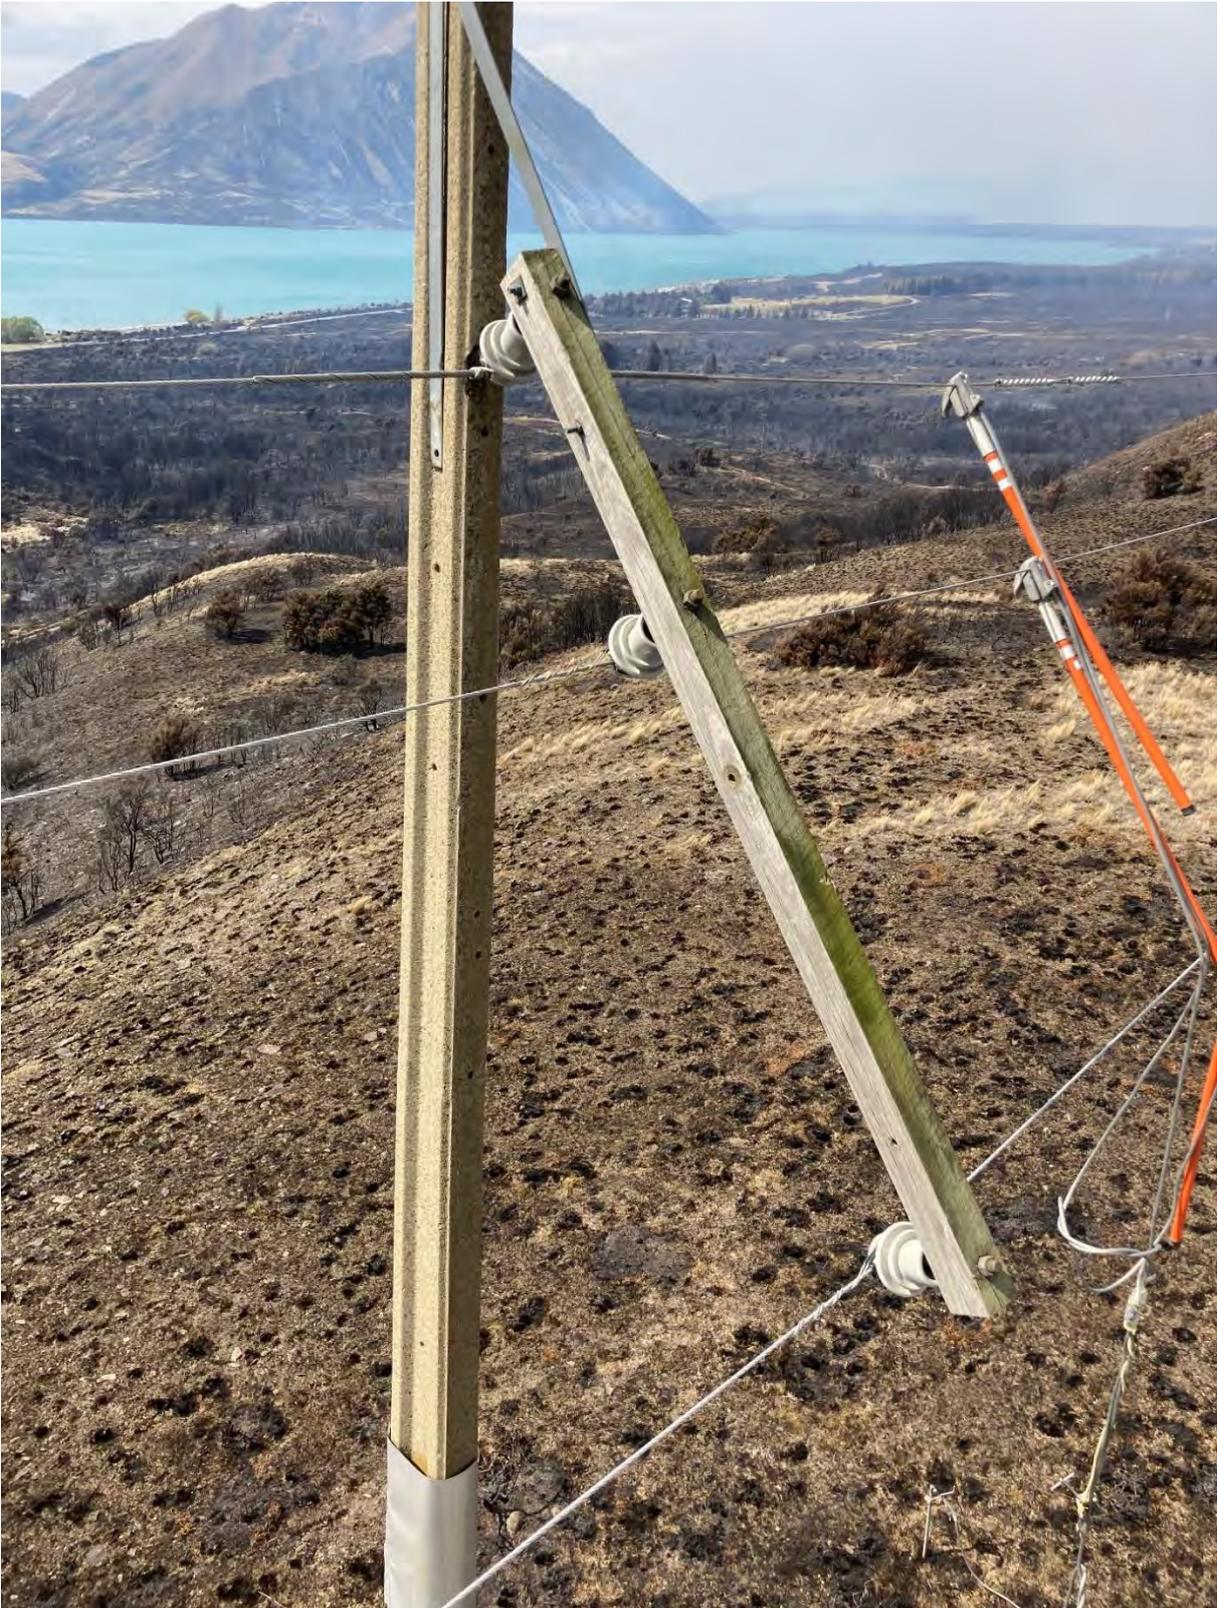
Fig. 55. Photograph (IMG_1711.JPG) above shows the cross-arm rotated over.
Photograph supplied by Network Waitaki.

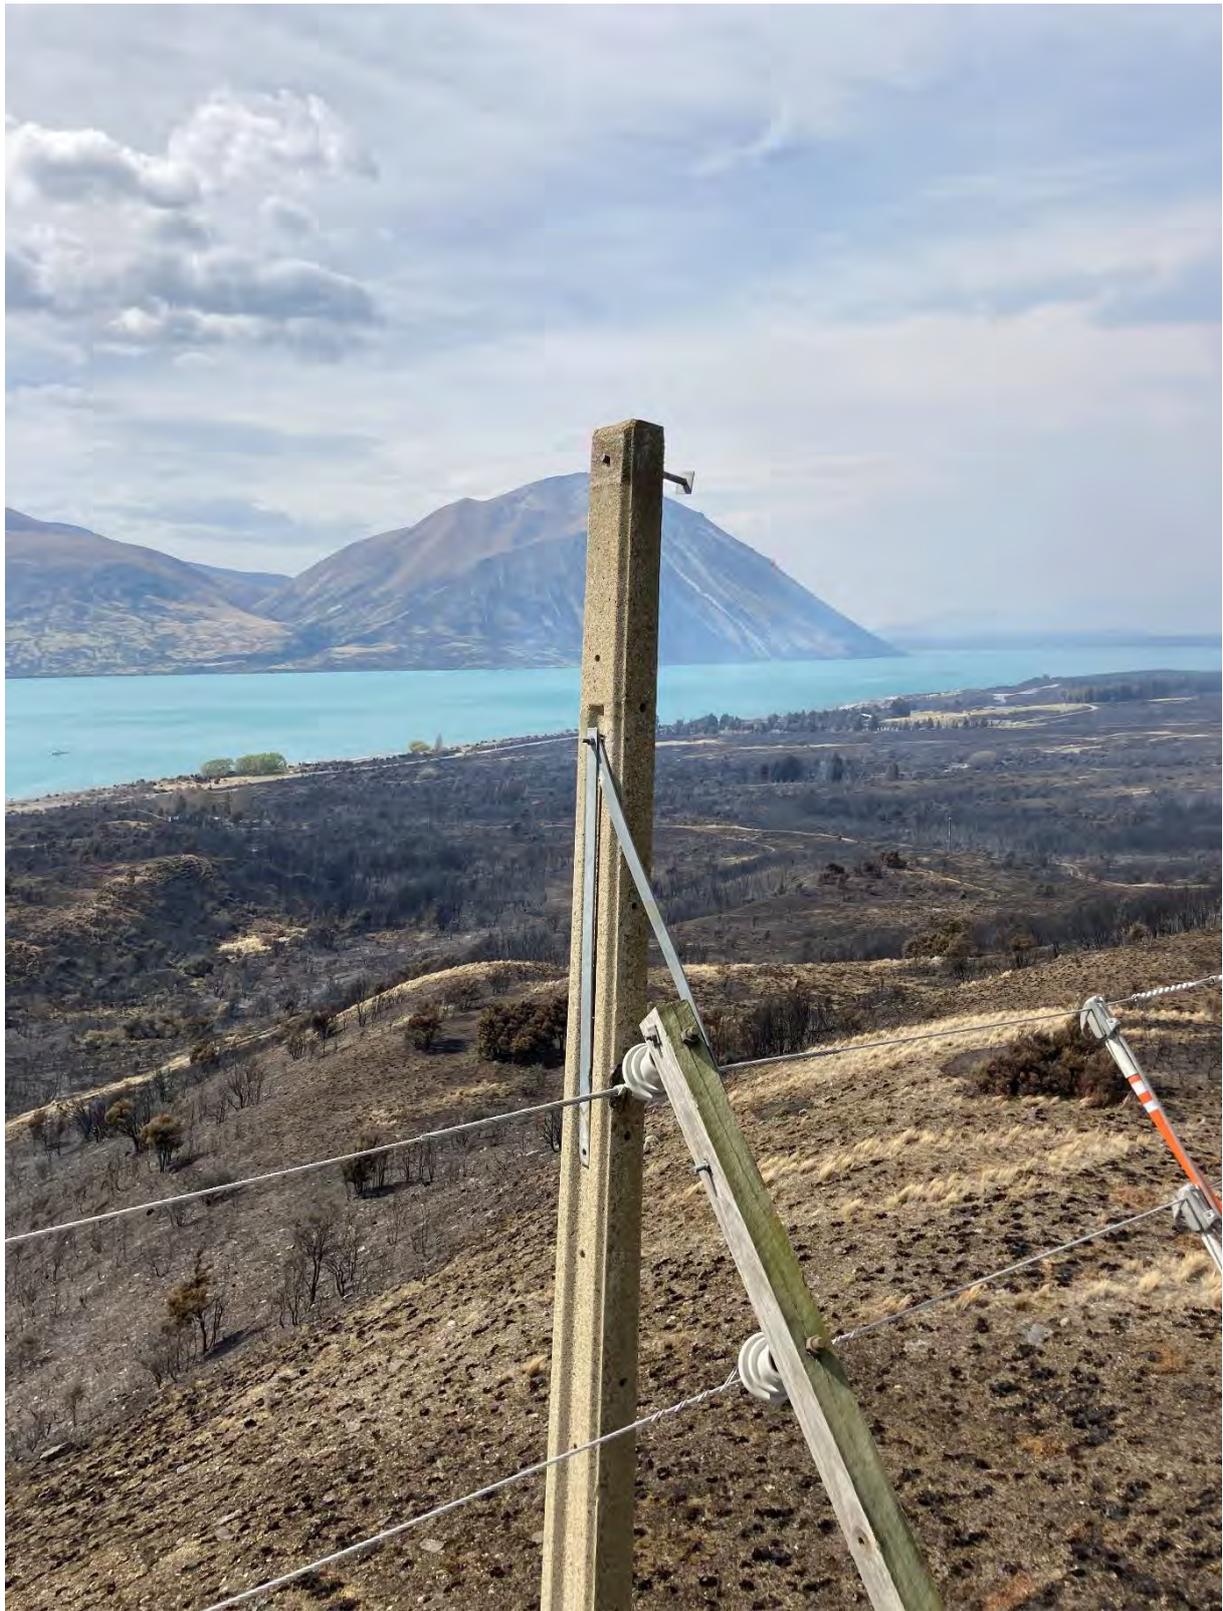
Fig. 56. Photograph (IMG_1712.JPG) above shows the lakeside metal stay arm hanging in the centre of the pole and the centre bolt that secured the wooden cross-arm to the pole has moved backwards but remains in the pole (note bolts have a single nut).

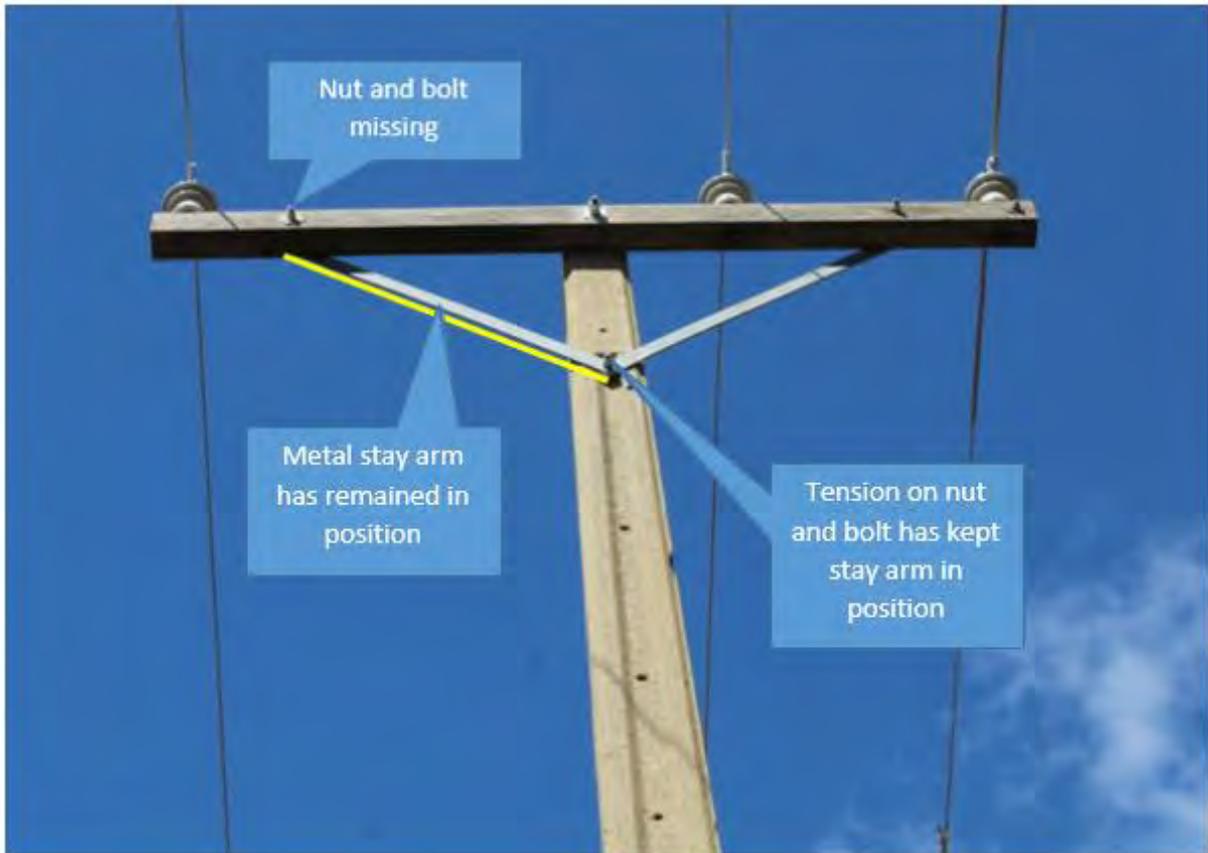
Fig. 58. Yellow line indicates the position the metal stay arm remained in once the bolt had fallen out.

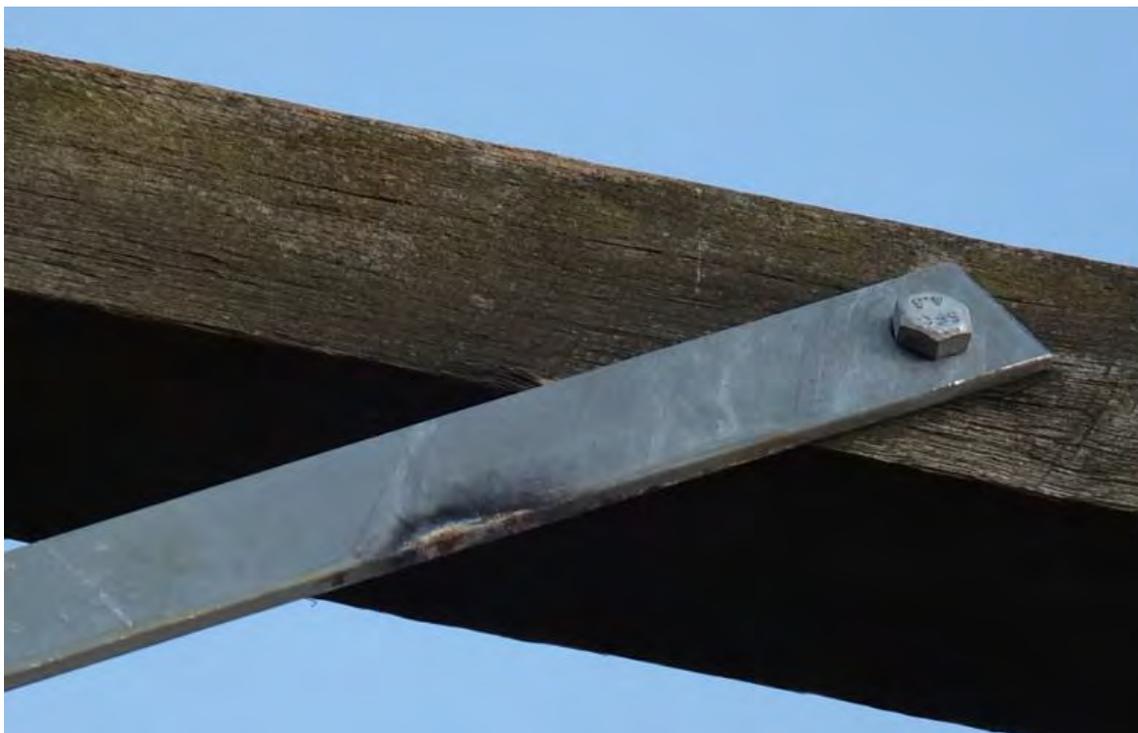
Fig.64. Arc mark of contact point on underside of Lakeside stay arm.

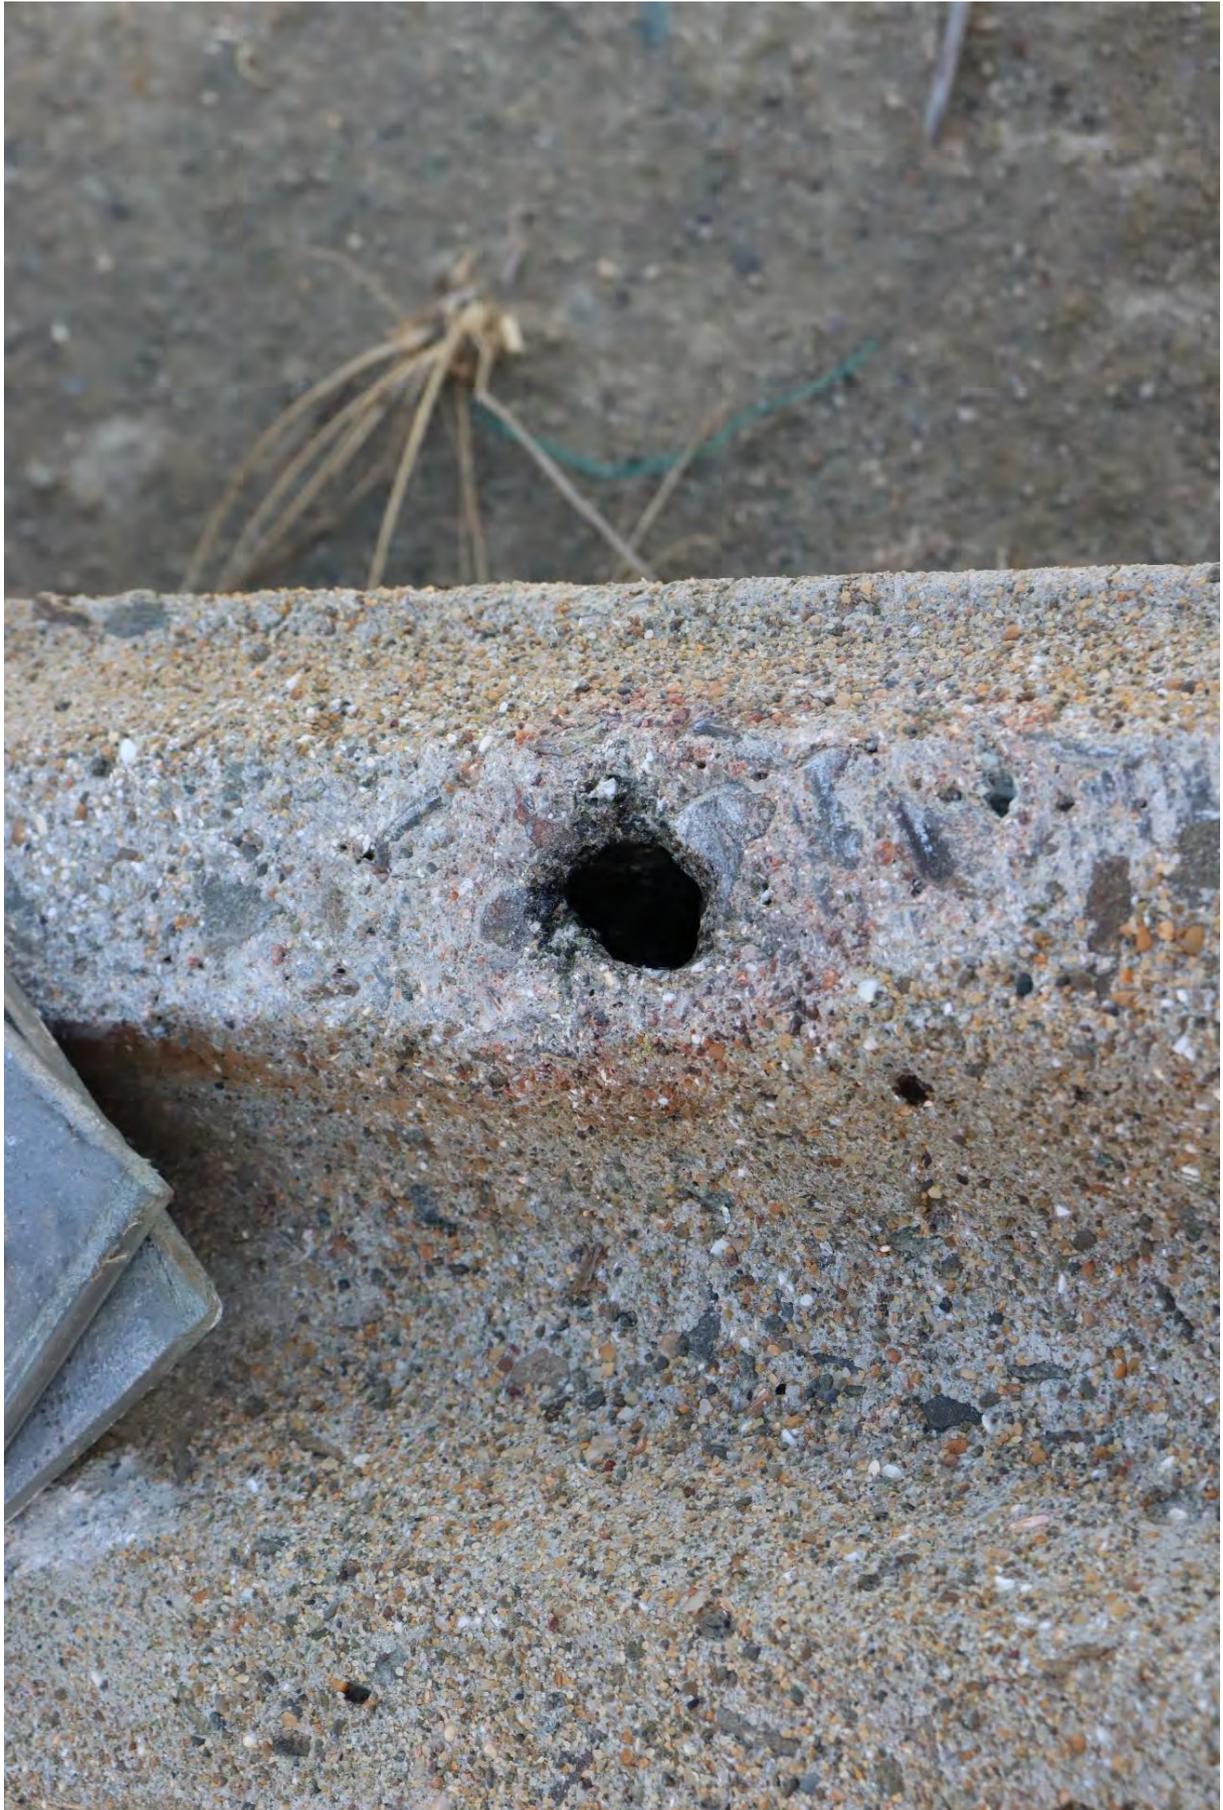
Fig. 65. Close up of the burn hole below the centre bolt holding the metal stay arms to the pole.

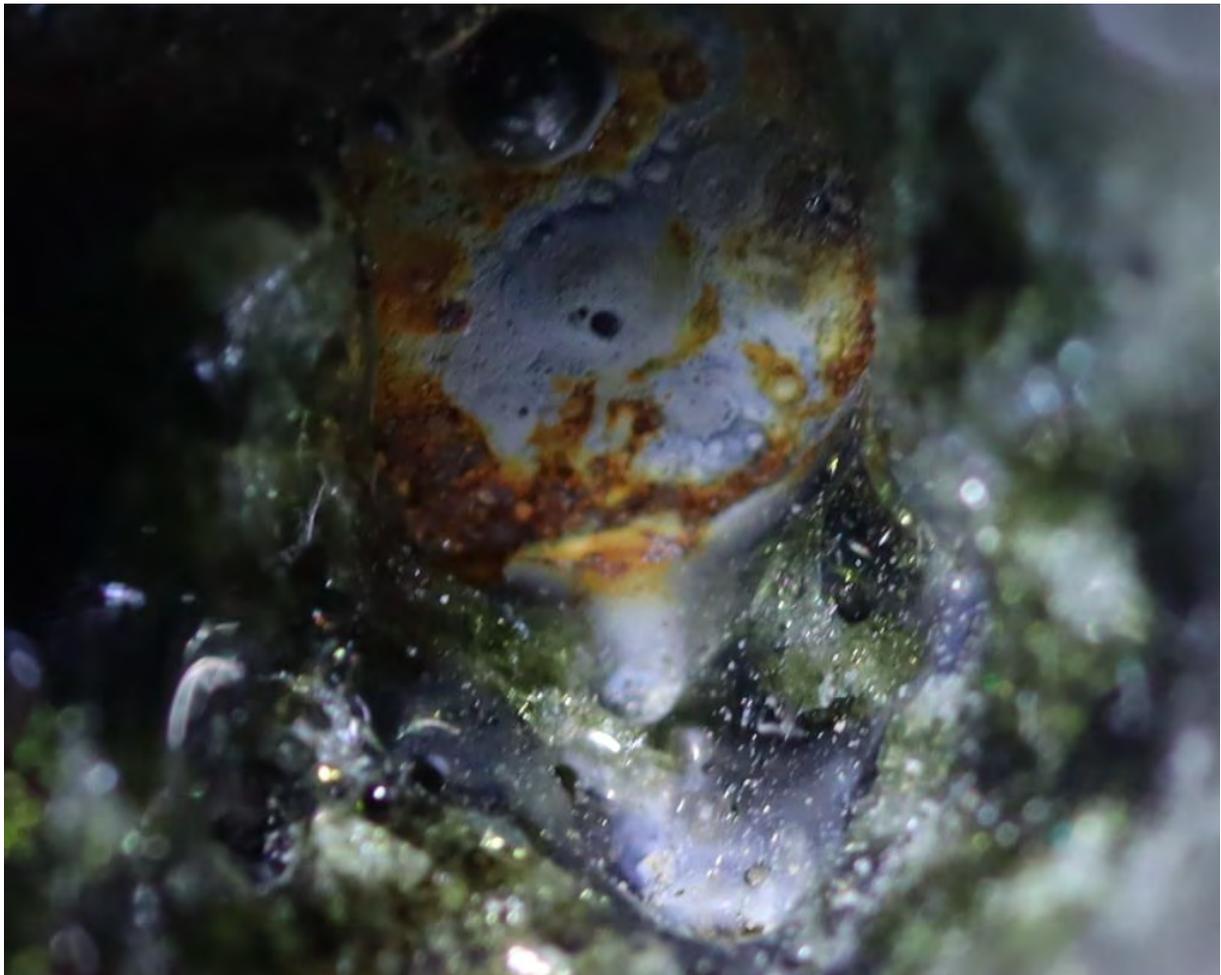
Fig. 66. IMG 1479JPG – cropped looking into burn hole, sand has melted like glass.

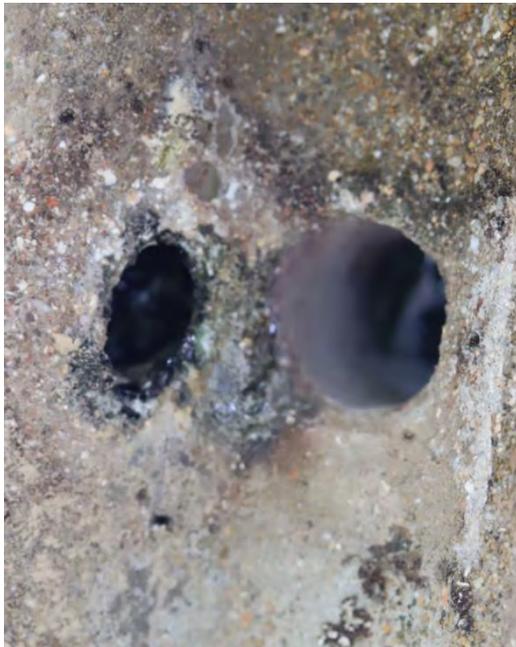
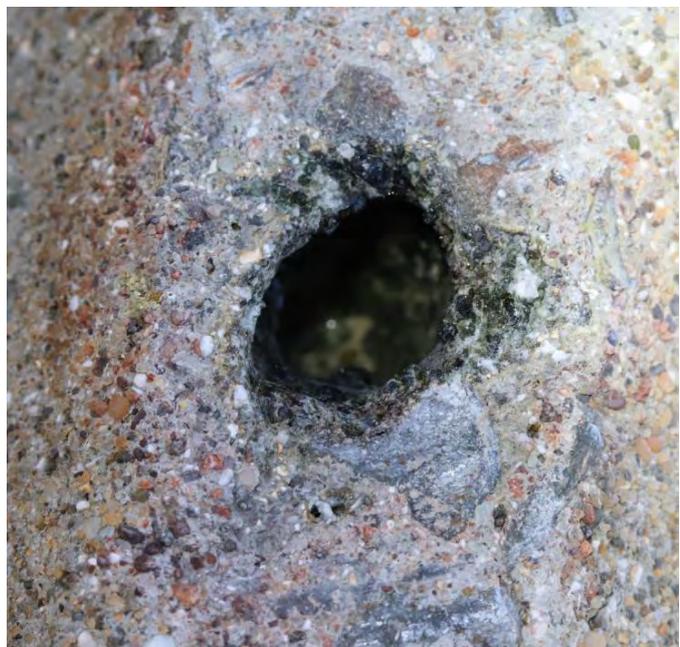
Fig. 67. Cropped IMG 1459JPG – hole left of centre. **Fig. 68.** IMG 1411JPG – 2nd hole below metal stay arms, opposite side of pole from Fig.67.

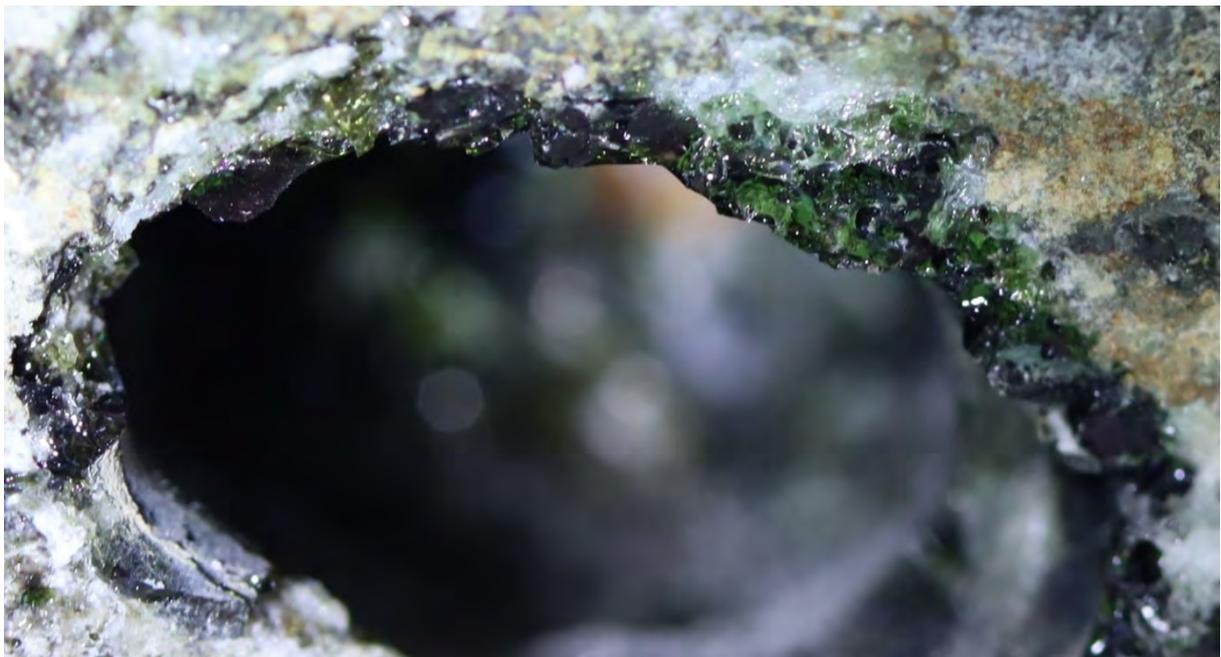
Fig. 70. Cropped IMG 1449JPG – edge of hole has melted like glass.

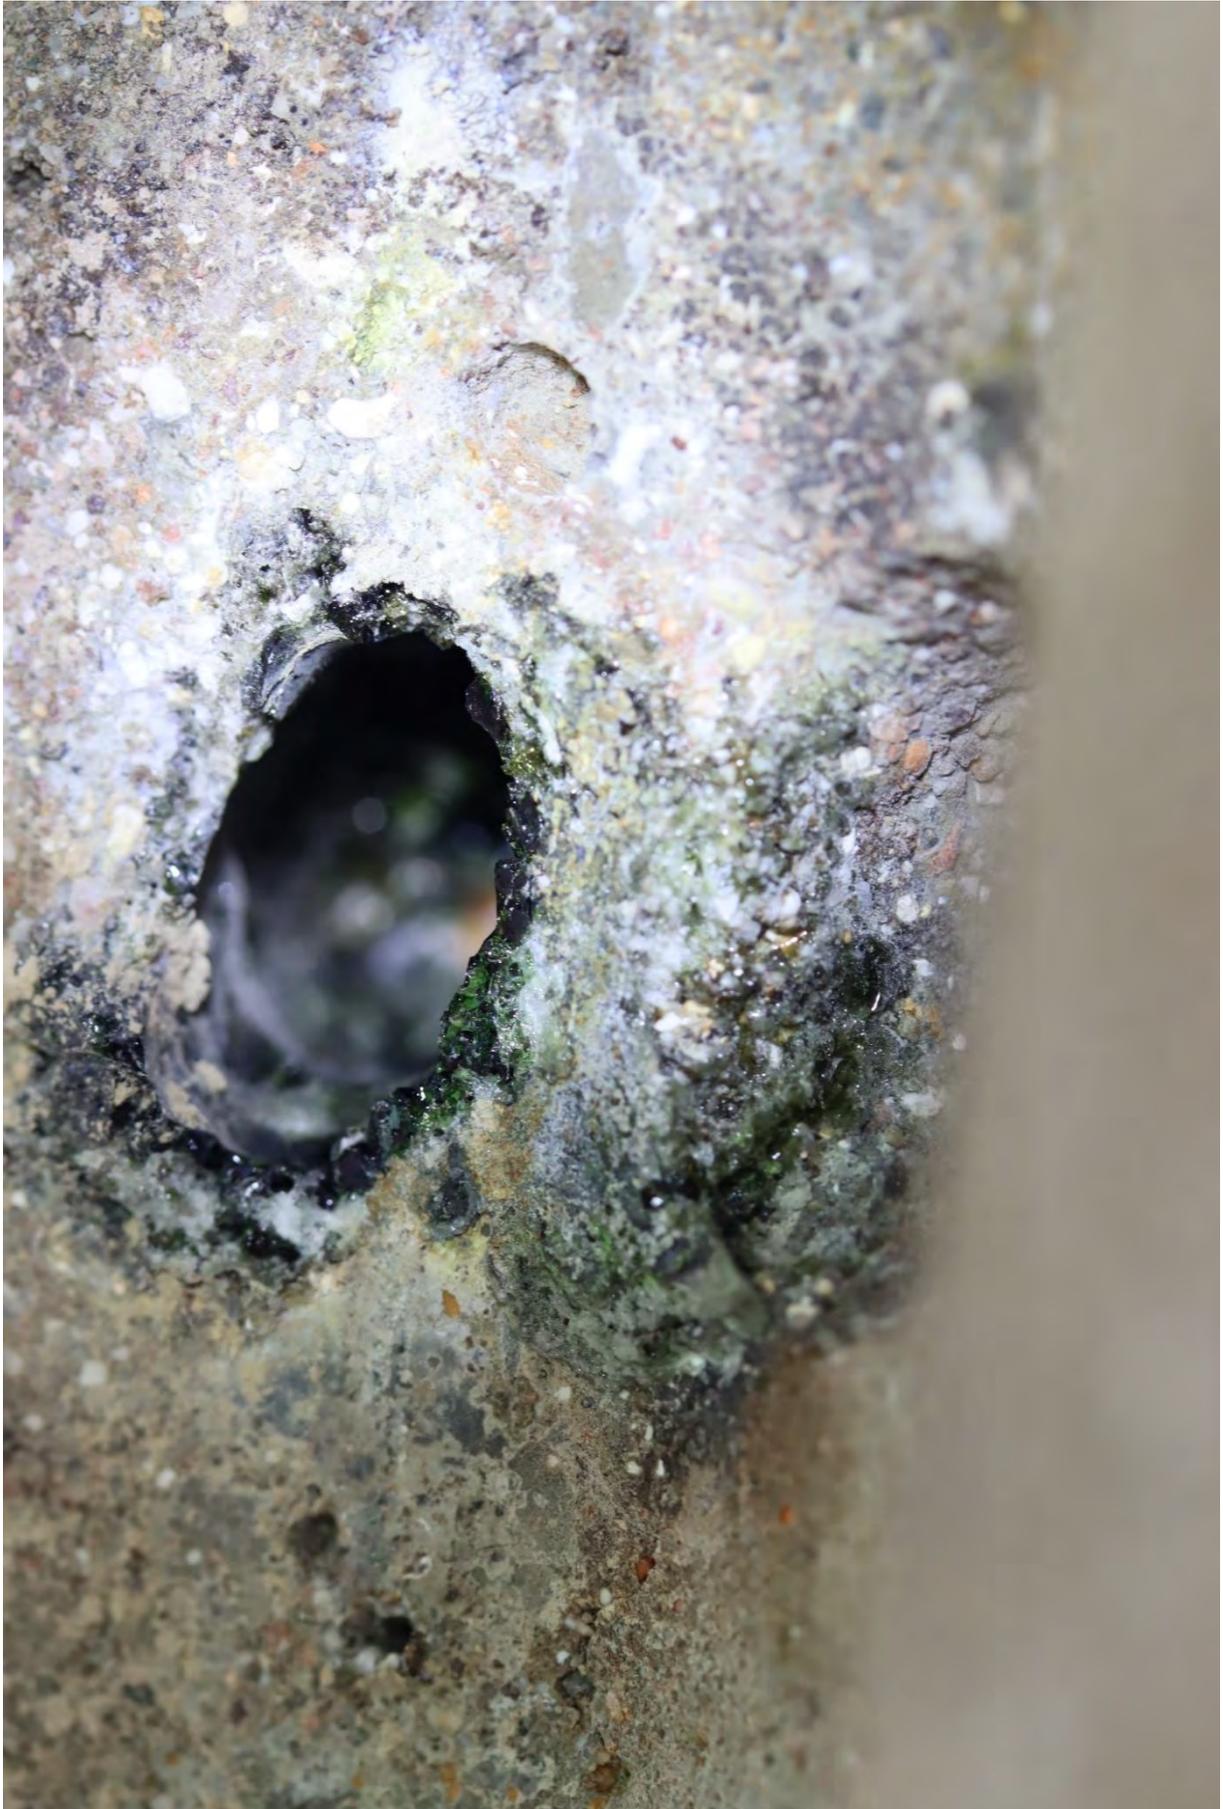
Fig. 71. IMG_1449.JPG edge of hole and surface of pole has been exposed to intense heat.
