Fire and Emergency New Zealand Wildfire Investigation Report

| Fire Name: | Lake Ōhau Fire, Lake Ōhau Road |
| Fire Date: | Sunday 4 October 2020 |

Classification of Fire Cause: Accidental

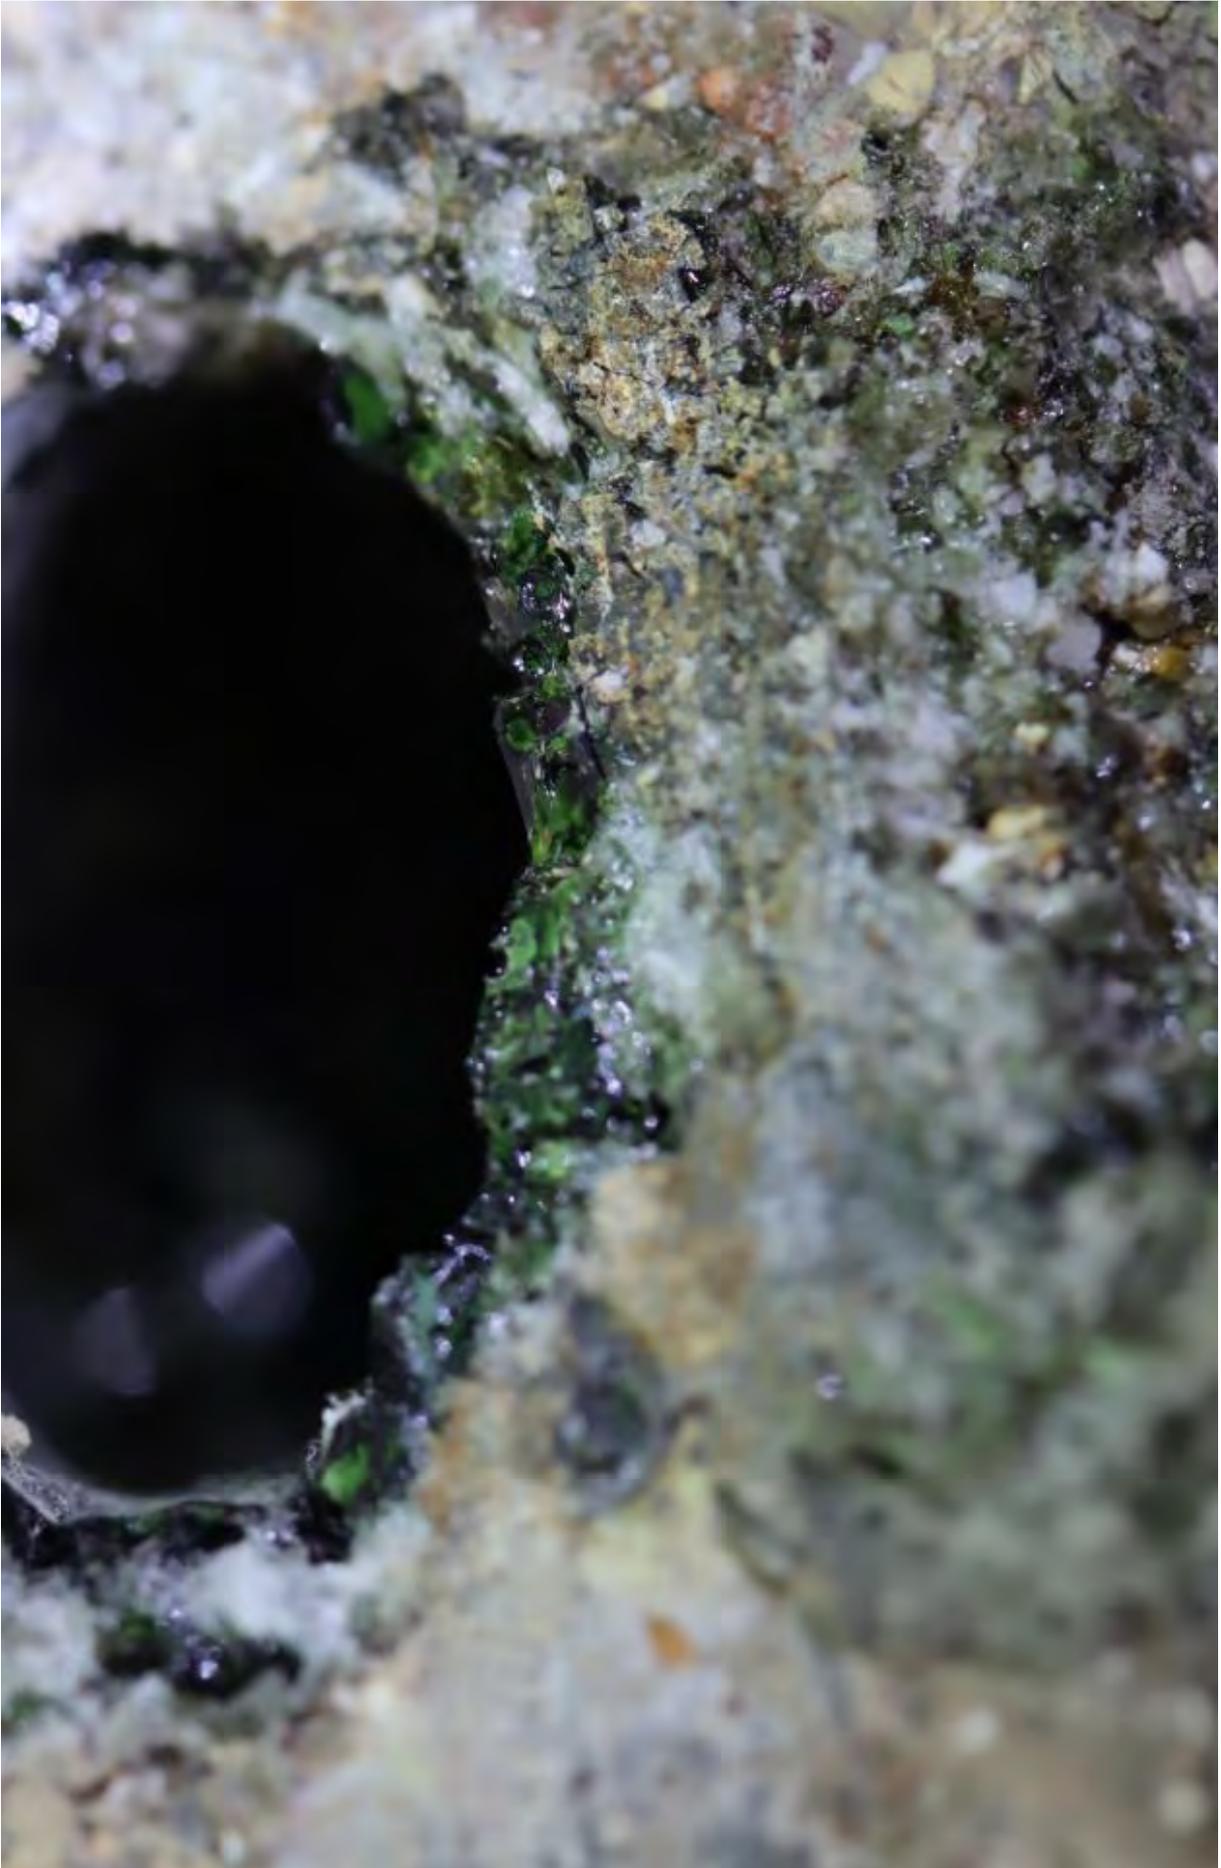
Fig. 74. Edge of hole and surface have appearance of melted glass.

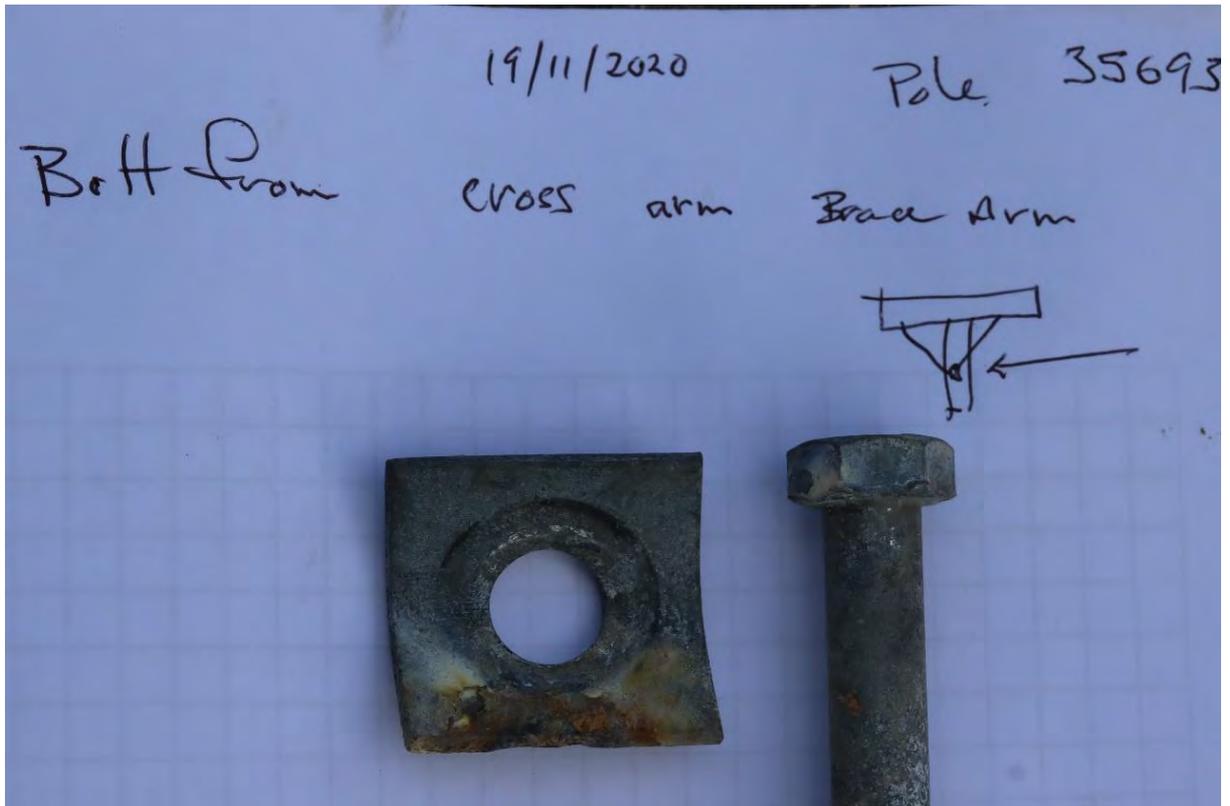
Fig. 76. Arc damage on bolt and washer – bolt holds both metal stay arms to centre of the pole.
IMG_1444.JPG.

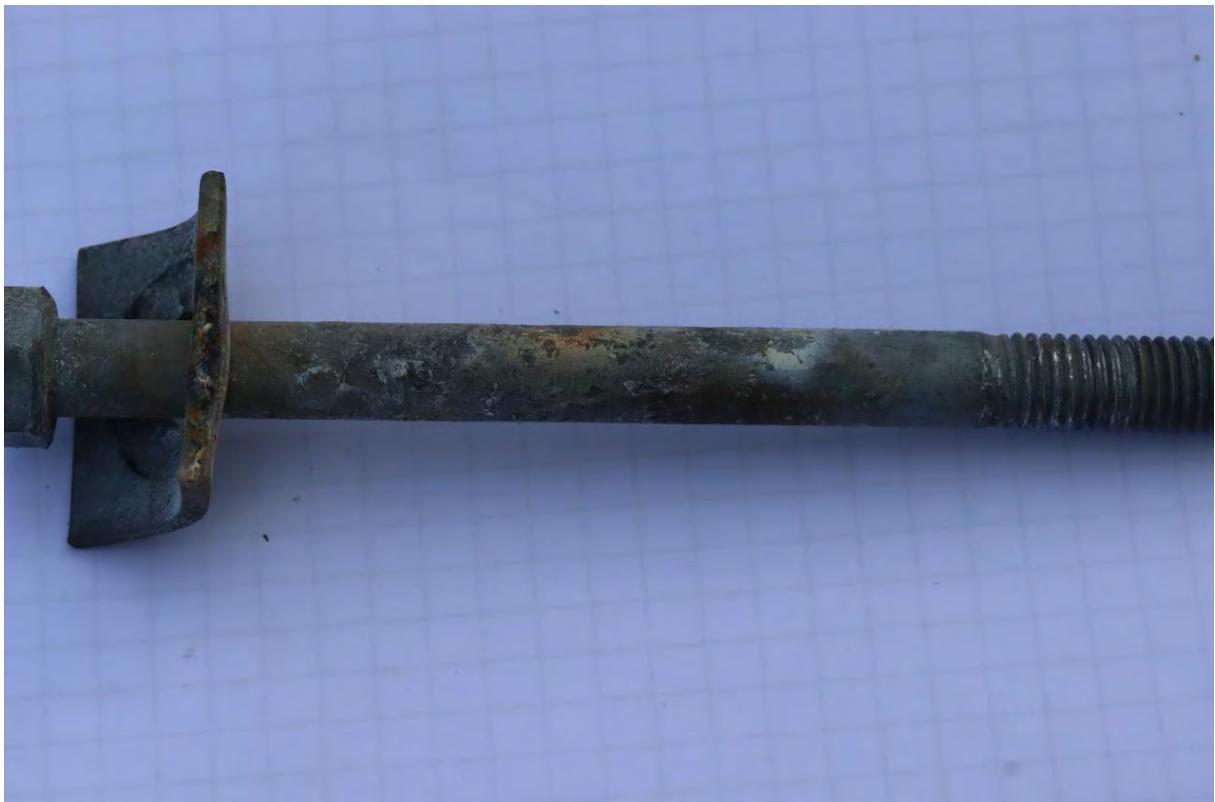
Fig. 77. Bolt from the centre of pole that held the metal stay arms with signs of heat damage.
IMG_1440.JPG.

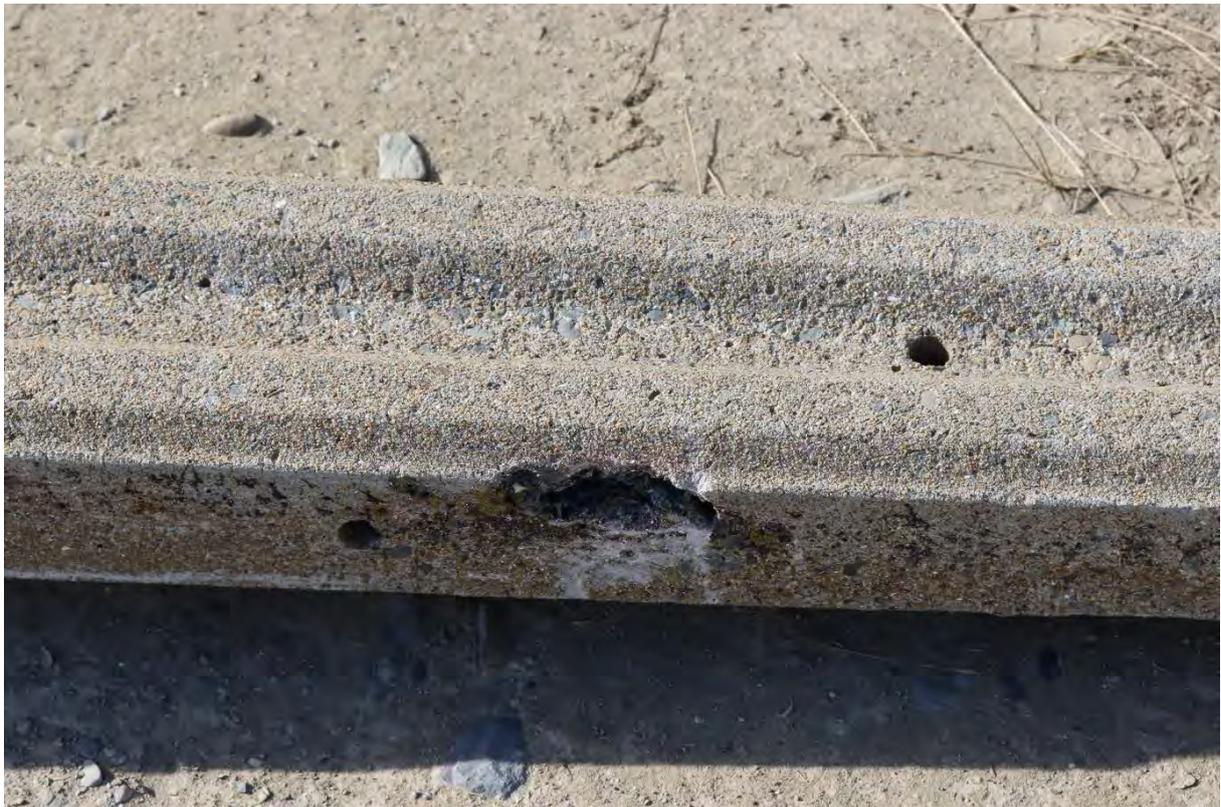
Fig. 78. Old damage on side of pole that lines up with the cross-arm when twisted over. IMG_1415.JPG.

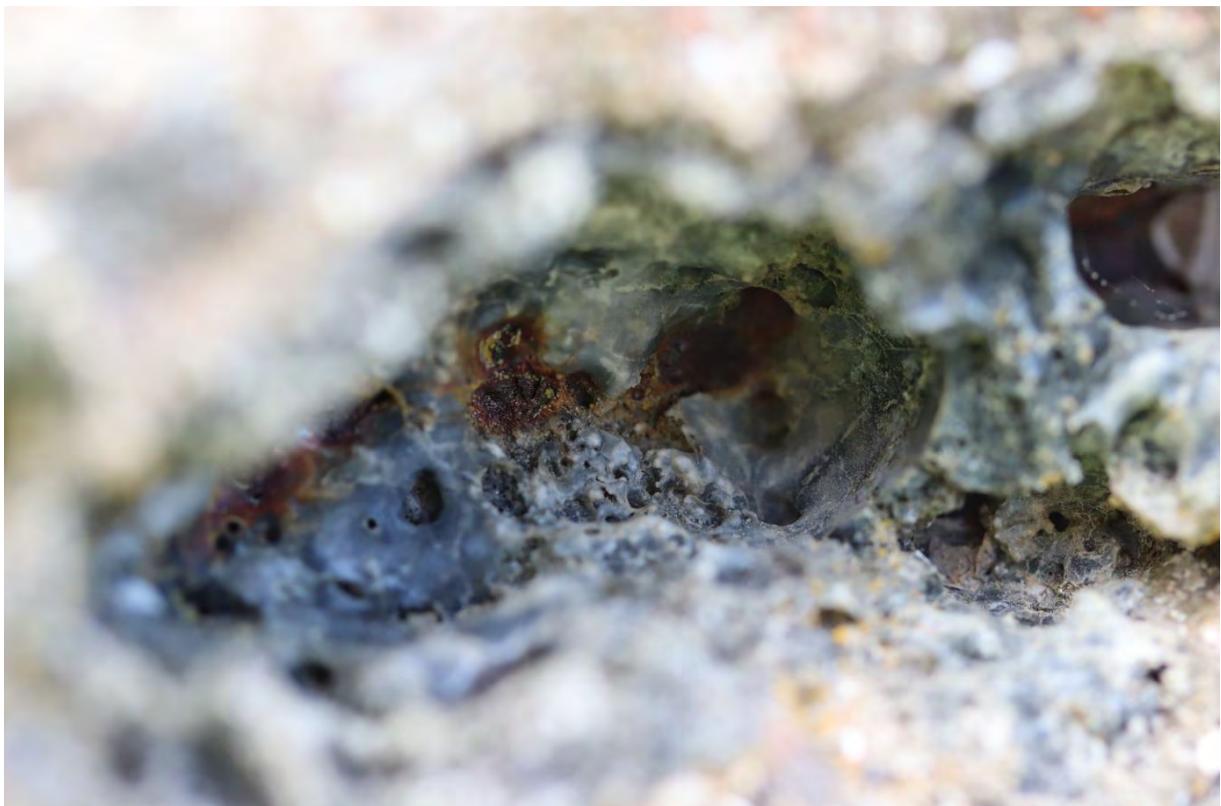
Fig. 79. Looking into old damage appears to display old heat damage. IMG_1485.JPG.

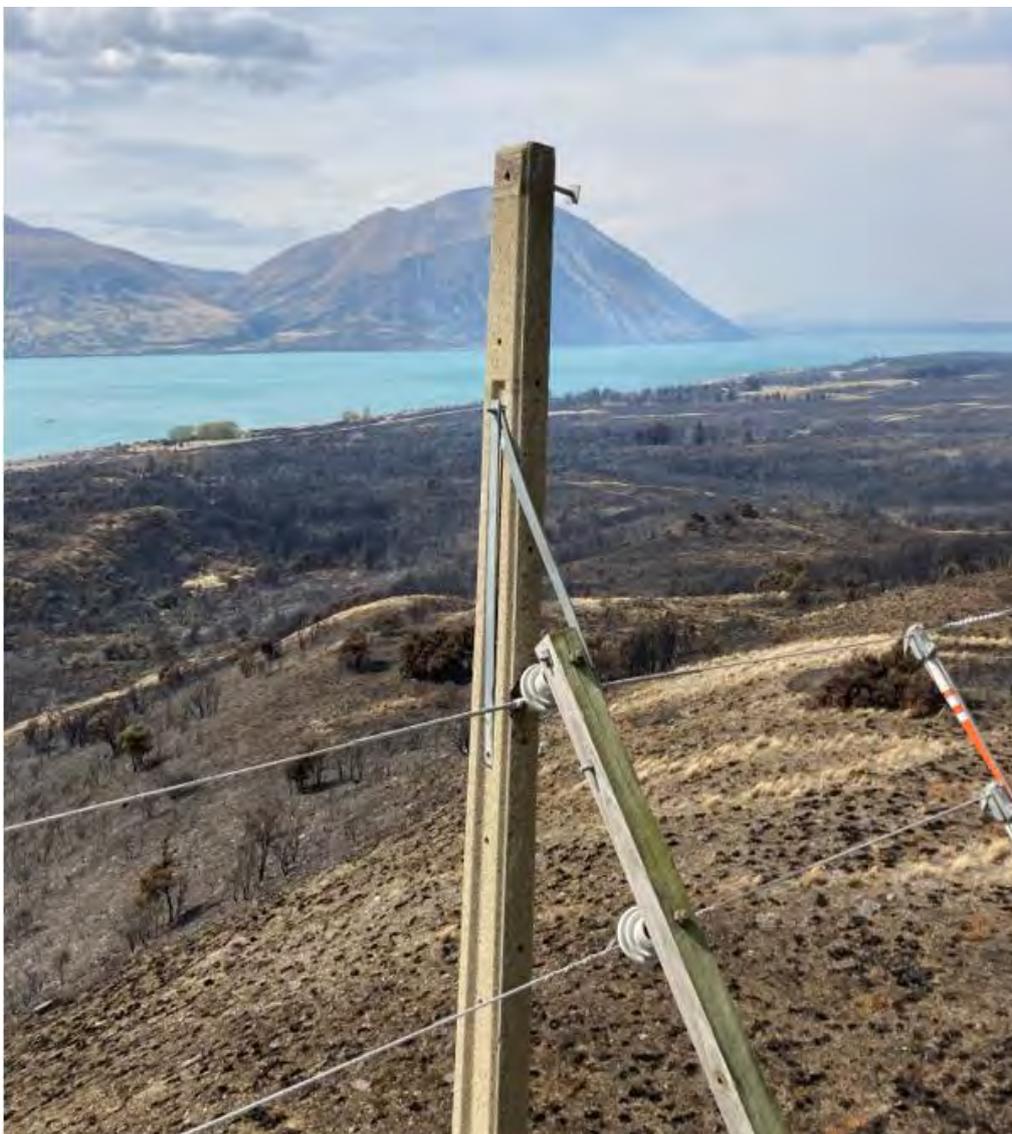
Fig. 80. Pole 35693 Blue Phase touching pole. (Photo supplied by Network Waitaki)

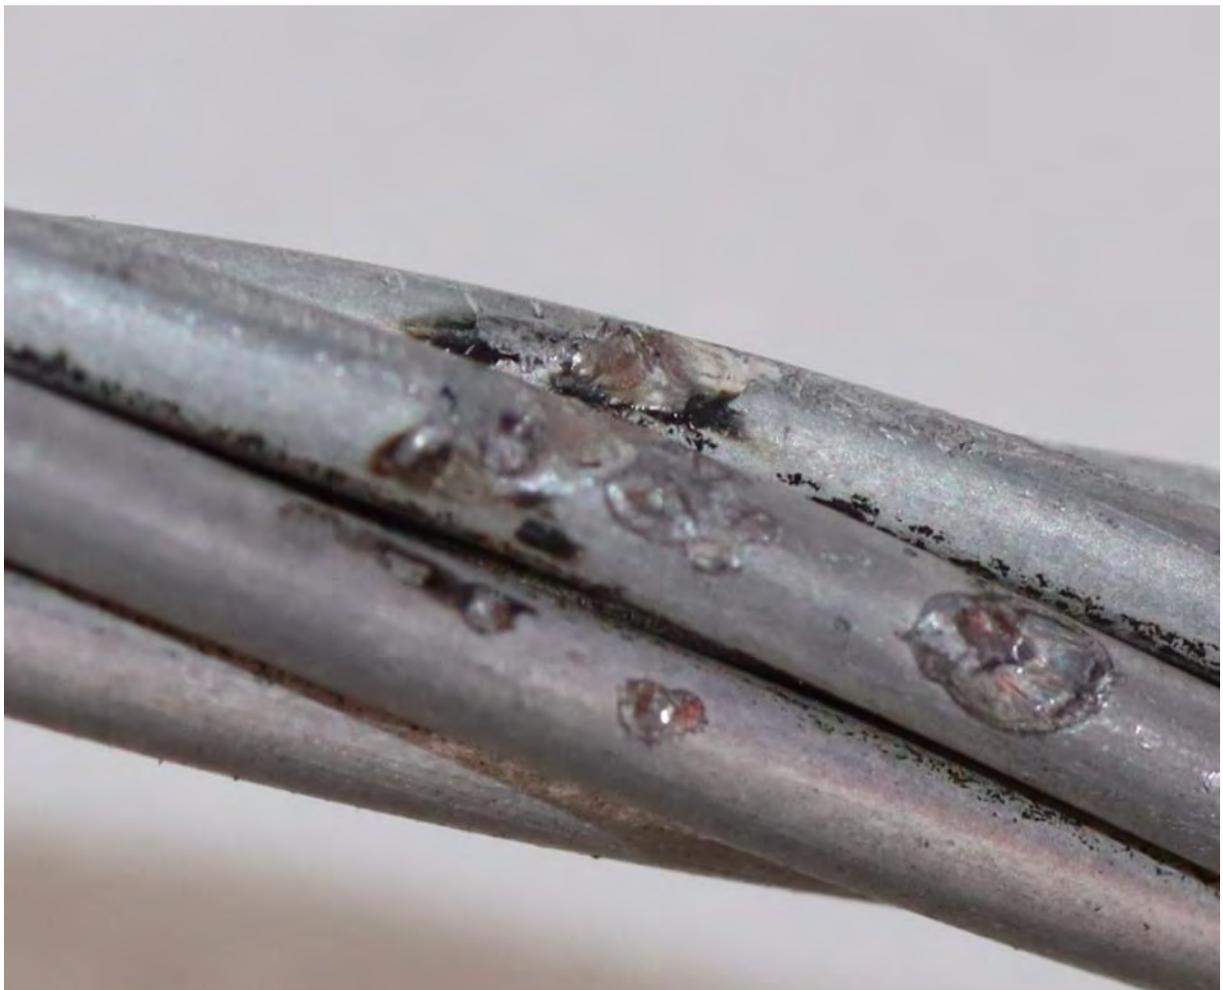
Fig. 84. Close up of arcing on twisted conductors IMG_1578.
