# Operational Review

Level 3 Vegetation Incident

F3914792

Port Hills

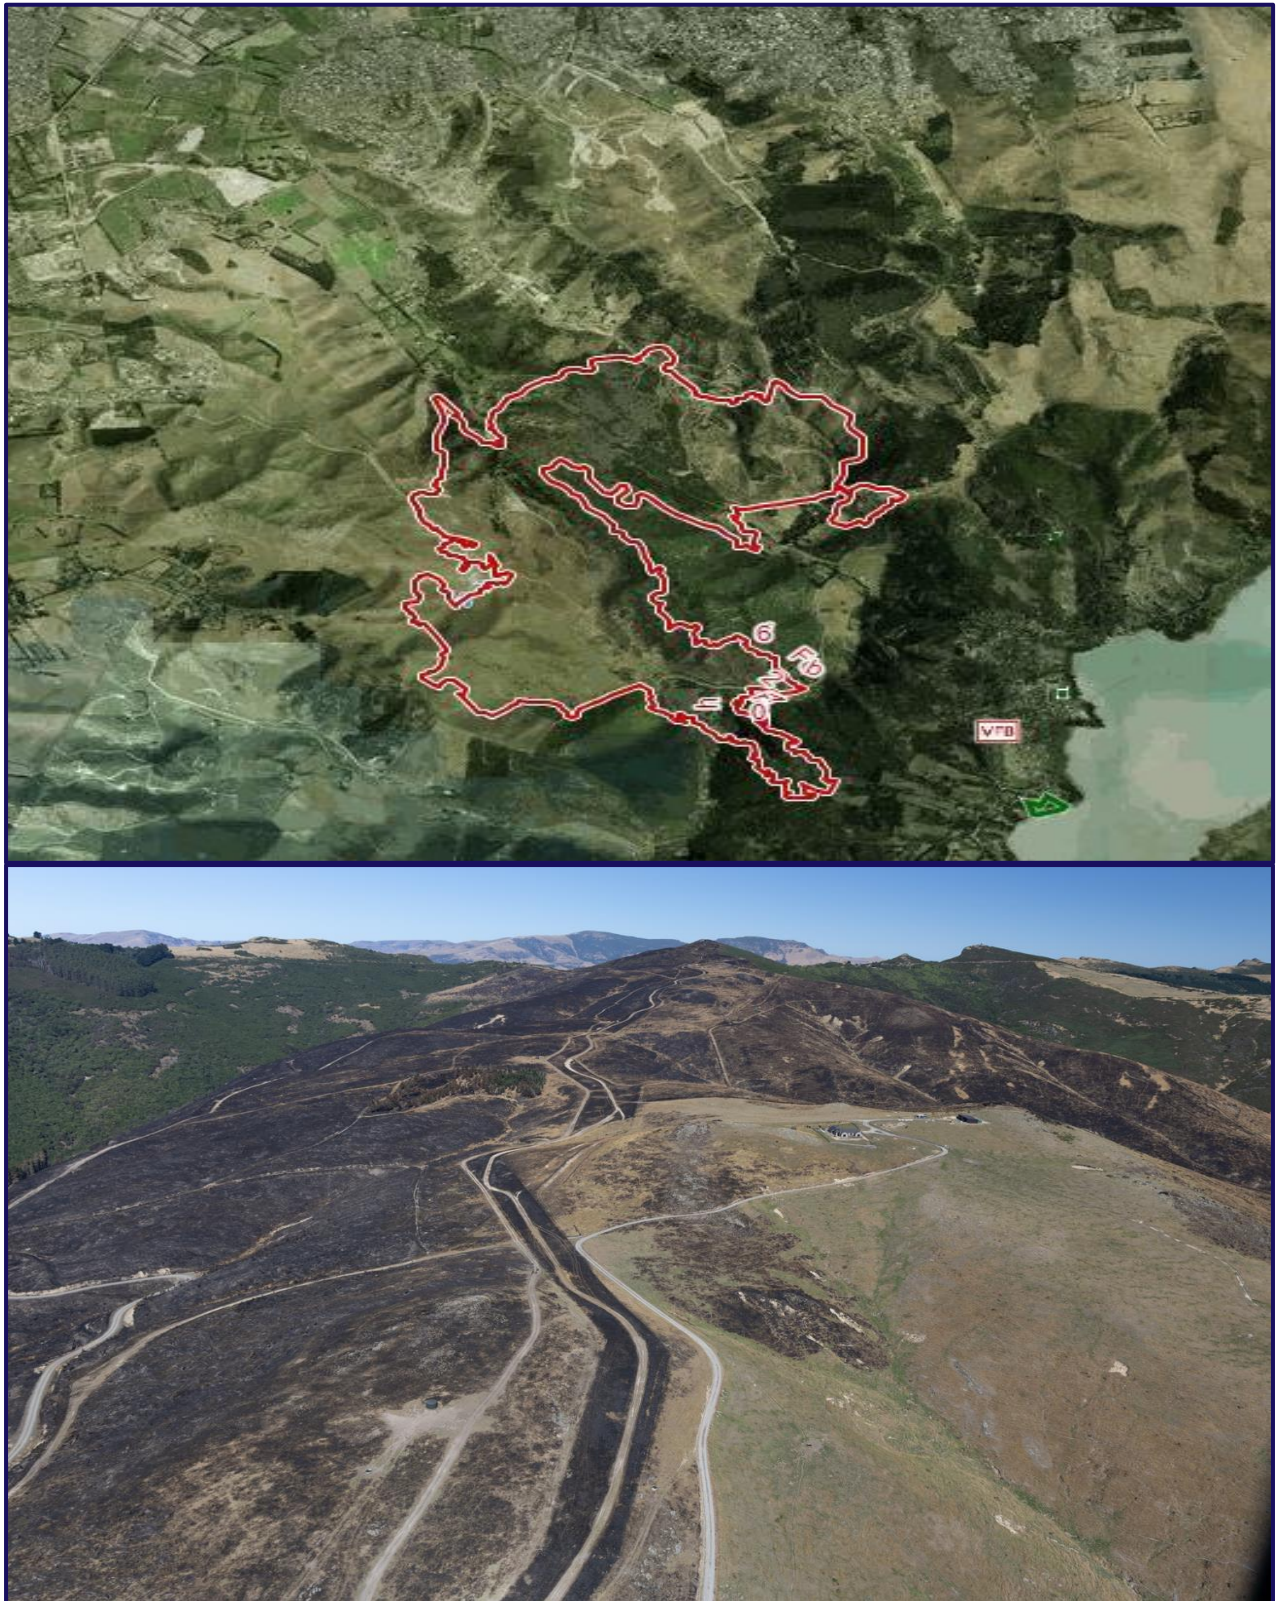
*Figure 1: Location of fire on Port Hills, extent of fire perimeter and a photo of some of the damage caused by the fire showing some of the terrain involved*

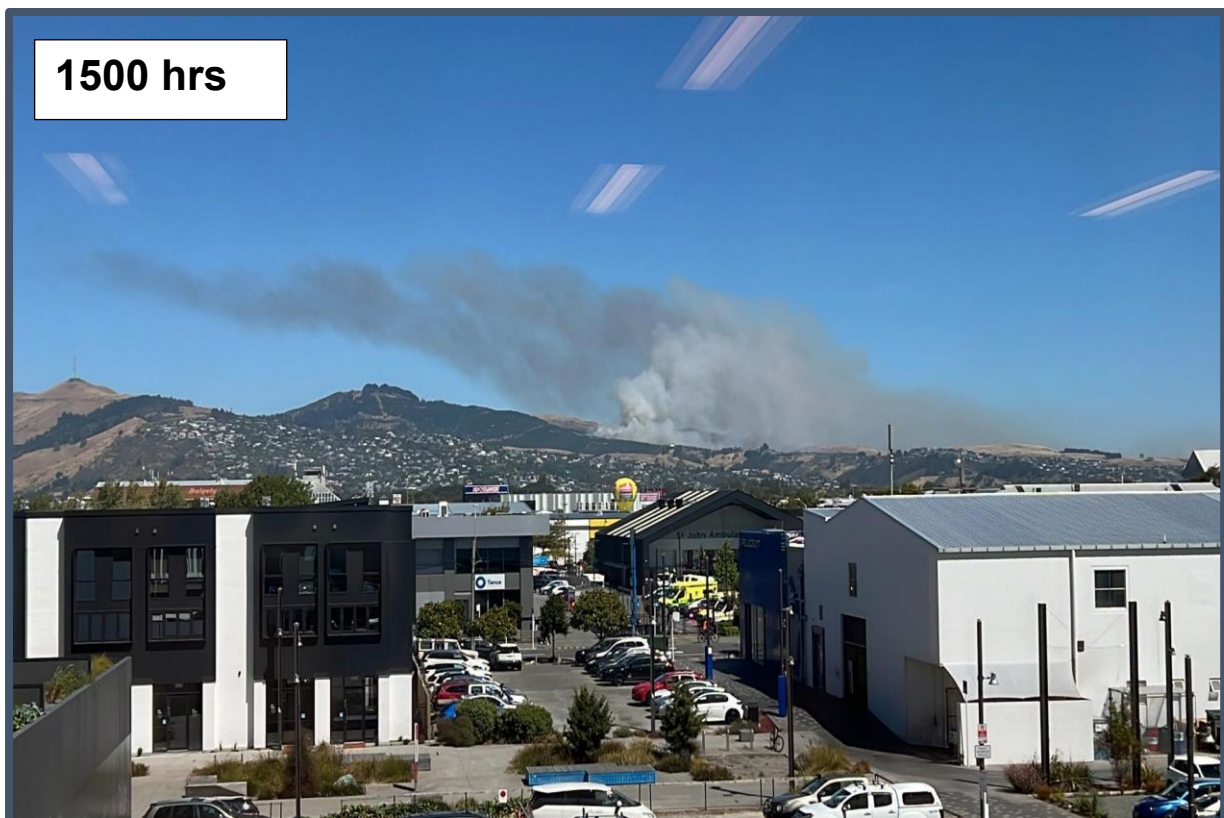
1509 hrs

As the following sequence of photos show the fire developed very rapidly:

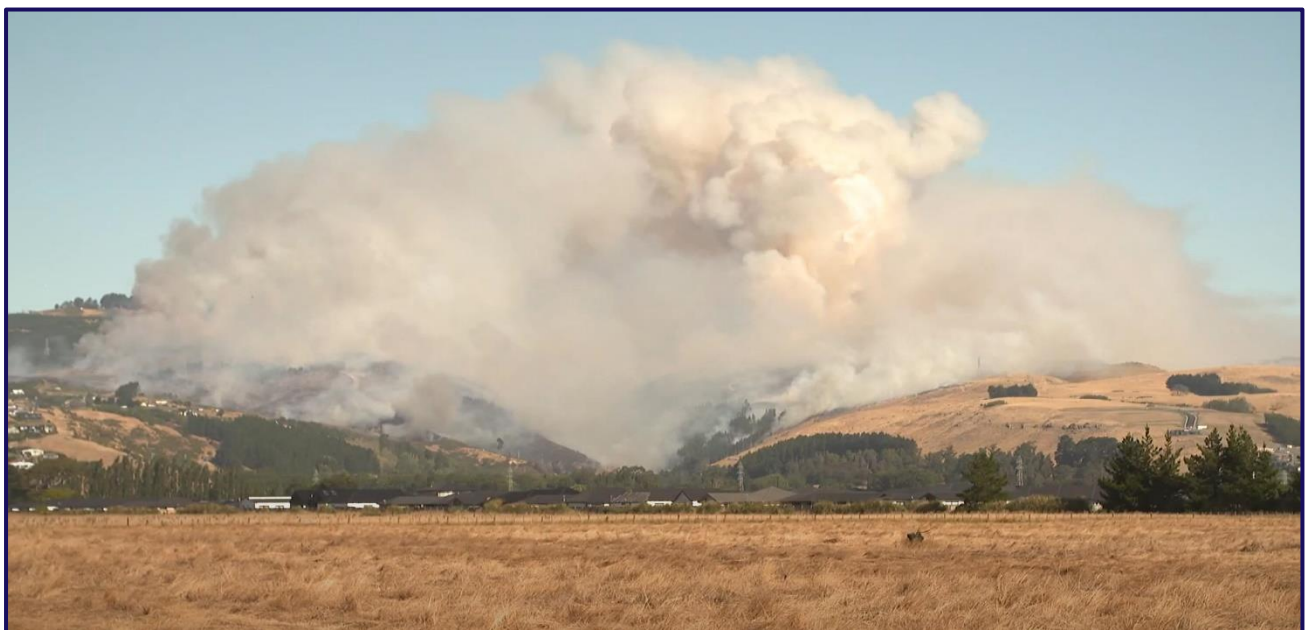
*Figure 2 showing extent of the fire at 1620 hrs on 14 February 2024 (image courtesy of Paho)*

The fire has intensified significantly, and efforts were made to ensure public access was restricted, and all possible places where people may have been within the area were now clear. Tactics at this stage were to utilise helicopter water drops to contain the fire, have ground crews in position to restrict possible breakout from the perimeter of the fire, use retardant drops to stop fire spread, and create some new fire breaks to minimise the chance of the fire reaching at risk properties.

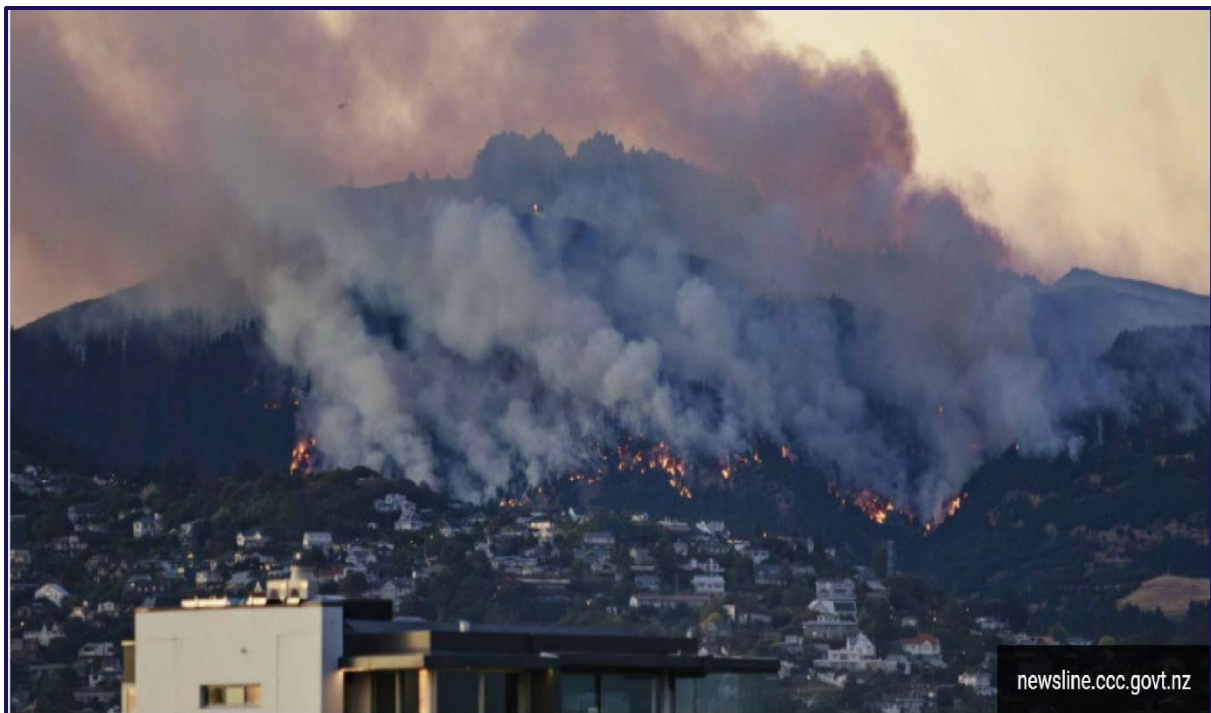
*Figure 6 showing extent of the fire at 0700 hrs on 15 February 2024 (image courtesy of Newsline)*
