Heads Up

BACKGROUND

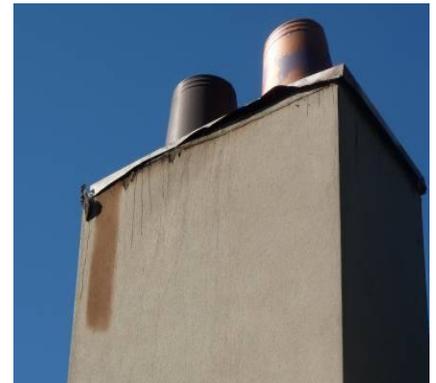
A chimney chase is a decorative surrounding that covers the metal flue of the chimney. In New Zealand modern construction typically includes timber framing clad with cement or other hard board which is plastered and painted for aesthetic effect. Recently a series of fires in chimney chases has drawn attention to incorrect design and construction methods.

Fireplace manufacturers installation instructions require chimney chases to include construction aspects including adequate ventilation (top and bottom), specified clearances and importantly, non-combustible material to be used under the flashing.

- Use non-combustible sheeting or material directly under the flashing
- Ensure adequate ventilation at the bottom and top of the chase to allow the conduction of heated air to ventilate externally
- Building inspectors should be vigilant for non-compliant designs and construction
- Acceptable solution C/AS1 Part9: Outbreak of fire requires chimney chases to be built to manufacturers specifications and should be rigorously adhered to (AS/NZS 2918).

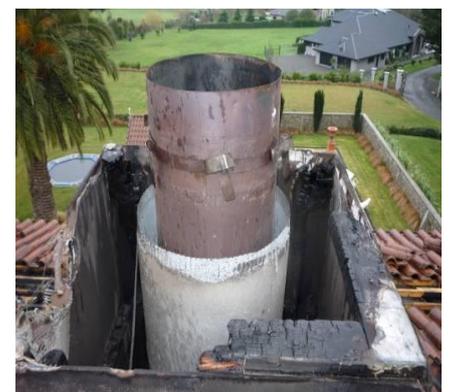
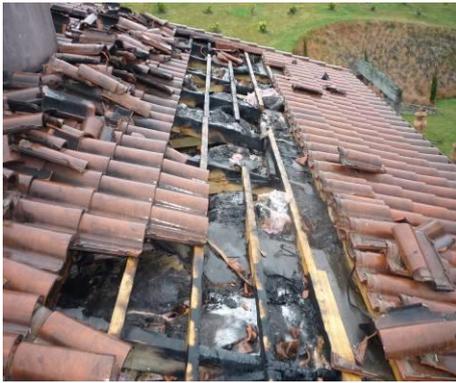
The recent chimney chases involved in fires investigated by the New Zealand Fire Service have had timber framing directly under the flashing. The timber is subjected to prolonged heating during operation of the fireplace creating a condition (sometimes referred to as pyrophoric action) where the ignition temperature of the timber is reduced to well below usual ignition temperatures. Eventually a fire in the chimney chase will occur.

Resulting fires may enter the roof space (left) or drop down through the chimney chase (right) leading to significant fire spread and damage to the home.

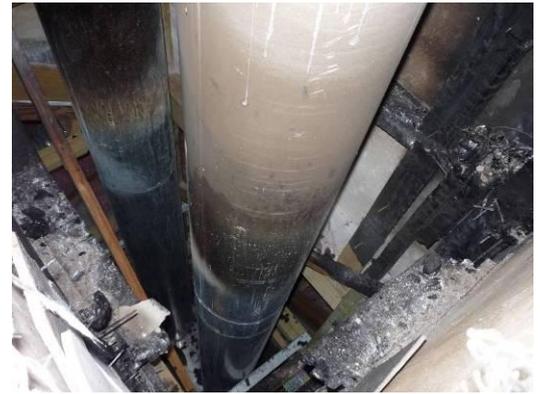
In one case the fire investigator was able to confirm the chimney chase had been built to the architectural requirements. Non-combustible material was not specified beneath the flashing.
