## Fire Research & Investigation Unit

# Heads Up

### BACKGROUND

### Incident Details

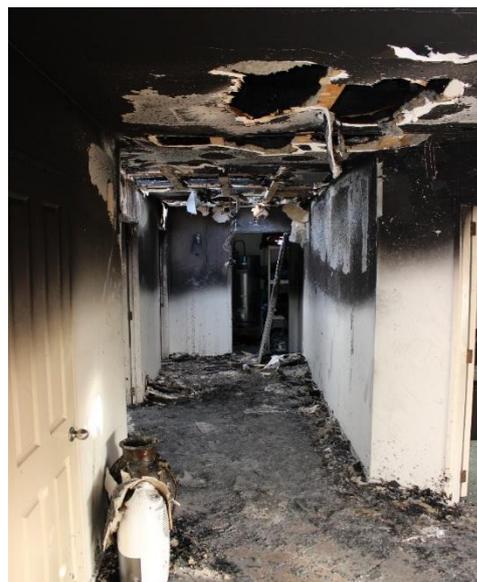
The fire started as an electrical fault in a ceiling mounted extraction fan in the bathroom and quickly spread throughout the ceiling void of the occupancy breaking into the main unit and causing widespread destruction in that tenancy. When the fire reached the internal wall separating the two tenancies, the fire separation prevented fire spread into the adjoining unit and enabled the safe escape of the occupant and the extinguishment of the fire in the main unit.

Photo above shows extensive fire damage in first unit.

- Fire separation is an effective means of providing fire protection for occupants in subdivided houses.
- The value and protection provided by fire separation is only effective when the fire separation is installed in accordance with fire design and manufacturer's instructions.
- All required work needs to be consented, consequently inspected and a Code Compliance Certificate issued on completion

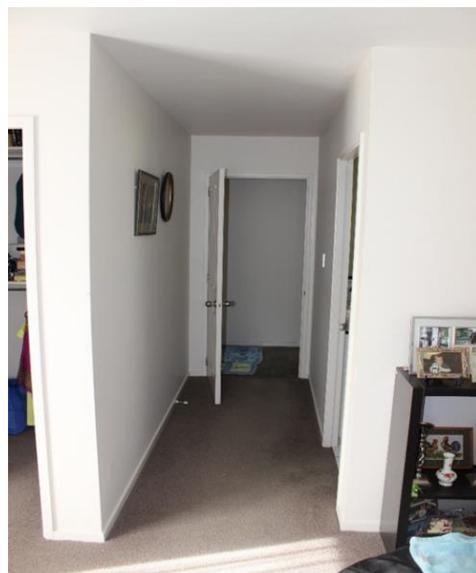
Photo below shows undamaged adjoining unit in same house protected by a well constructed fire wall.

The adjoining unit remained almost totally undamaged. Inspection of the ceiling void above the main house revealed an intact fire separation which extended from the walls below terminating at the roof junction. Effective fire separation requires wall to floor and subfloor junctions to be sealed correctly where applicable.

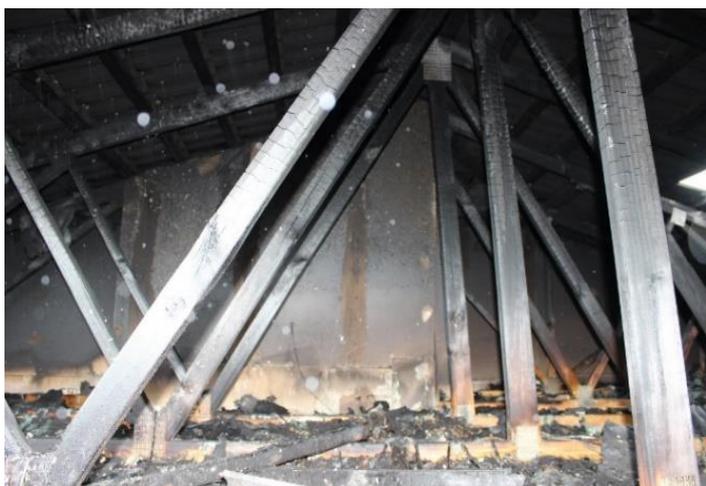
Image above shows fire damage in ceiling space of fire affected unit. The fire separation wall is visible in the rear of image.

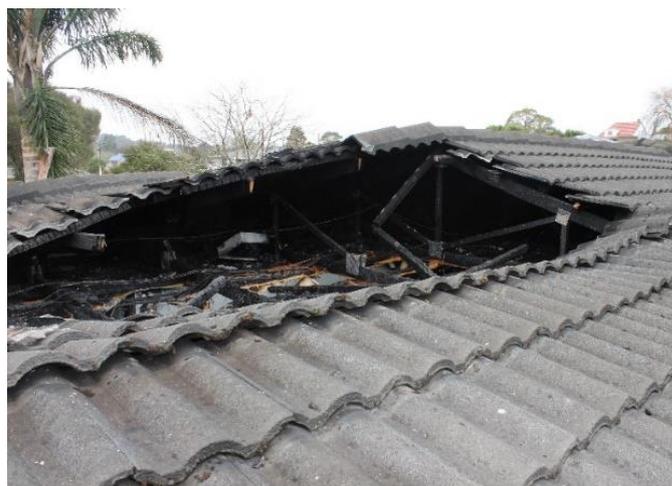
Image above shows partial roof collapse on the fire side of the separation wall.

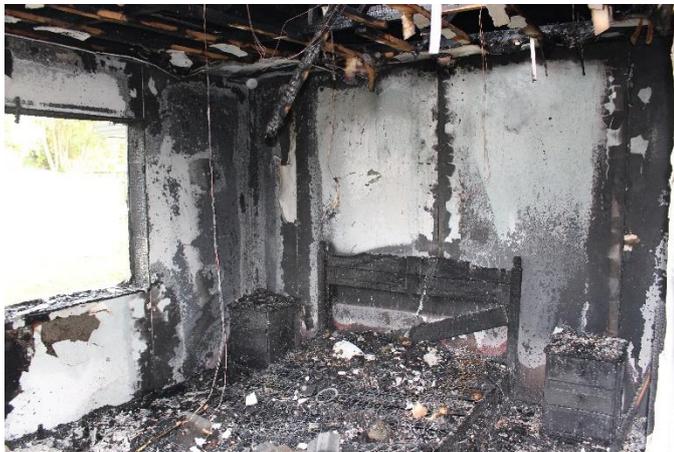
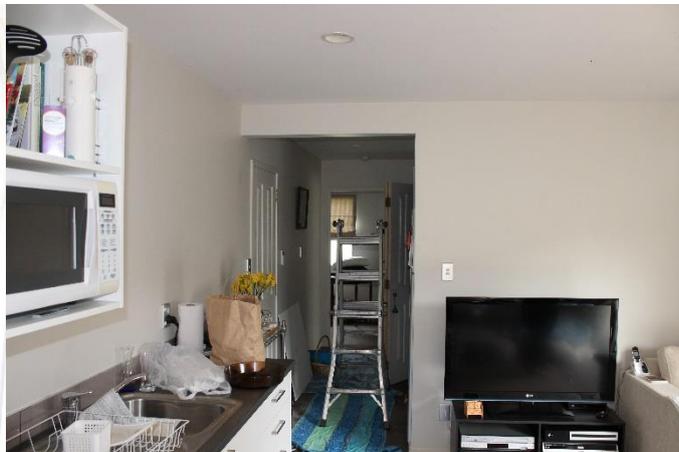
The photos above clearly show the value of effective fire separation in reducing damage in the event of a fire in a subdivided house.
