National Rural Fire Authority

Rural Fire Investigation Report

Fire Name: Waimarama Fire

Fire Date: 13 February 2017

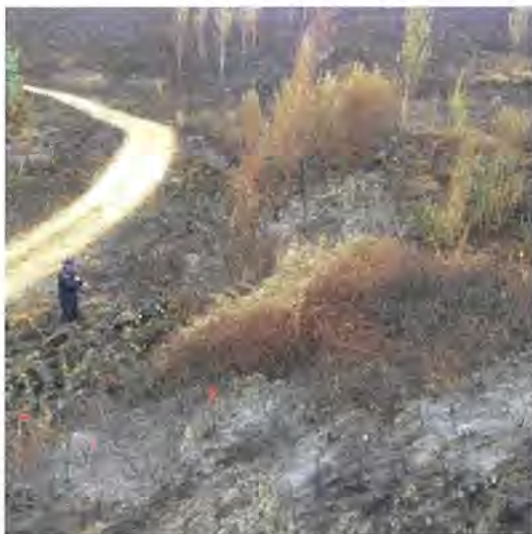
The flagging system being used, red flags can be seen, which identify the main fire run.

The fire behaviour indicators were used to identify the directional spread of the fire which included the main head of the fire, transition zones, flanks and the lower intensity backing fire. A flagging system was used to assist with the identification of the FBI's. The red flags indicate the higher intensity head fire, yellow flags the transition from the head to a flank (lesser intensity) fire and the blue flags show the lower intensity fire characteristics generally exhibited by a backing fire.

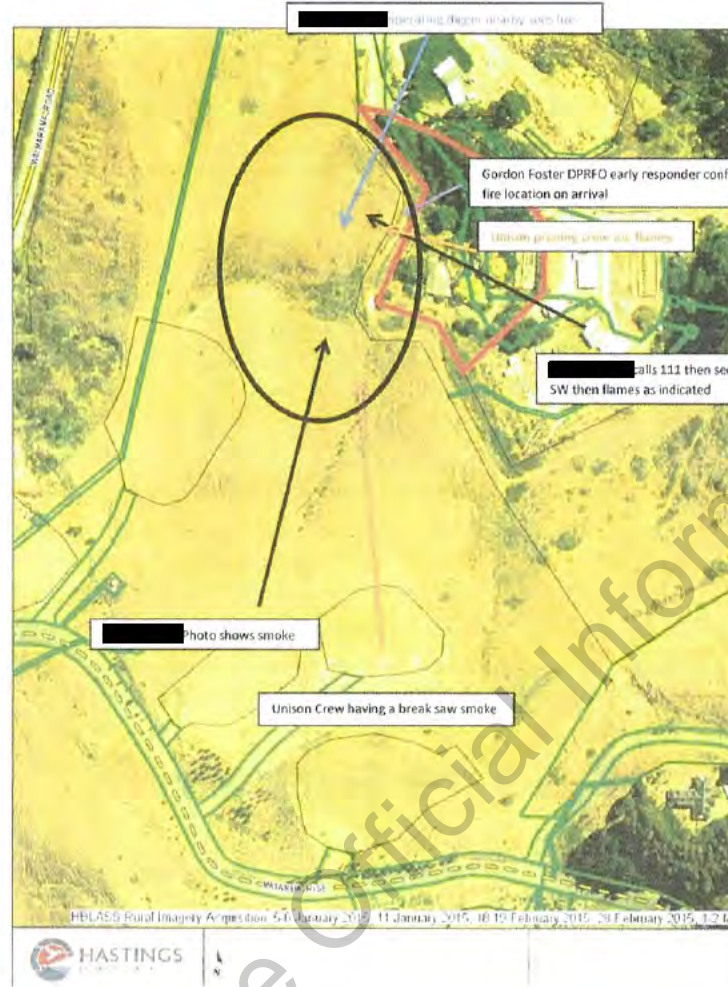
General Area of Origin and witness references

The general area of origin was able to be identified and confirmed from witness observations and pictures. These included two of the Power Authority crews working in the area, the 1st 111 caller, [REDACTED], a digger operator working nearby, and [REDACTED], who took a picture from lot 8 above.

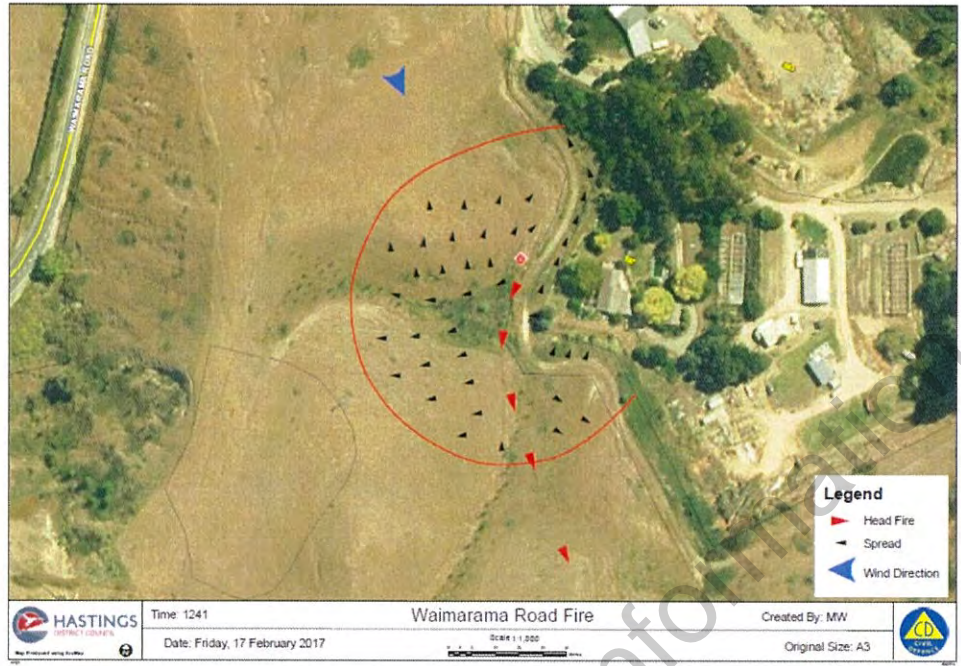
General area of origin – shows wind direction and fire spread

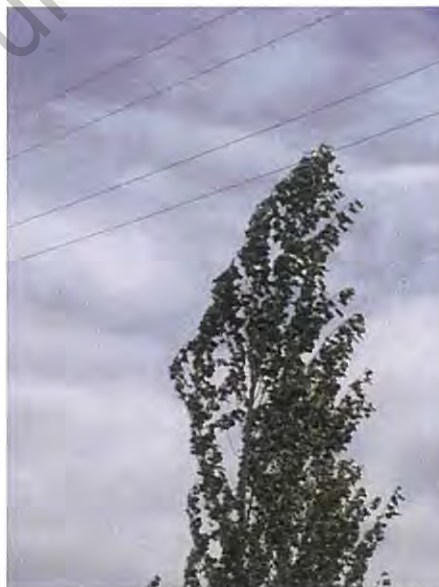
Trees were observed to touch power lines both where the Unison crew were pruning and further up the power line toward Lot 8 above. (Ref CM Photos 15th Feb).

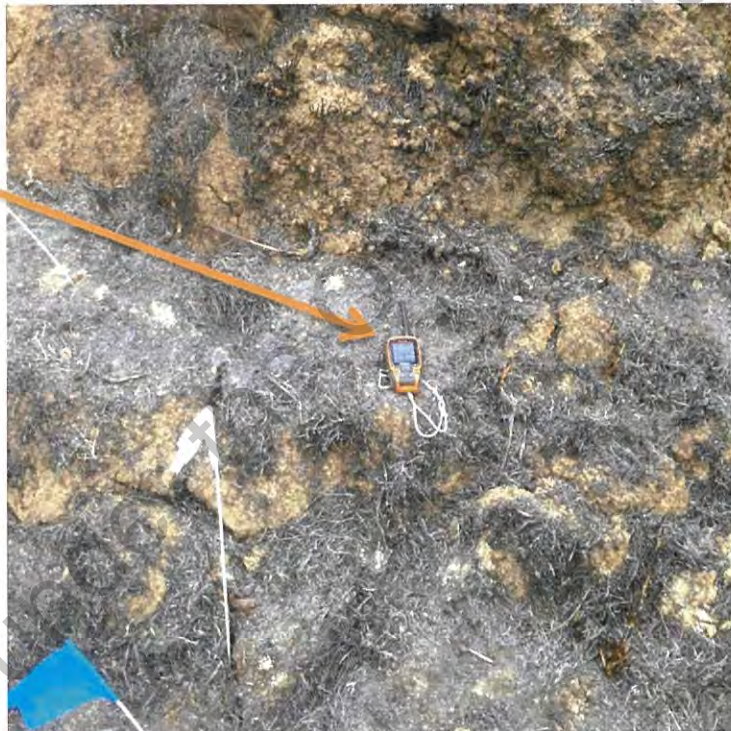
Specific point of origin

Specific Point of Origin - GPS Co-Ordinates S 39 43.271' E176 55.865'

Directly above the identified point of origin were some overhead power lines.

During the field investigation it had been observed there were markings on the lines that looked like they had been clashing together and potentially arcing.

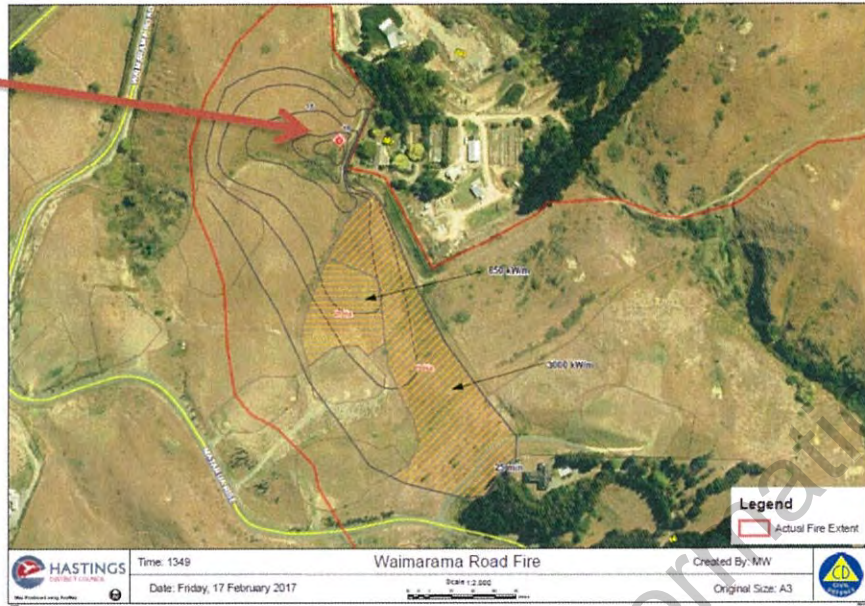
Map identifies the specific point of origin and the fire spread characteristics based on the field observations and fire behaviour indicators observed by the team.

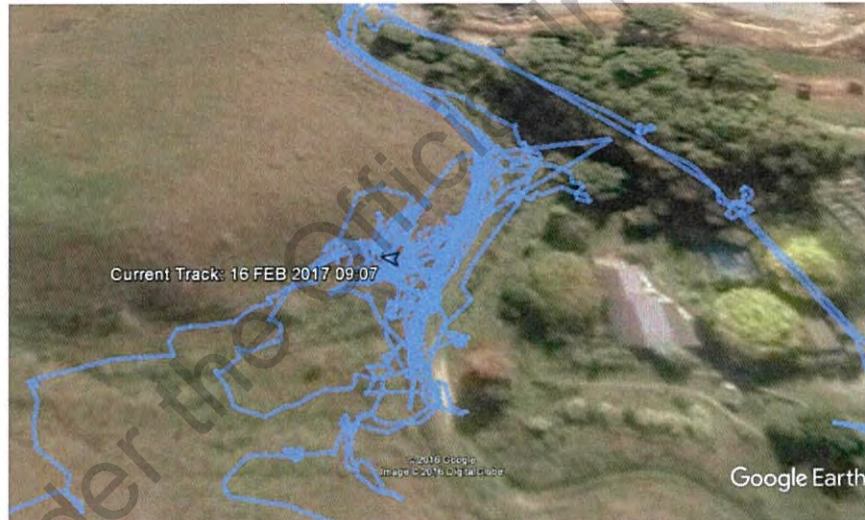
GPS tracking of field investigation (general area of origin) track log on google maps

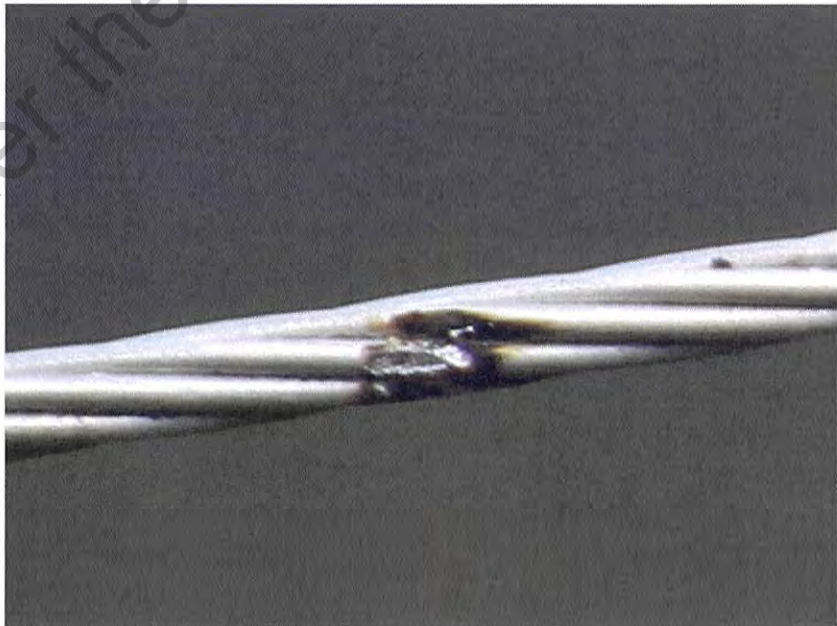
- 4.1 There is evidence of the d power line conductors clashing due to the high wind conditions in the span between poles 125760 and 155487.

The arcing resulting from the conductors clashing has produced aluminium particles that were burning, or sufficiently hot, to set fire to the vegetative material below.

Example of the arching observed on the powerlines from the adjacent bank.

- 4.2 If Unison had fitted spacers at intervals along the power line span (between poles 125760 and 155487) to maintain the separation of the conductors, the probability of the power line conductors clashing (and arcing) would be negligible.
