Fire Research Report

Impact of Fire Service Activity on the Environment

Landcare Research

Landcare Research Contract Report: LC0607/098

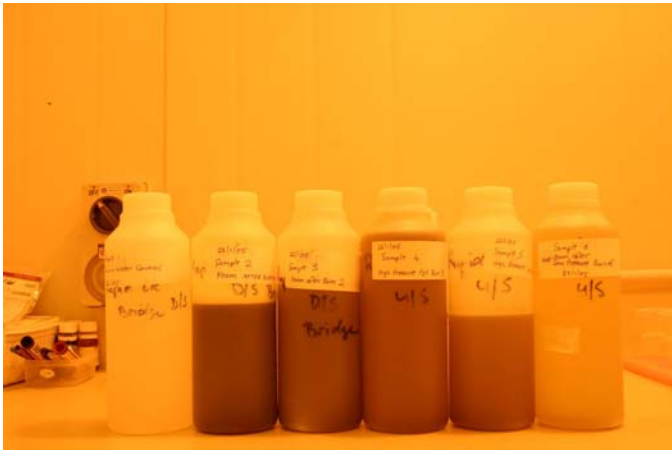
Figure 1. Fire-water samples following filtration

The St Mary's School burn samples were passed through a glass wool filter, then a Whatman No 1 filter, then finally a Whatman No 3 filter under vacuum to remove soot. As the air bubbler caused excessive foaming, all foam samples were diluted 100-fold before toxicity testing. Figure 1 shows the difference in clarity in some of the filtered samples.

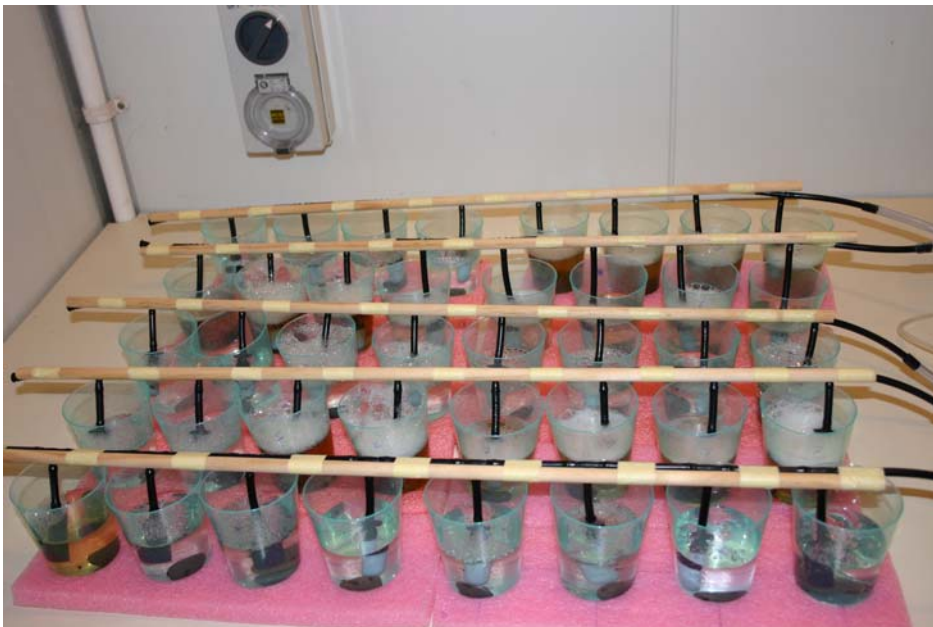
Figure 2. Experimental set up of the aquatic toxicity tests with mayfly larvae.

Each exposure vessel was supplied with a gentle stream of air from the end of an air stone, as generated by an airpump. Treatments were distributed in a random manner, ensuring an even spread of mayfly larvae size across all replicates and treatments. In the St Mary's School test a clean acid-washed river stone (with the biofilm scrubbed off) was placed into each container to provide shelter for the larvae. As this caused some problems, stones were not used in the second set of tests.

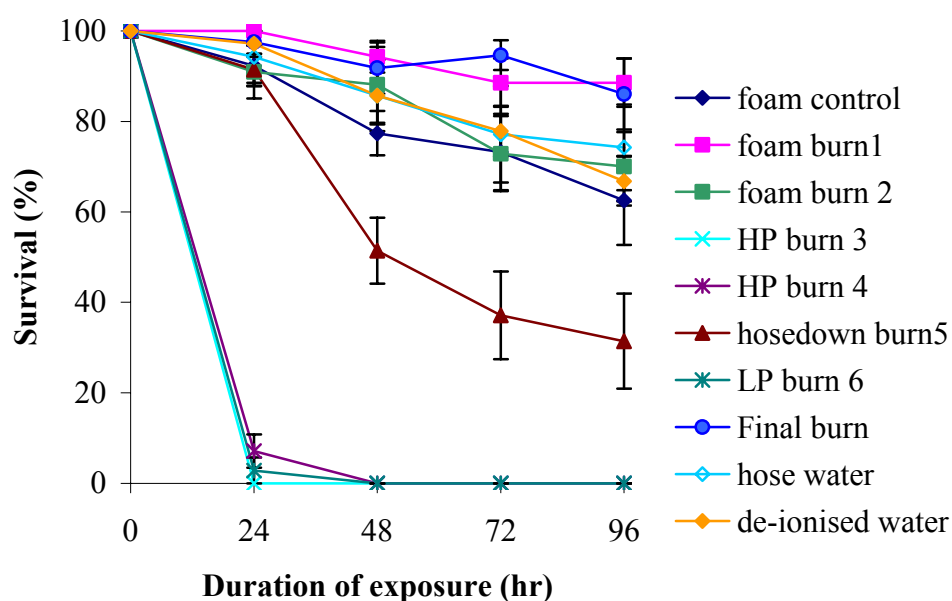
Fig. 3. Survival of mayflies exposed to fire-water from St Mary's School for up to 96 hr.

Burns 3 and 4, which were managed using water from a high-pressure hose, produced highly toxic fire-water that resulted in almost 100% mortality in mayfly larvae within their first 24 hr of exposure, and it is highly likely that mortality occurred at a much earlier time point (Fig. 3). The first burn (burn 5) to be managed with water from a low pressure hose yielded no fire-water for testing as it evaporated on interaction with the fire; the building was therefore hosed out afterward to provide some water for toxicity testing. Mayflies showed moderate toxicity to this sample after 48 hr exposure, indicating toxic material remains after a fire is extinguished (Fig. 3). This material was washed off and subsequently discharged into the environment.

Burn 6 was also managed using a low-pressure hose and fortunately sufficient water was collected for toxicity testing. Like the fire-water collected from the fire extinguished using a high-pressure hose, the burn managed with a low-pressure hose yielded equally toxic fire-water (Fig. 3). In the final burn, a tremendous amount of water was used to protect surrounding buildings from catching alight during the intentional destruction of the St. Mary's tennis shed. Fire-water was collected from a nearby stormwater drain (approximately 100 metres from the tennis shed site) and although the water was significantly discoloured, it was not acutely toxic to mayfly larvae.

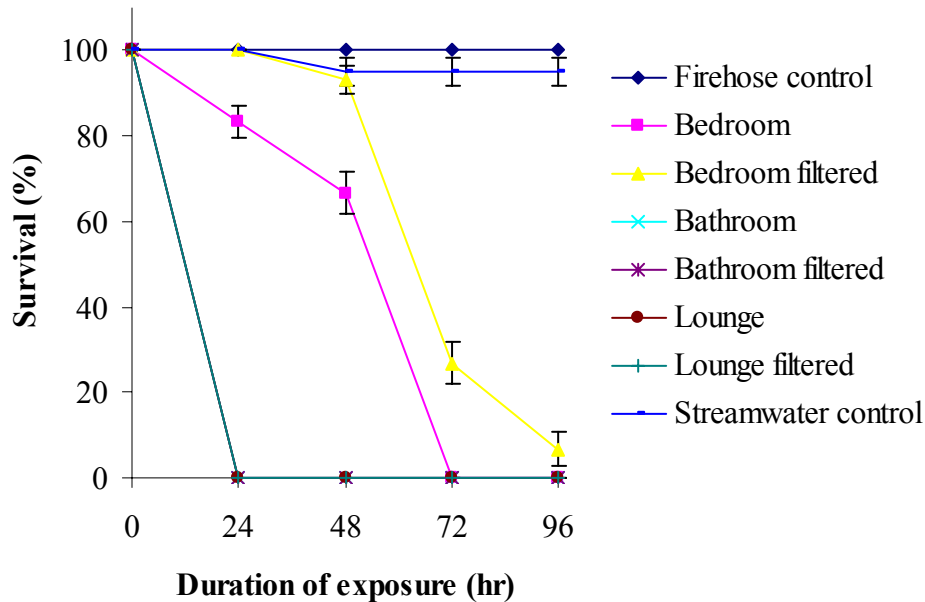
Fig. 4. Survival of mayflies exposed to fire-water from the Waiuku fire-water samples for up to 96 hr.

For the Waiuku fire-water samples, control mortality was very low, with only 1 mayfly dying out of the 60 used (Fig. 4). However, the fire-water samples all proved very toxic, with only 4 mayflies out of the 180 tested surviving at 96 hr. There was no obvious difference in mortality between animals exposed to filtered or unfiltered samples. The samples from the bathroom and lounge fires were very toxic with total mortality within 24 hr, while the bedroom fire sample showed gradual, but still 100% (or almost) mortality within 96 hr.

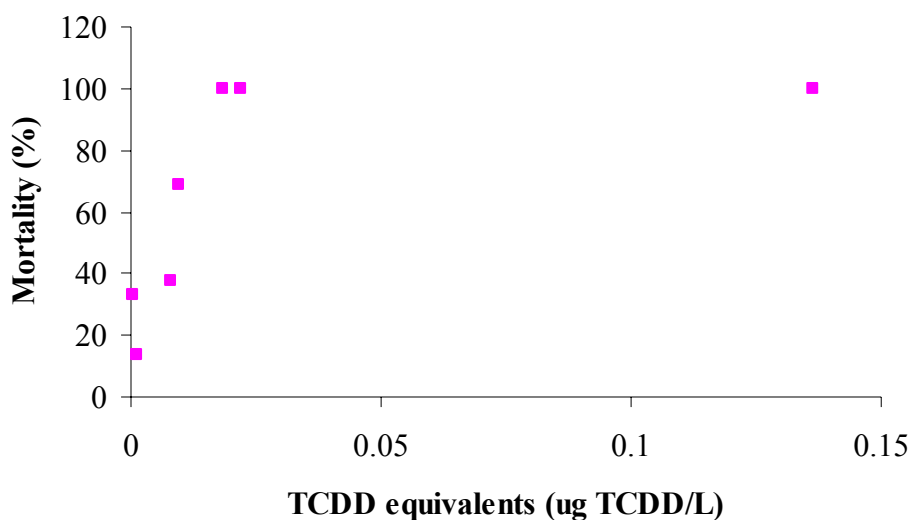
Fig. 5. Correlation of dioxin equivalents as calculated using the H4IIE- EROD assay with toxicity to mayflies.

It is worth noting that some of the samples extracted contained ultrafine particulates (this was most likely in samples 2 and 3) that were not removed by coarse filtering. The dioxin equivalents stated here may therefore have been artificially increased due to bound contaminants on these particles (normally binding causes a reduced bioavailability) being removed during the extraction process. Cytotoxicity was seen in many samples. The sample containing the most TCDD equivalents was the fire-water collected after the initial burn that was managed with foam. This sample contained almost 0.696 μg TCDD/mL, compared to between 0.0012 to 0.136 μg TCDD/mL in the other fire-water samples. Fire-hose control water, hose down water and storm water from the final burn had relatively insignificant TCDD concentrations. The TCDD concentration in the first foam-controlled sample compared with the second could be indicative of the material that was burnt. It is noted that this first fire caught alight very dramatically, indicating highly flammable material. When comparing the TCDD equivalents in each fire-water sample with toxicity to mayflies it is evident there is a good correlation between toxicity and dioxin (Fig. 5).

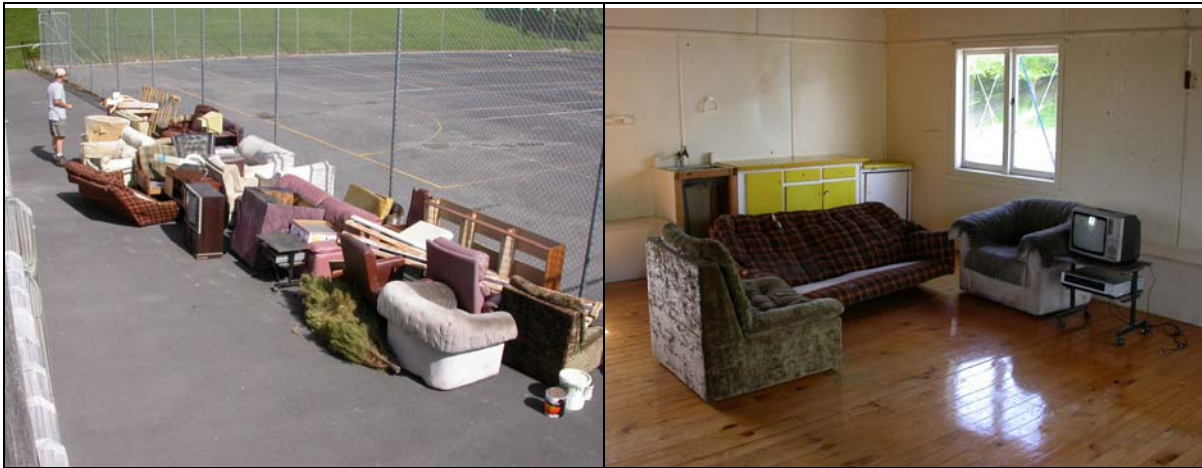
Figure 1: Preparation for fire exercises at St Mary's School. Left: Second-hand furniture items ready for six simulated living room fires. Right: Mock living room set up for the first burn.

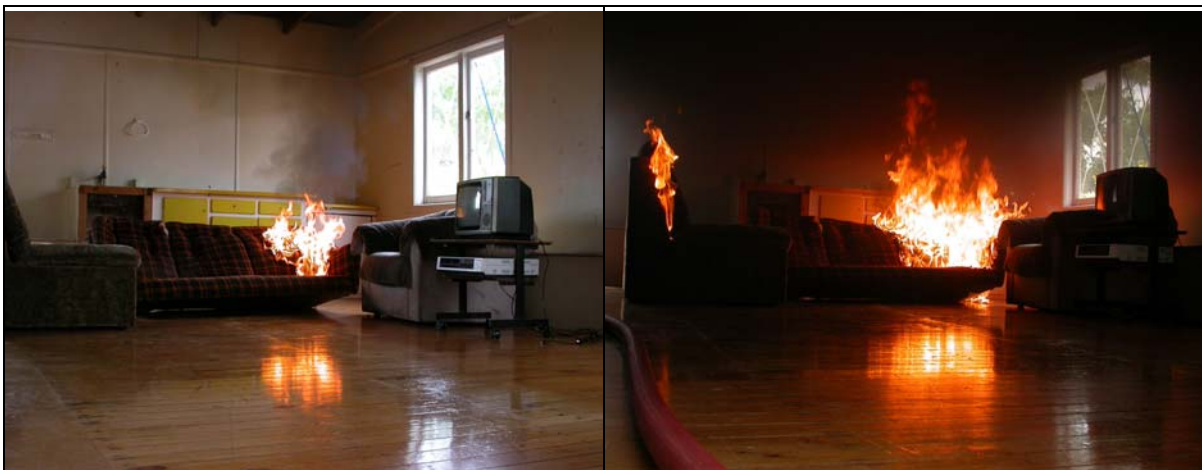
Figure 2: Mimicking a typical house fire using the St Mary's School tennis shed. Left: Fires were set to mimic a typical couch fire. Right: Mid-way through the first fire exercise, approximately one minute before this fire was extinguished.

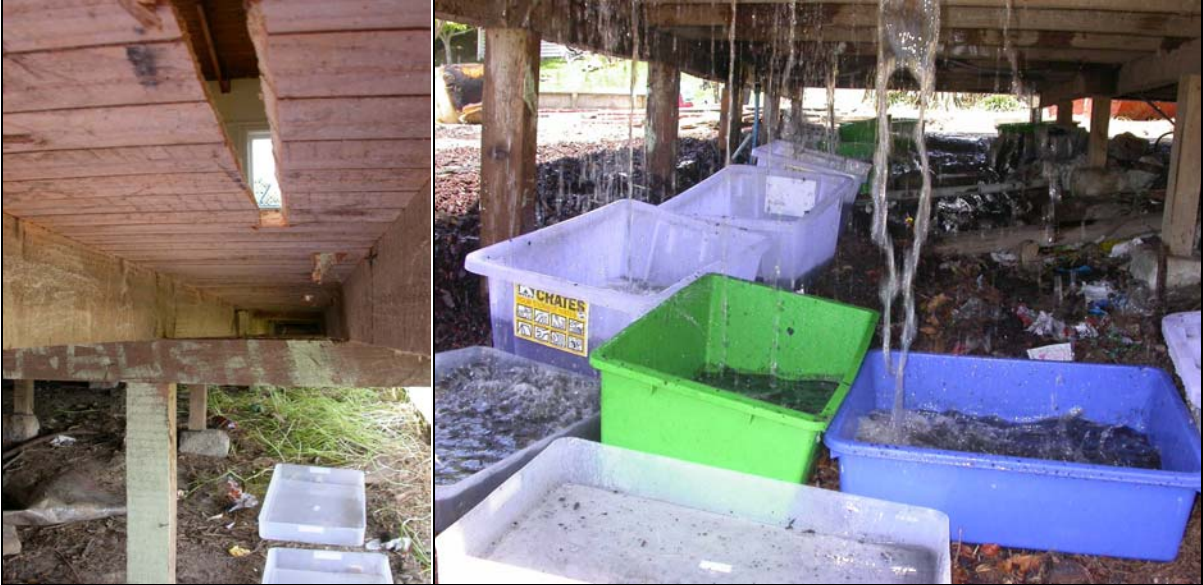
Figure 3: Fire-water collection below the St Mary's School tennis shed. Left: Holes cut into the floor allowed collection of fire-water beneath the shed. Right: Fire-water draining into plastic bins placed below the drainage holes.

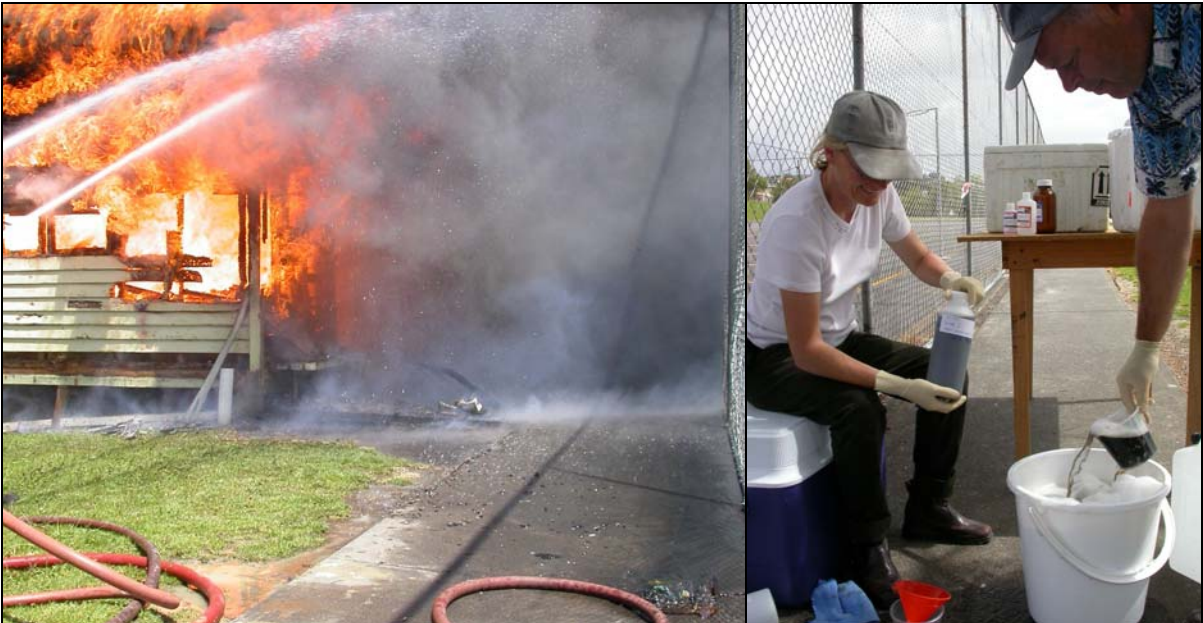
Figure 4: Fire-water collection from the St Mary's School tennis shed. Left: Fire-water flowing overland to tennis court stormwater drain (bottom right of photo). Right: Fire-water being bottled for contaminant analysis and toxicity testing.

Nine samples were collected in total (Appendix 2, Fig. 4), consisting of 5 fire-water samples from the 'lounge room' burns, water collected from a hose down following the first low pressure burn (where no fire-water was collected due to such a minimal amount being used), one fire-water sample collected from the storm water drain during the final burn (Appendix 2, Fig. 5), and two controls (a foam-water and a hose-water control):

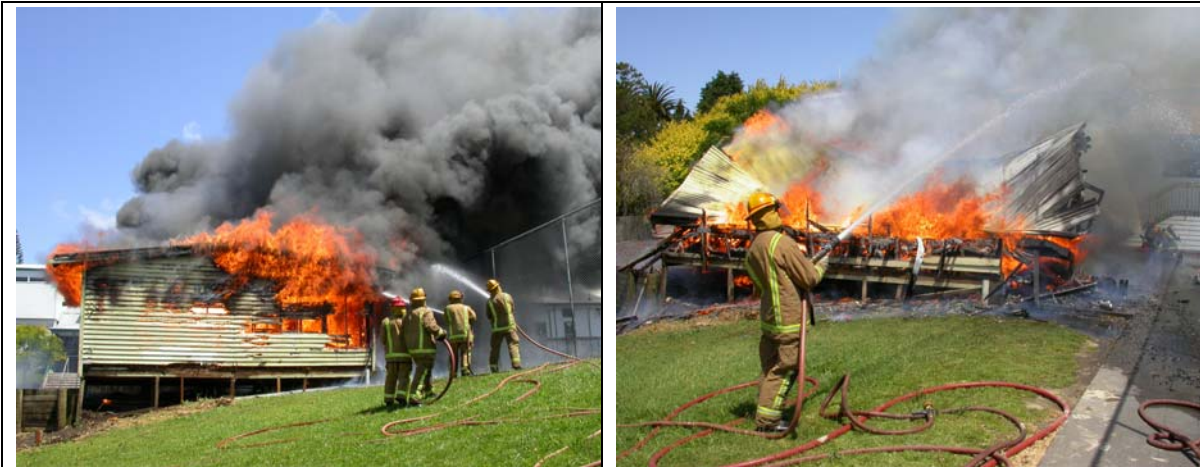
Figure 5: St Mary's School tennis shed burn, 22 January 2005. Left: Significant smoke plume developing during the final burn. Right: Steam and smoke generated during the latter stages of the final burn.

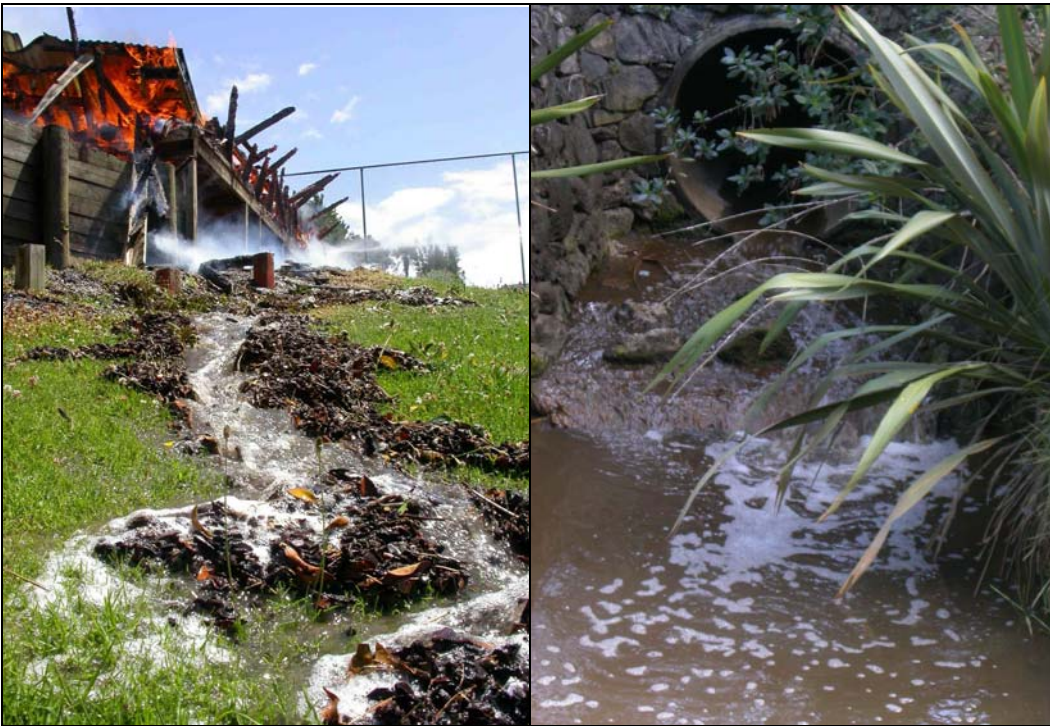
Figure 6: Fire-water path from the St Mary's School tennis shed burn, 22 January 2005. Left: Fire-water flowing overland to car park stormwater system (the brown solid matter is wood chips from around the shed). Right: Final stormwater discharge to the lower Onepoto Stream, approximately 500 m downstream of the fire scene.

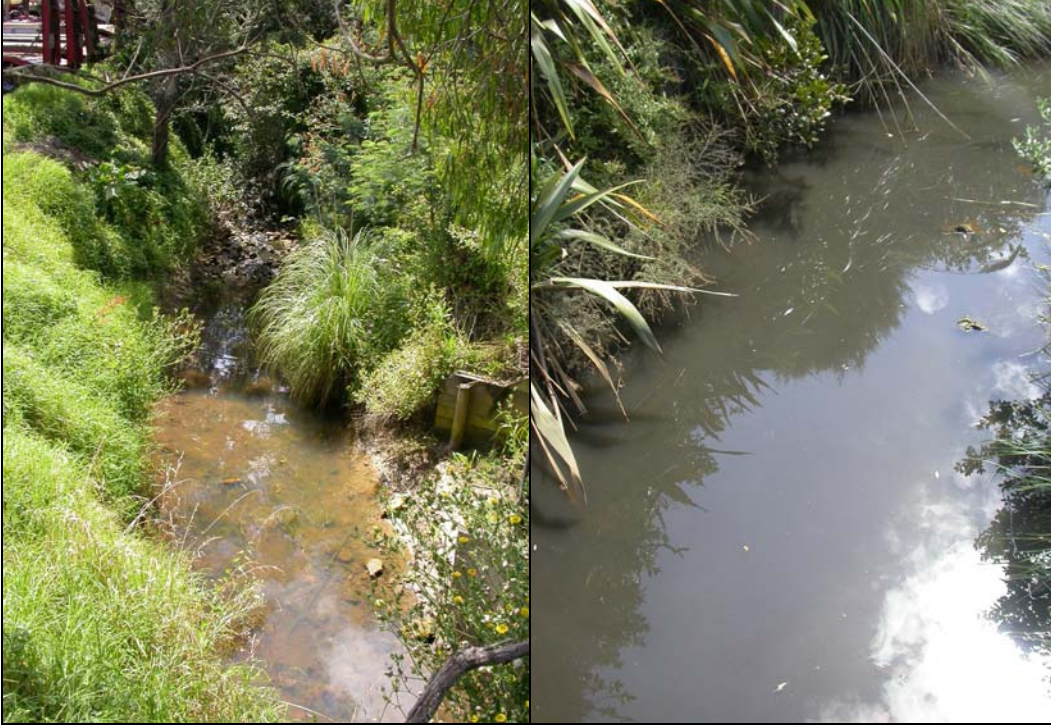
Figure 7: The Onepoto Stream was the receiving water for discharges of fire-water from the St Mary's School tennis shed burn, 22 January 2005. Left: Onepoto Stream at Lake Road upstream of the point where fire-water reached the stream. Right: Onepoto Stream downstream of the fire-water discharge (via the stormwater drain shown in Fig. 4).

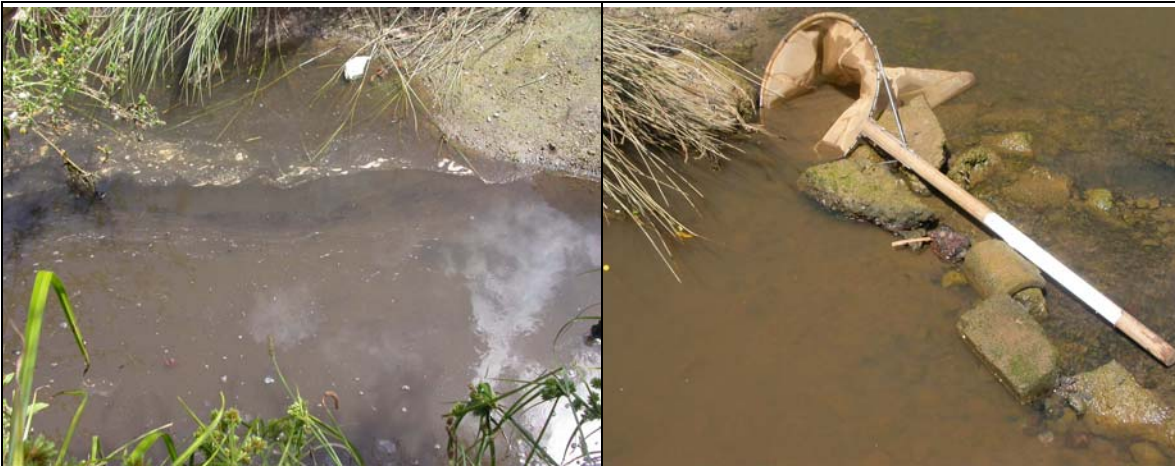
Figure 8: The Onepoto Stream downstream of discharges of fire-water from the St Mary's School tennis shed burn, 22 January 2005. Left; Soot visible in backwaters. Right: Net used to collect fish fleeing downstream during the period of fire-water discharge.

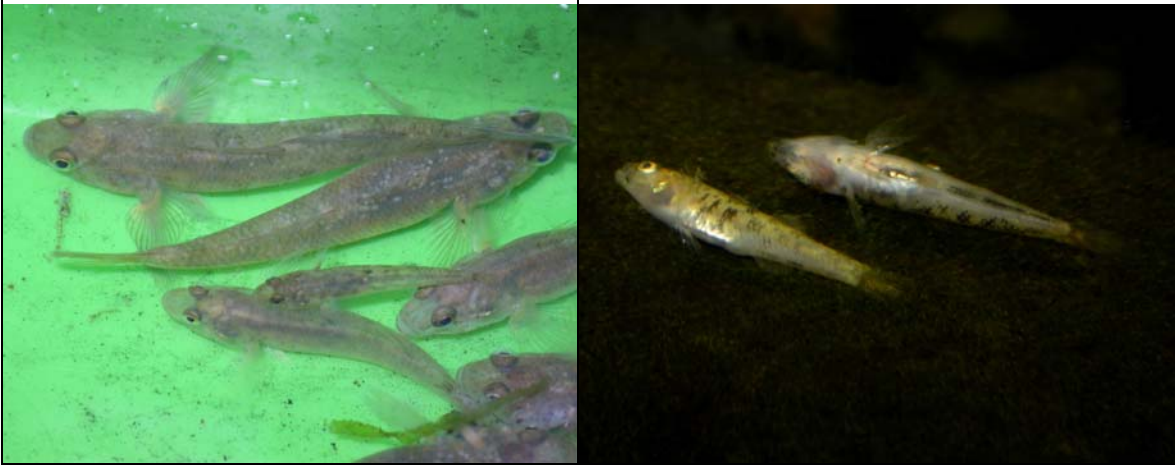
Figure 9: Native fish caught fleeing downstream during the fire-water discharge in the Onepoto Stream, 22 January 2005. Left: Live common bullies. Right: Juvenile bullies that died shortly after being removed from the stream.

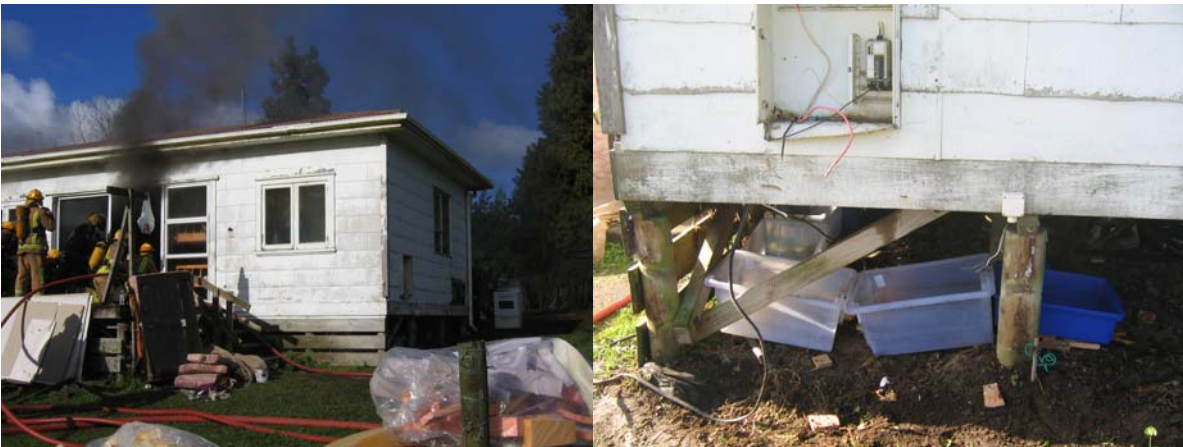
Figure 10: Left: House at 68c Marae O Rehia Rd, Waiuku used for the second controlled burn. Right: Plastic bins placed under the bedroom to collect fire-water.

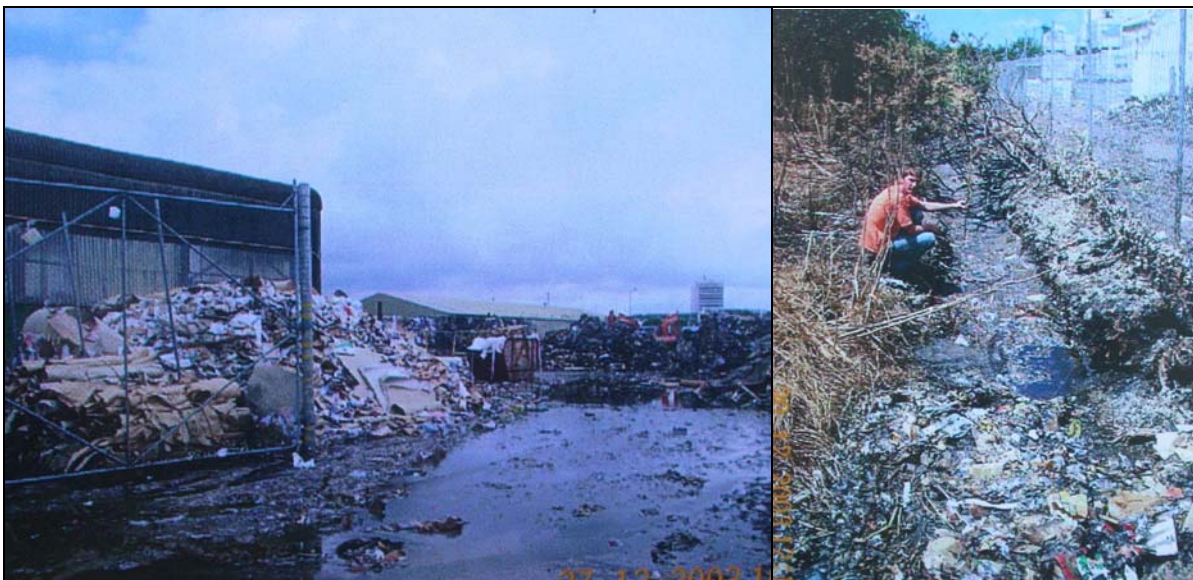
Figure 14: Carter Holt Harvey Pulp & Paper fire, Penrose, 26 Dec 2003. Left: Waterlogged paper and fire-water. Right: Waterlogged paper and ash carried by fire-water to stormwater drains. (Photos: Auckland Regional Council).

In December 2003, a fire developed in stockpiled paper bundles at a Carter Holt Harvey Pulp & Paper yard in Penrose, and this fire burned for several days. Unfortunately, the water used to extinguish the fire carried large quantities of ash and waterlogged paper into the site stormwater drains (Appendix 2, Fig. 14), and then into stormwater settling ponds (Appendix 2, Fig. 15)

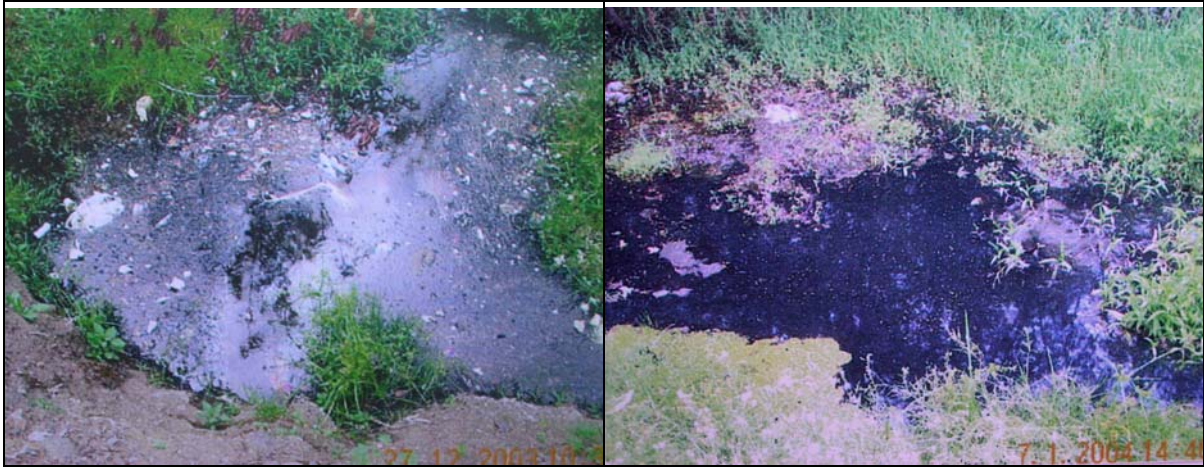
Figure 15: Carter Holt Harvey Pulp & Paper fire, Penrose, Dec 2003 to January 2004. Left: Stormwater treatment ponds filled with waterlogged paper and ash. Right: Twelve days later the stormwater ponds had become anaerobic (black). (Photos: Auckland Regional Council).

Despite the initial pumping, sufficient anaerobic sludge remained in the ponds to cause the pond water to become anaerobic during the 2 weeks following the fire, causing the ponds to turn black (Appendix 2, Fig. 15). The discharge of such anaerobic pond water could have significant adverse effects on a small receiving water stream providing little dilution. The bottom sludge was therefore removed in early 2004 (Appendix 2, Fig. 16).

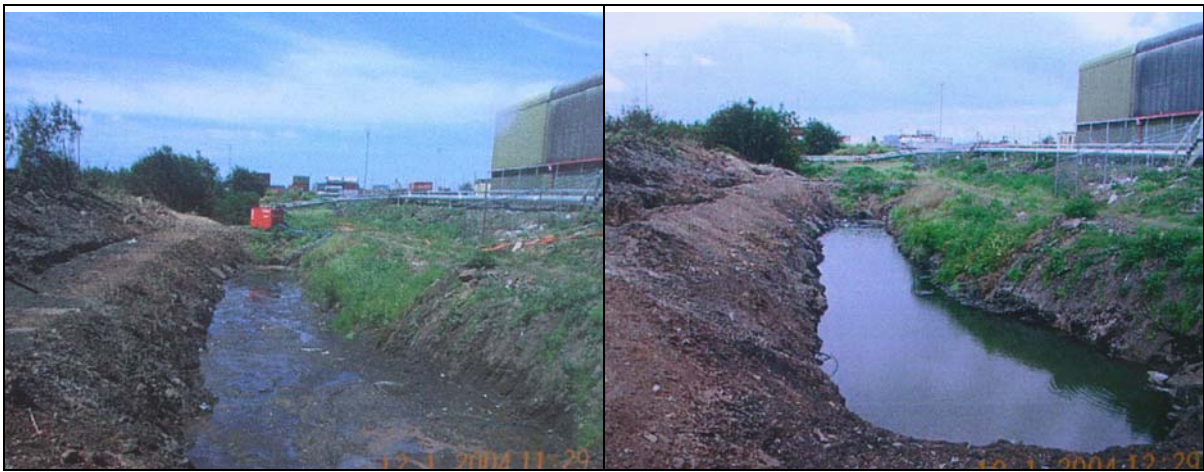
Figure 16: Carter Holt Harvey Pulp & Paper stormwater ponds, after the December 2003 fire. Left: Pond filled with decomposing paper, 12 January. Right: Pond after paper sludge removed, 19 January. (Photos: Auckland Regional Council).

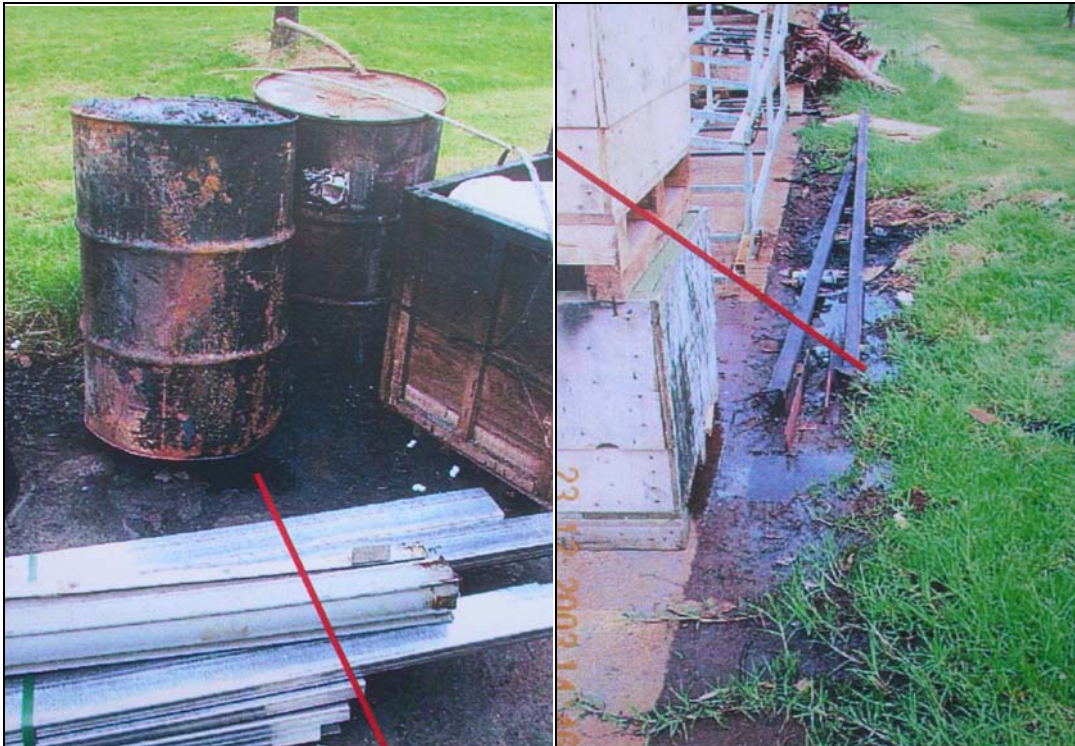
Figure 17: Duffett Doors, Papatoetoe, 21-Dec-03. Left: Oil drums damaged by fire. Right: Oil from leaking drums running overland. (Photos: Auckland Regional Council).

In December 2003 a fire at the Duffett Doors property in Papatoetoe was thought to be the cause of a subsequent leakage of oil from at least one storage drum (Appendix 2, Fig. 17). Oil on the ground was washed with fire-water into a stormwater cesspit, before discharging to a small tributary of the Puhinui Stream. Oil may have been carried into the drain with fire-water as fire-fighting occurred, but the ARC file also suggests fire fighters had washed down the area, hosing oil into the drain.

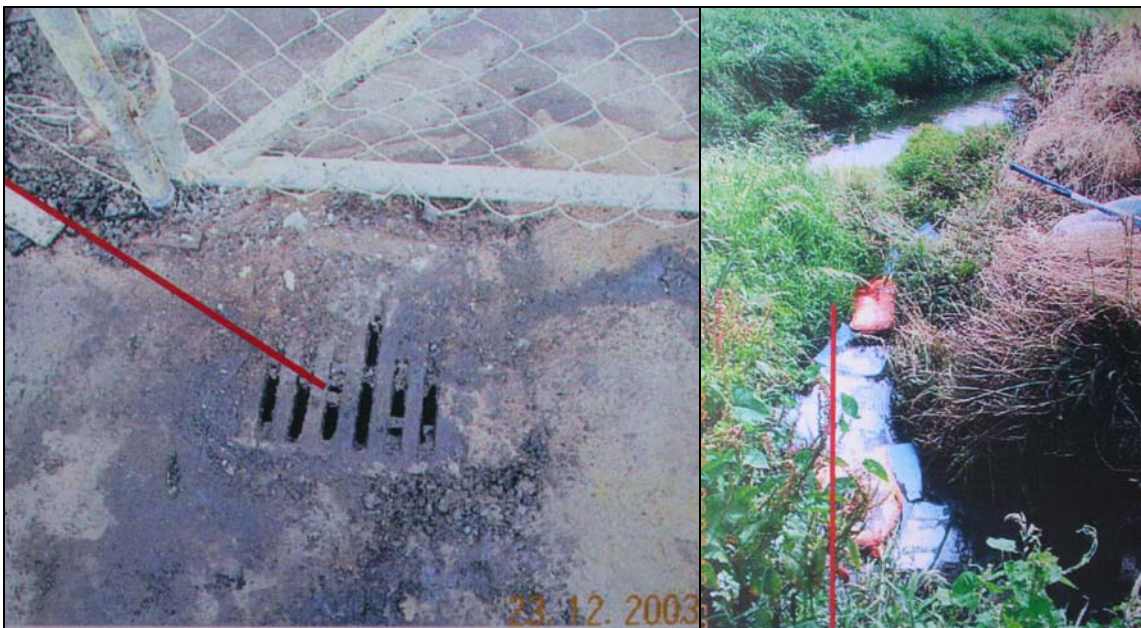
Figure 18: Duffett Doors, Papatoetoe, December 2003. Left: Oil running into a stormwater drain (leading to the Puhinui Stream). Right: White and pink absorbent pads and pillows used to soak up oil from below the stormwater outfall into a tributary just above the confluence with the Puhinui Stream. (Photos: Auckland Regional Council).

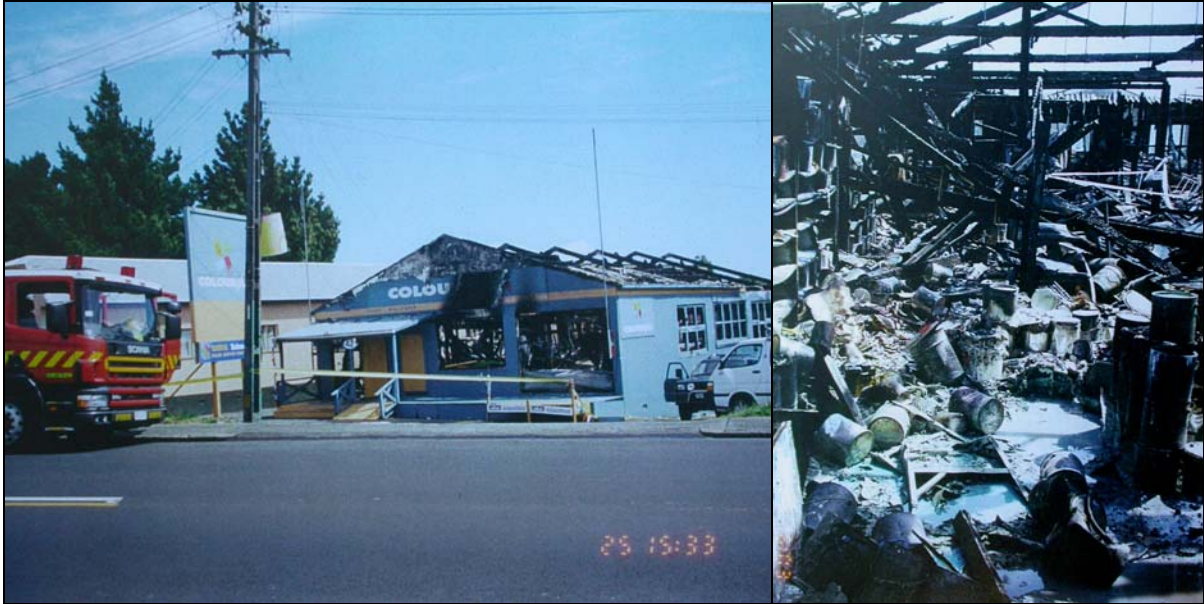
Figure 19: Colourplus paint manufacturers, Mt Roskill, 24 – 25 Jan 2002. Left: Paint manufacturing building damaged by fire. Right: Interior of building showing spilt paint likely to be flushed by fire-water. (Photos: Auckland Regional Council).

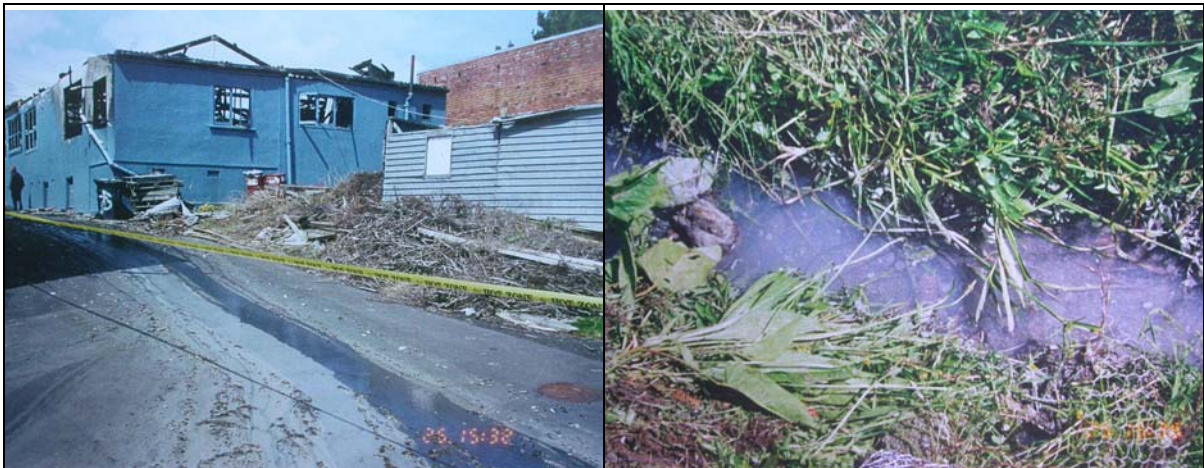
Figure 20: Colourplus paint manufacturers, Mt Roskill, 24 – 25 Jan 2002. Left: Fire-water running down driveway towards the stormwater system and stream. Right: The slow, weedy stream (a natural filter) meant the front of the fire-water travelled only 450m from the site in 18 hours. (Photos: Auckland Regional Council).

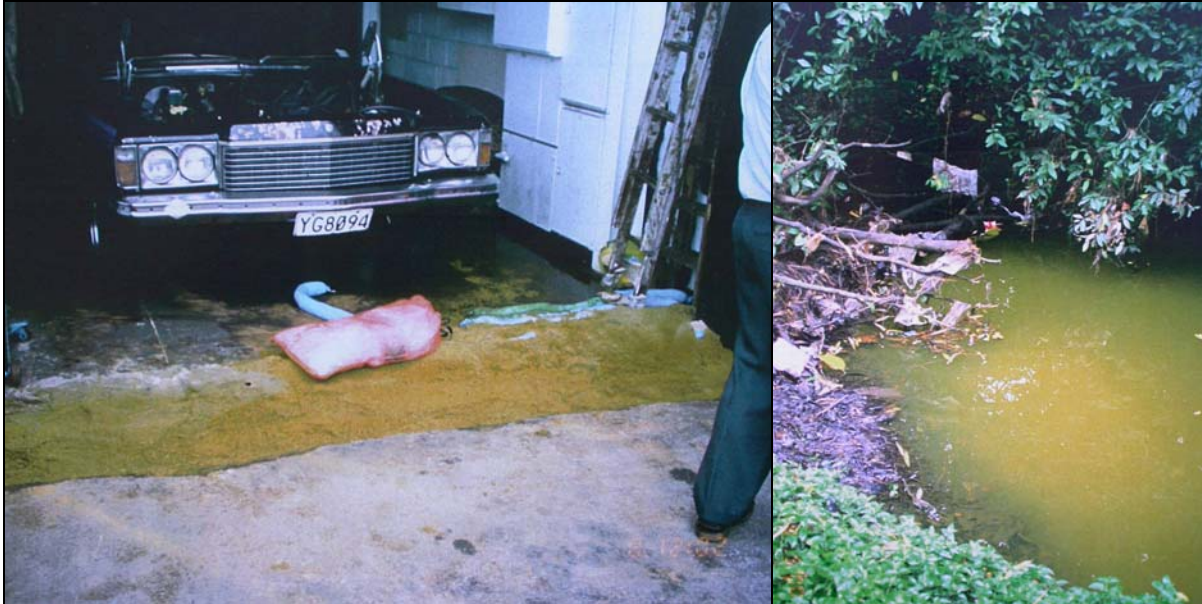
Figure 21: Otahuhu Chromeplaters Ltd, 7 – 8 May 2000. Left: Sand used as a bund and to absorb chromic acid displaced from acid baths by fire-water. Right: Stream coloured yellow by chromic acid due to the fire-water discharge (before sand bunding). (Photos: Auckland Regional Council).

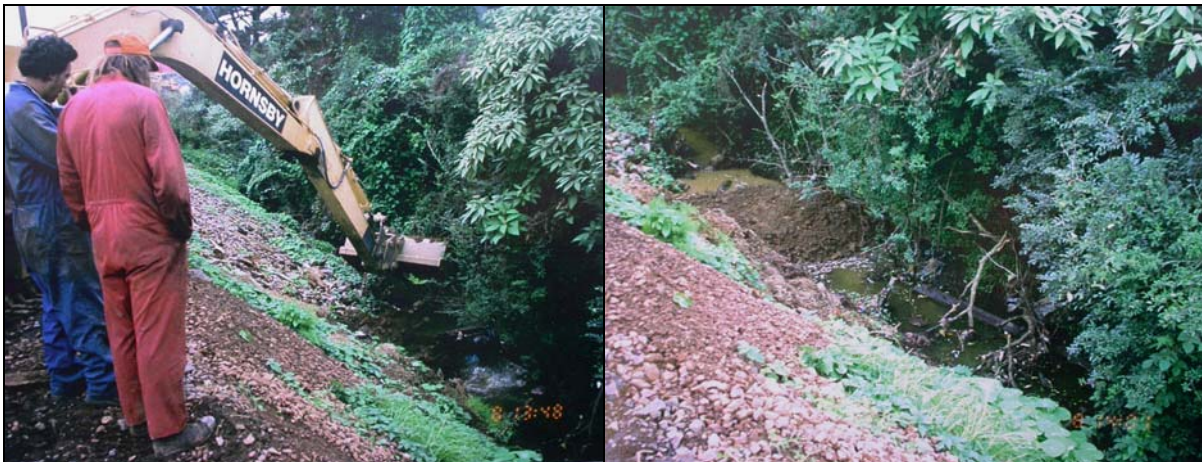
Figure 22: Otahuhu Chromeplaters Ltd, 7 – 8 May 2000. Left: Construction of an earth dam in the stream to intercept contaminated fire-water. Right: Completed earth dam retaining fire-water, allowing removal of contaminated water by Chemwaste sucker trucks. (Photos: Auckland Regional Council).

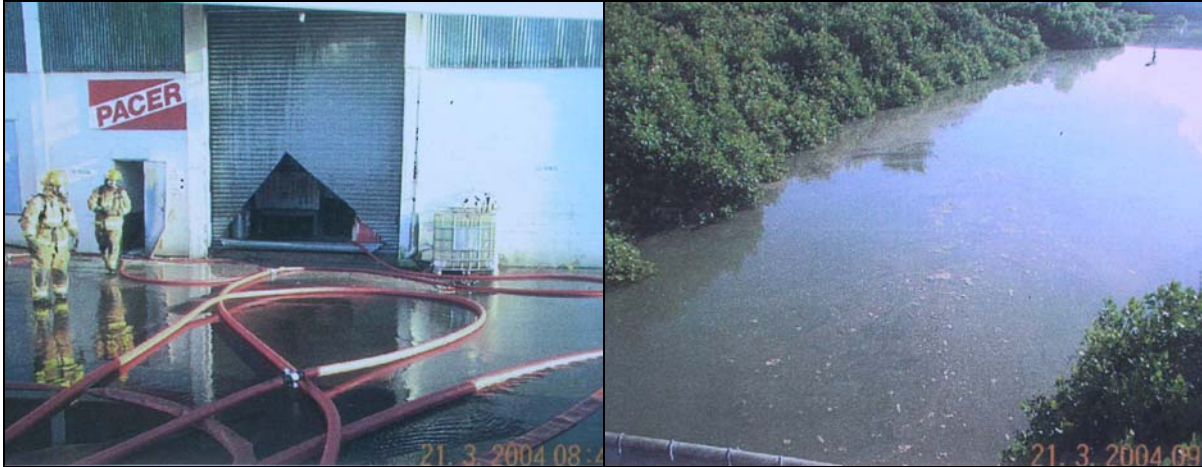
Figure 23: Pacer Car Clean Products, Otahuhu, 21 March 2004. Left: Fire-water washed from the car clean property to the stormwater system leading to the Tamaki River. Right: Ash carried by fire-water to the tidally flushed Tamaki River was considered unlikely to cause significant adverse environmental effects (only aesthetic effects). (Photos: Auckland Regional Council).

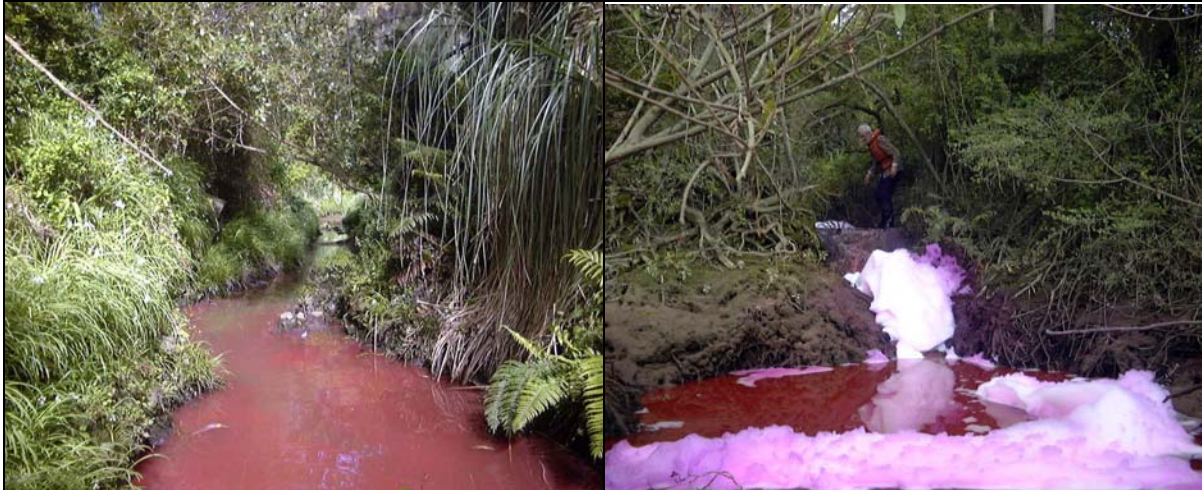
Figure 25: Cobham Drive, Hamilton, chemical truck fire, 23 Sept 2002. Left and right: The truck fire resulted in the spillage of a range of toxic chemicals, which entered this tributary of the Waikato River, causing a fish kill. The colour was mostly rhodamine dye (used in paints and markers for animal health products). (Photos: Environment Waikato).
