Appendix G – 19 Derrimore Heights

From: Jewel Zhu – Fire Engineer

Date: 23 June 2022

Action: 19 Derrimore Heights Residential House Fire

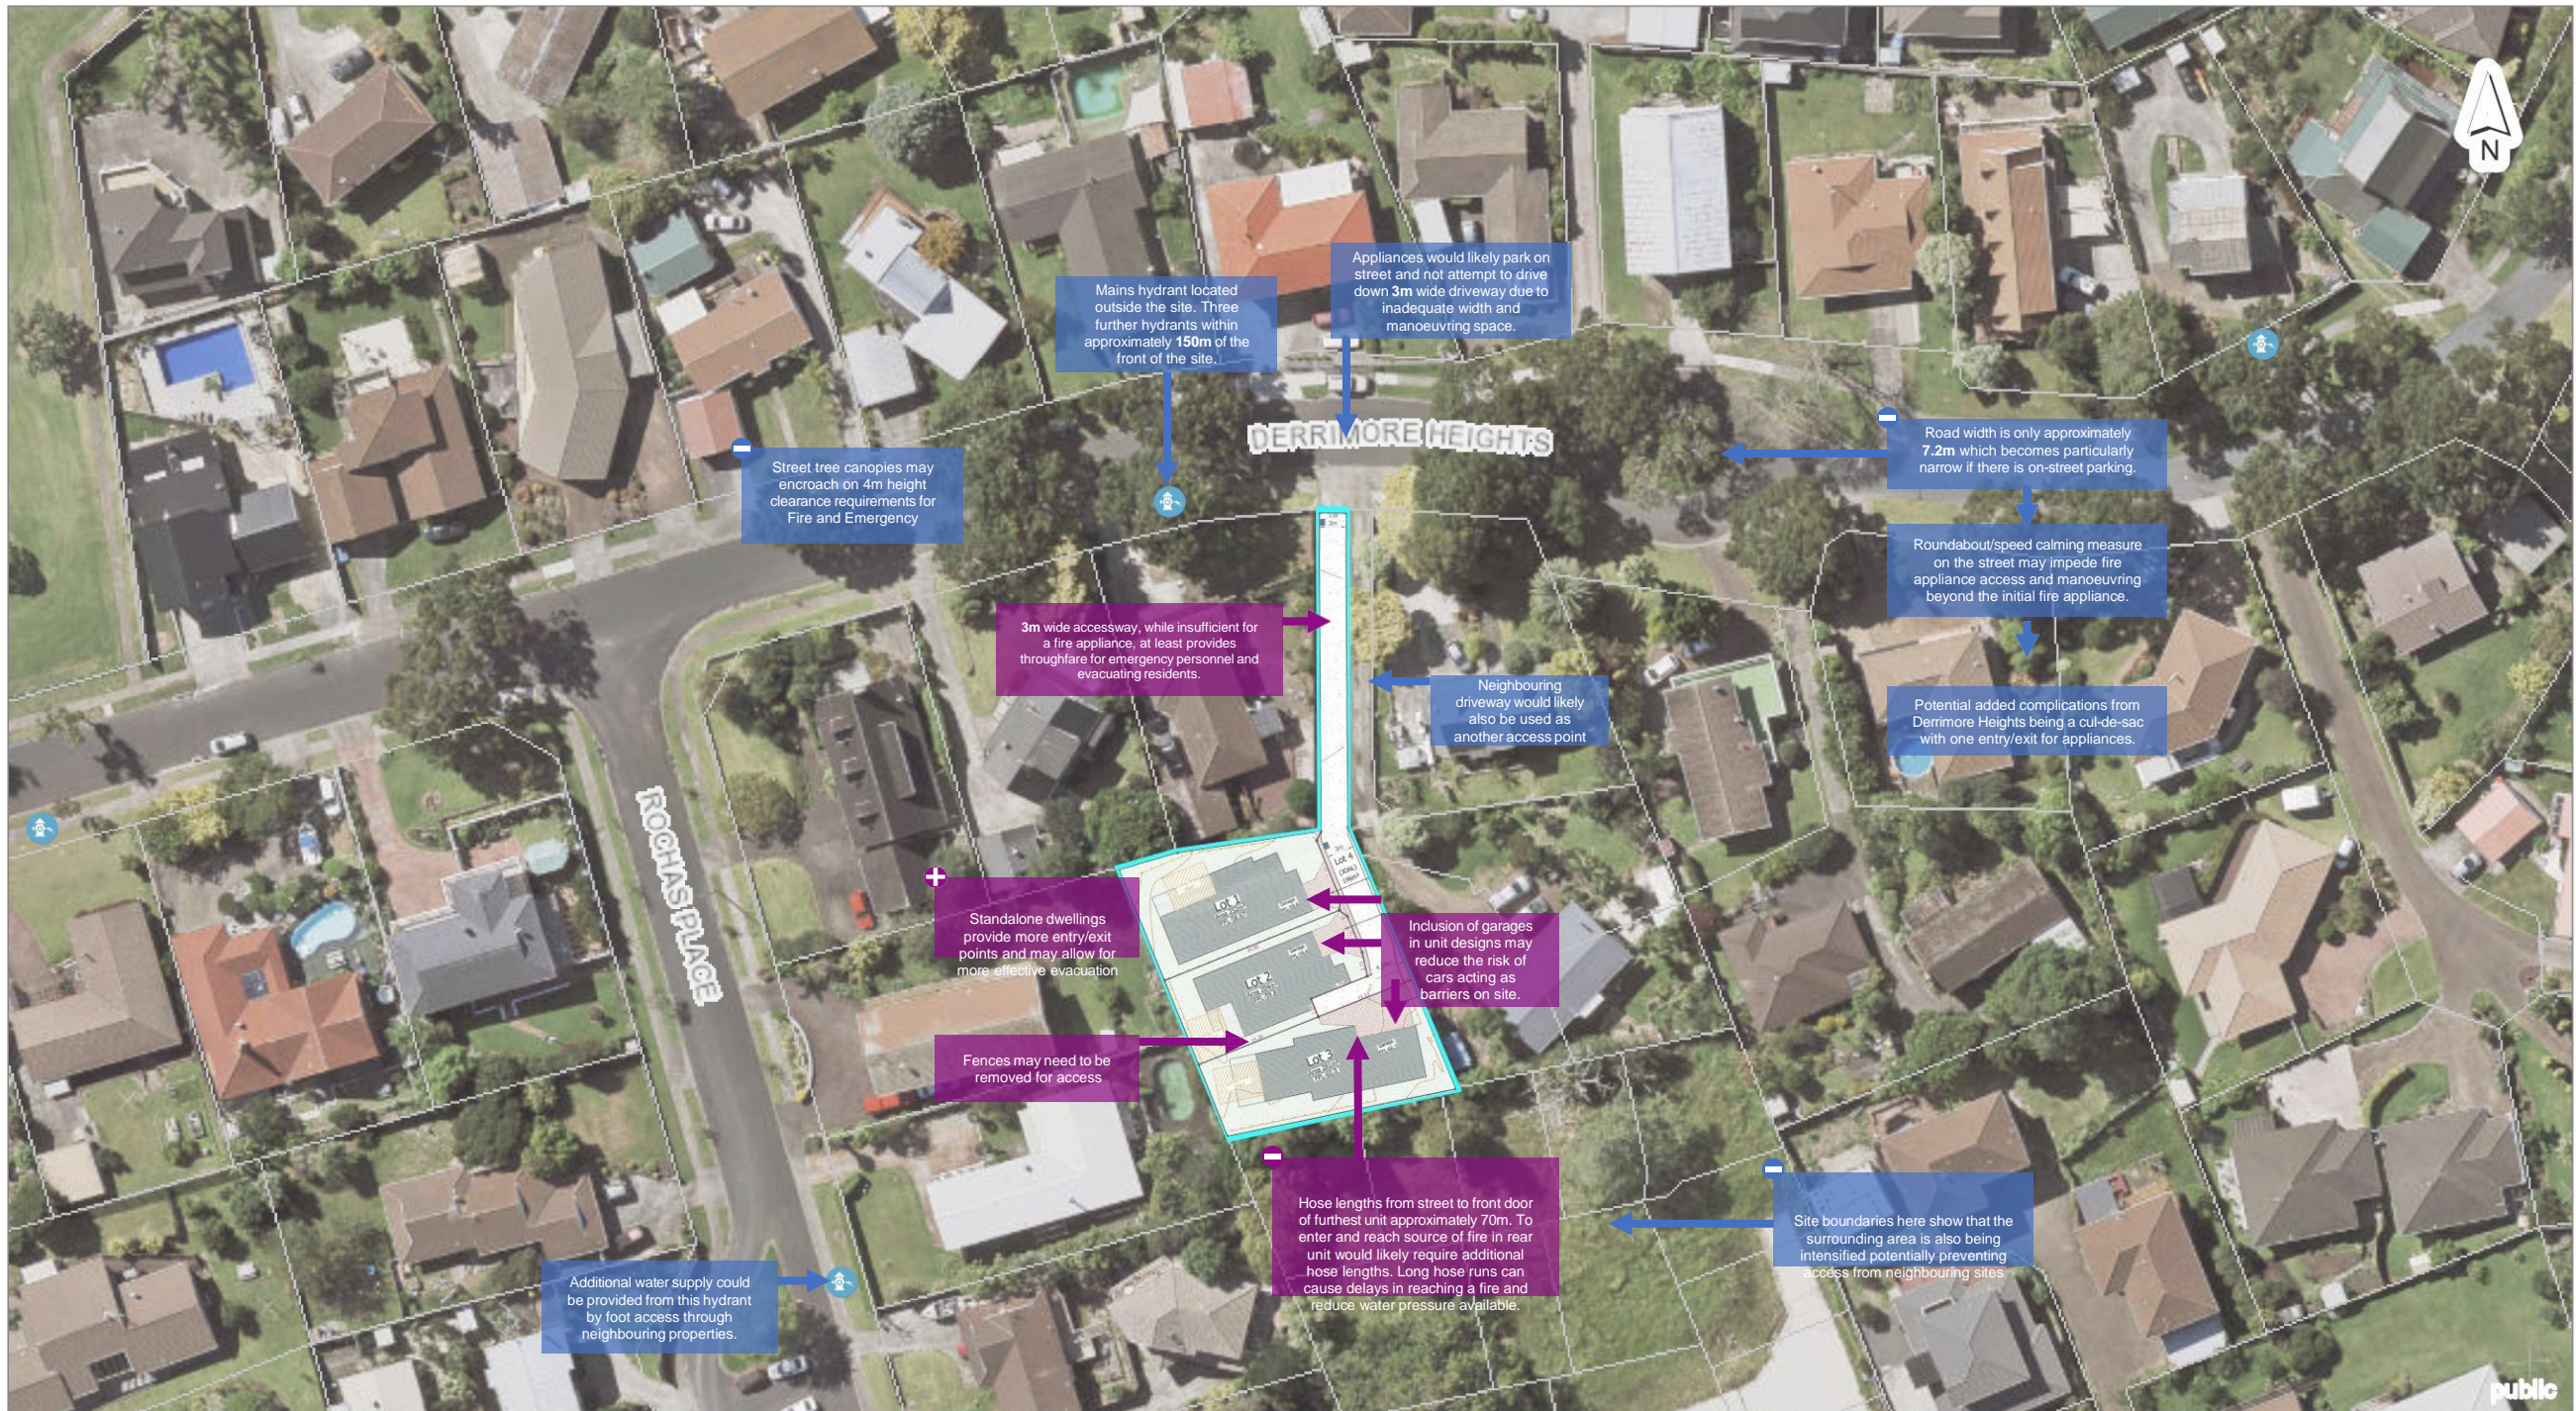
Site Specific Maps with Nearest Water Hydrants: 19 Derrimore Heights

Note: this is applying the same methodology as the earlier case studies, and so does not include the real-life fire findings

- Street, fire appliance, and hydrant considerations
- On-site personnel access and evacuation considerations
- Matters disrupting/hindering emergency response
- Matters supporting emergency response

The flow test conducted by Fire and Emergency indicates that the hydrant located outside the 17 Derrimore Heights (denoted as H1 shown in Figure 3) has a flow rate of 300L/minute. As the two hydrants outside the 7 Derrimore Heights (denoted as H4) and 6 Rochas Place (denoted as H2) are served by the same water main as H1, the three hydrants (i.e. H1, H2 and H4) combined would provide a flow rate of 900L/min in a best-case scenario. It is noted that in reality, the combined flow rate is likely to be much less as the flow and pressure would reduce significantly as additional hydrants are opened. Therefore, when comparing the water flow available with the requirement of SNZ PAS 4509, the shortfall is noted to be 600L/min at least.

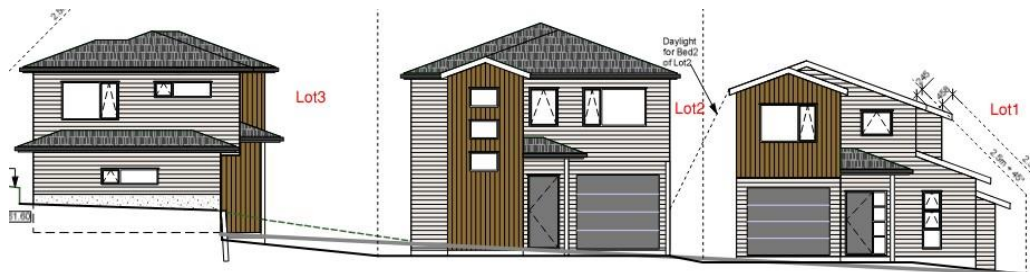
Figure 2: Proposed three new standalone two storey dwellings at the same site – elevation view from the east

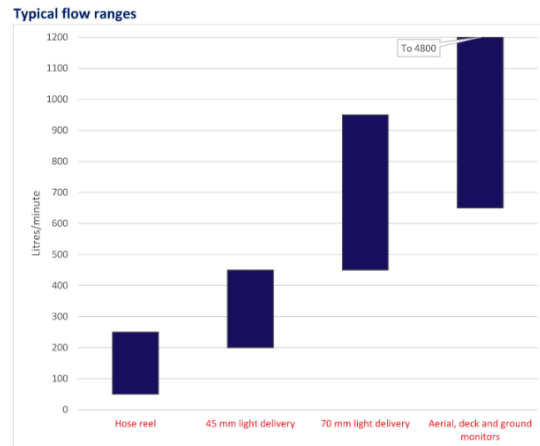
Figure 5: Typical flow ranges – Extracted from F1 GD Fire Suppression Guide

In accordance with *F1 GD Fire Suppression Guide*, the typical flow ranges for LPD (i.e. with 45mm diameter delivery hose) is from 200L/min to 450L/min, refer to Figure 5 for details. Noting that the flow rate used in the calculation below is taken as 400L/min, for conservatism.

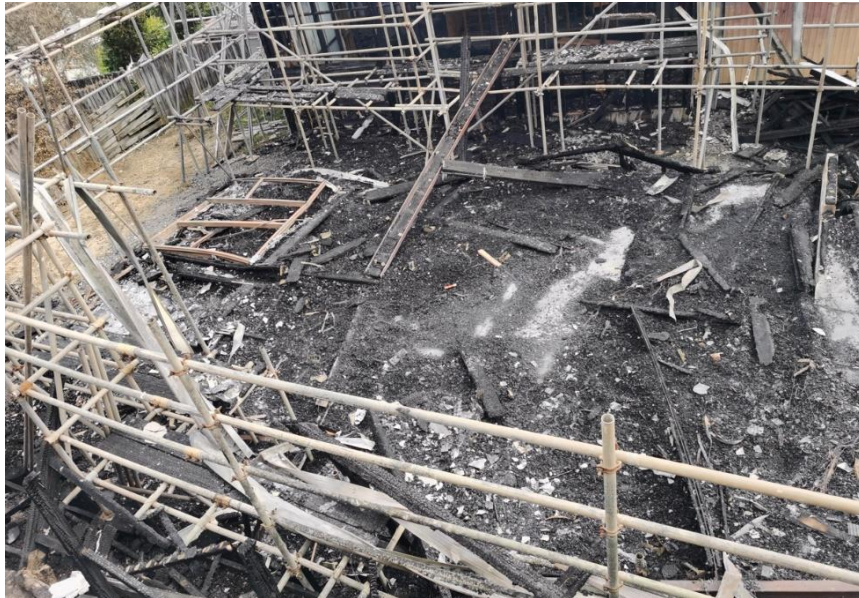
The three dwellings on site are generally comprised of timber framing, timber subfloor and cladded with weatherboard type of façade. In Dwelling 3, the roof, subfloor, and majority supporting structure collapsed, combustible internal partitions and external facade were entirely consumed. The top floor of dwelling 2 was also extensively damaged by fire, including majority section of the roof and upper floor façade burnt through.

The extent of damage to dwelling 2 and 3 (as shown in the figures below) was generally in line with expectation given the type of structure and the severity of the fire. Refer to Appendix A for more details.

Figure 6: The extent of damage to Dwelling 3 – Overlook from South

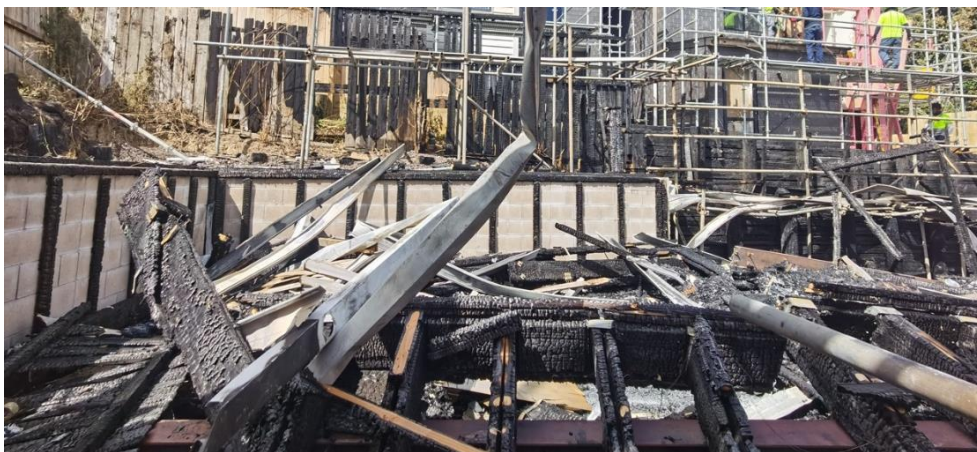
Figure 7: The extent of damage to Dwelling 3 – View from North (entry access way)

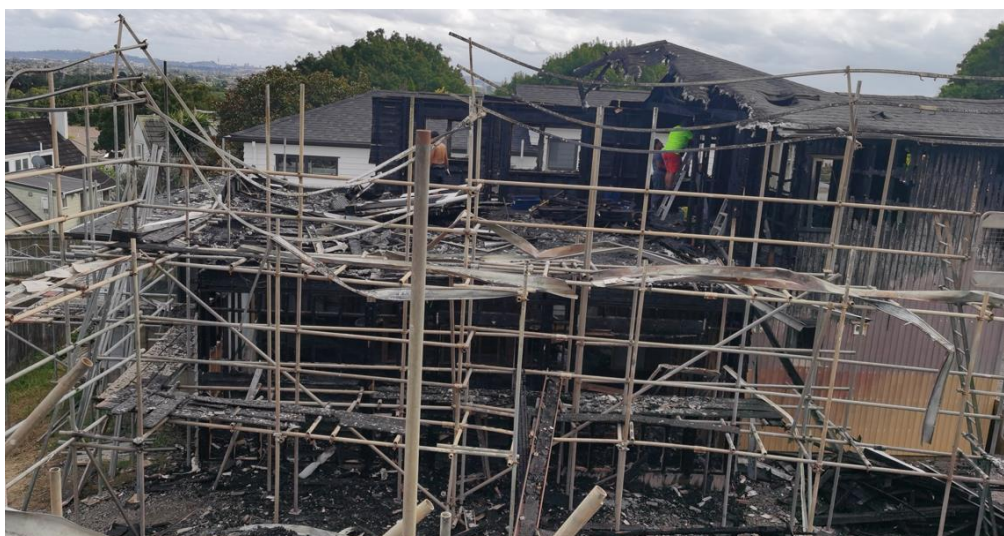
Figure 8: The extent of damage to Dwelling 2 – Overlook from South

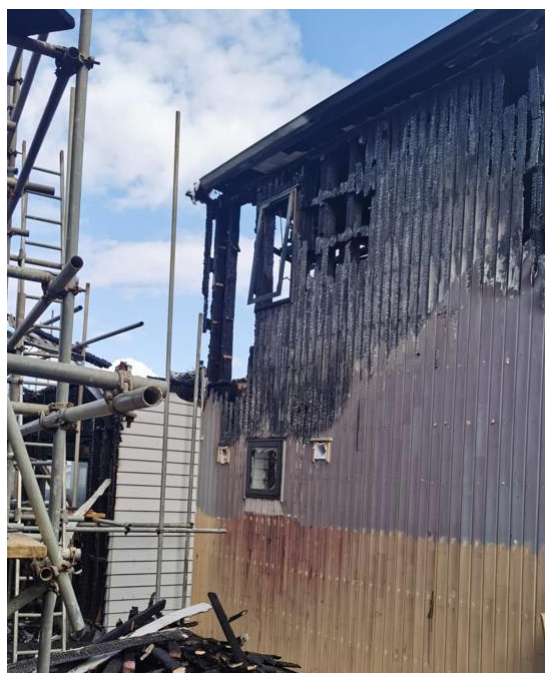
Figure 9: Partial northern external wall of Dwelling 2 – View from Dwelling 3

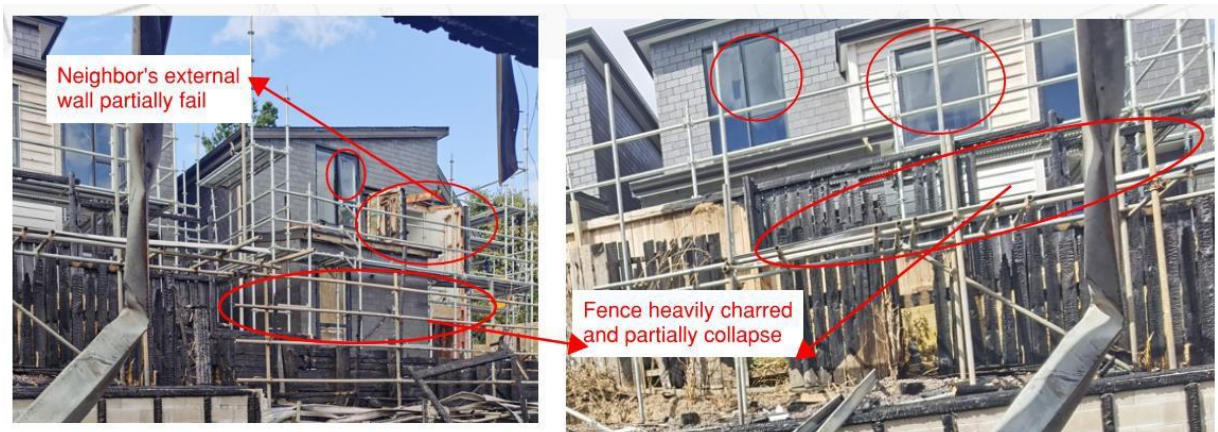
The fire in the dwelling 3 spread throughout the building envelope and then into the neighbouring Redoubt Rd properties that backs on the Derrimore Heights site. The neighbouring subdivisions which are also under construction, sustained some fairly severe damage to its boundary fencing, cladding and external glazing. Attending crews indicated that the wind direction was north to south (i.e. from Derrimore site to Redoubt Rd site) on the day of the incident, compounded with other factors such as short separation distance (i.e. 3m) in between, the fire was therefore driven towards the rear neighbouring subdivision, the intense heat and direct flame impingement would have been sufficient to cause fence collapse, glazing fracture and ignition of the external wall. Refer to Figure 10 for details.

Figure 10: Extent of damage neighbouring Redoubt Rd subdivisions at the rear

- It is acknowledged that the fire design complies with C/AS1 in relation to the external fire spread, substantial damage to the rear neighbouring properties (located at 42 Redoubt Road) were observed on site. This suggests that the requirements outlined in Compliance Documentation, i.e. C/AS1 part 5, consisting of a minimum 1m separation distance may not be sufficient to address the control of external fire spread, particularly in situations where firefighters may not be able to readily protect neighbouring properties.

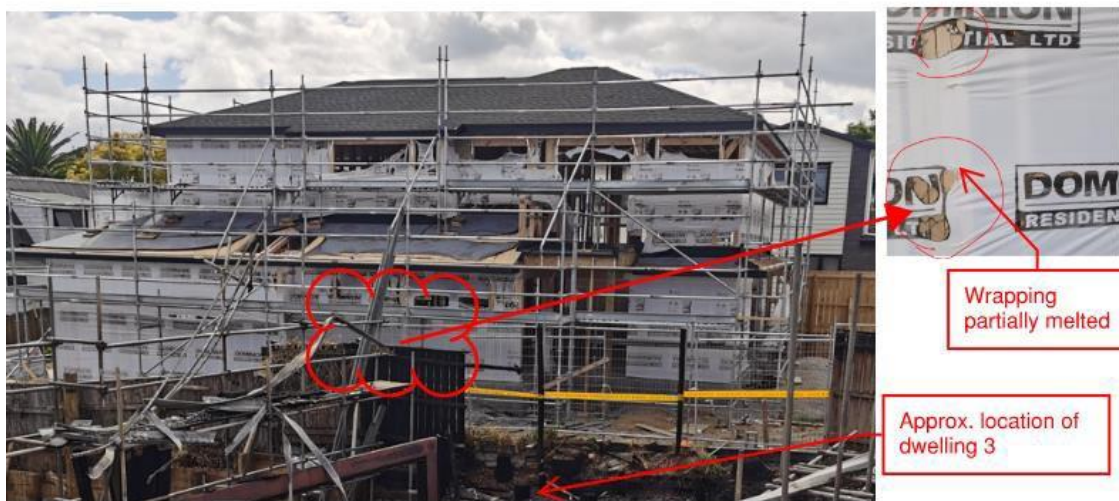
It is also noted that the building to the east of the Derrimore site had very minor damage around the wrapping material around the building envelope, which had partially melted. As part of the that building located approximately 4m away from dwelling 3, the extent of damage was limited by a combination of separation distance, wind direction (driving the fire in the opposite direction) and the action of firefighting crews.

Figure 11: Extent of damage neighbouring properties under construction from the east

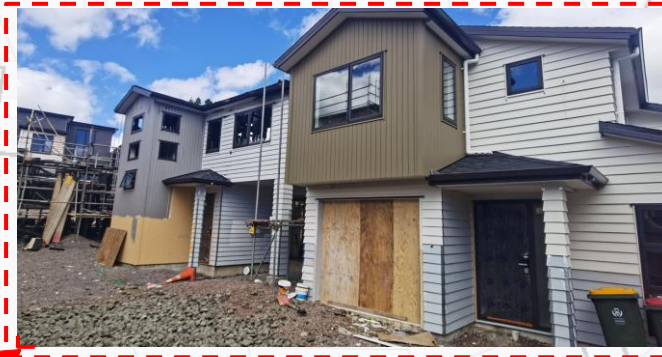
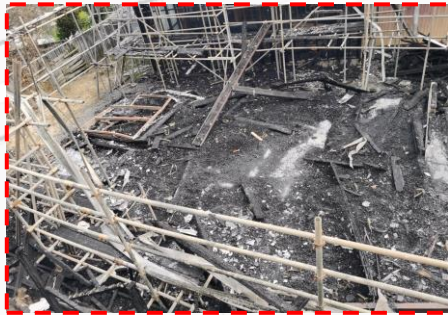
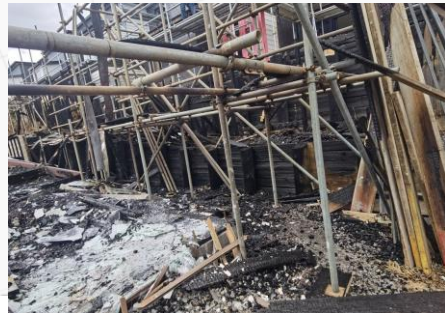
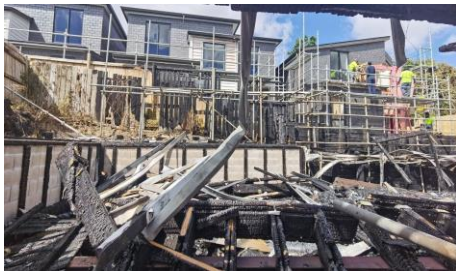
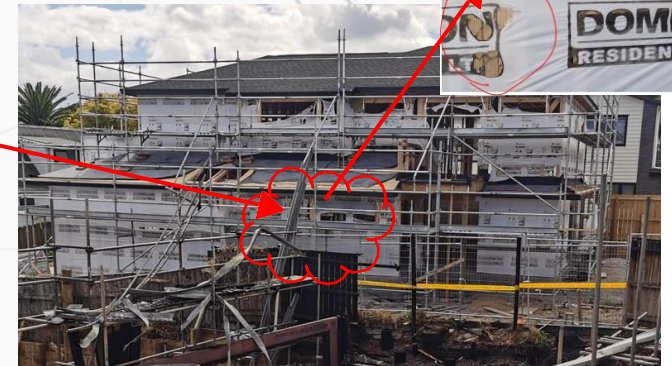
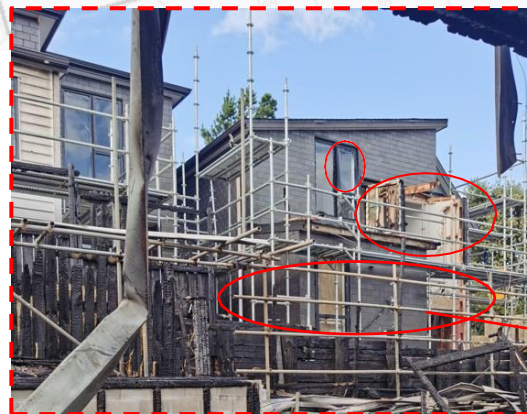
Drawing Ref: FS02
Project: F3436740
Drawn by: JZ

access via other residential property

Back of the neighboring residential property (obstruction)

view from property view from street

access via other development (under construction) from Redoubt Rd

It is noted that during the firefighting operations, additional firefighting accesses were established from Rochas Place to the west and Redoubt Road to the south, in order to control the fire spread to the neighbouring properties (mainly the 42 Redoubt Road properties). However, this was limited to firefighters on foot establishing hose lines through other properties but did not offer alternative access for appliances.
