OPERATIONAL REVIEW

F3200236
Vehicle Fire
Stanley Road, Dromore
Ashburton
15-03-2021

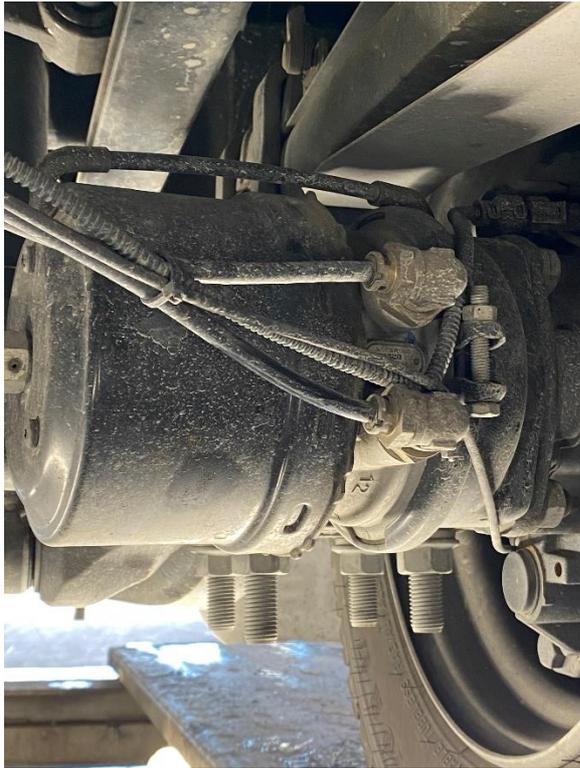
Fig 1.3

- There wasn't a complete understanding of the new Type 1 IVECO Pump features. The review team confirmed that it automatically disengages the pump while the pump is engaged when shifted into gear.
- The review team found that vehicle brakes have failed at previous incidents when involved in fire, affecting the crew's ability to move the appliance from harm's way. In addition, the team found that the nylon brake lines used on the IVECO appliance ^{Fig1.3} can be easily affected by fire, especially when put under pressure releasing the brakes.
