Fire Research Report

The Adequacy of Existing House Foundations for Resisting Earthquakes: Effect on Service Reticulation and Ignitions

a Report Submitted to the New Zealand Fire Service
by Dr G.C. Thomas and J.D. Irvine
School of Architecture
Victoria University of Wellington

16 August 2007

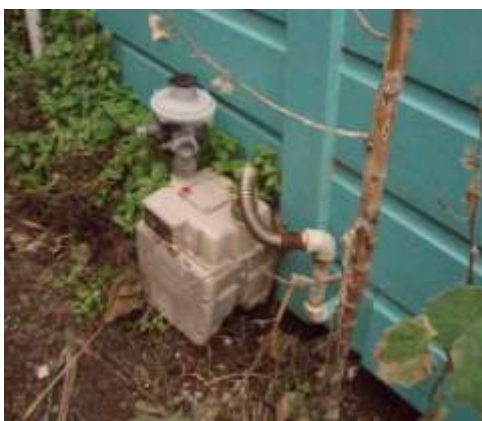
The entry of gas into the dwelling (depending on the where the gas actually enters the dwelling) will largely determine the flexibility of the connection. Many dwellings have gas meters and therefore pipe connections through sub-floor walls [Figure 4.2], meaning that if a dwelling was to move significantly and the pipe had rigid fittings [Figure 4.3], the pipe may rupture at this connection. This type of connection usually differs between foundations type and also often when the reticulated gas was installed in the dwelling.

Figure 0-2 Flexible Gas Connection into Sub-floor Wall

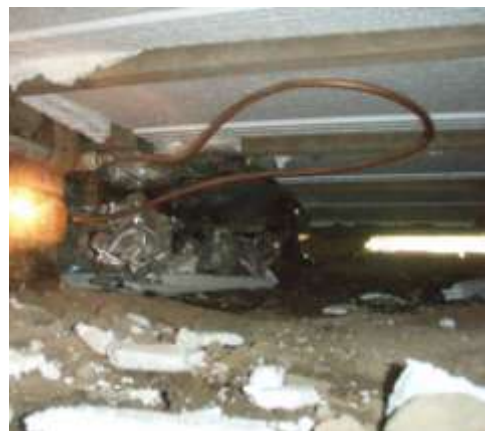
The likelihood of breaking of piping is also increased if the pipe material is of low grade steel with threaded connectors that do not behave in a ductile manner (Williamson and Groner 2000). This would be a common situation in older dwellings. However, often in older dwellings, pipe networks are laid on the ground [Figure 4.6], underground or have flexibility and reserve capacity in the length of pipe work not connected to any part of the foundation [Figure 4.7]. Both of these factors increase the flexibility of any reticulated gas system.

Figure 0-6 Gas Pipe work laid on the Ground under Dwelling
Figure 0-7 Copper Gas reticulation with reserve flexibility of tubing

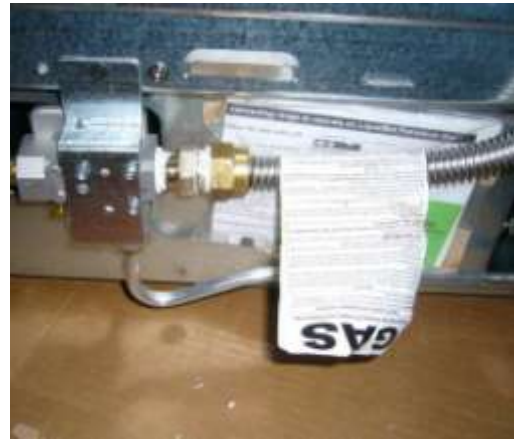
Perhaps the most crucial connection for all dwellings is the connection into the flooring [Figure 4.8] and whether or not flexible connections exist between the gas mains and the appliance it is serving [Figure 4.9]. If this connection is not flexible, any significant movement of the foundations, including even slight swaying, could shear off the gas connection into the dwelling causing a gas leak (Scawthorn 1987).

Figure 0-8 Rigid Gas Connection into Flooring of dwelling
Figure 0-9 Flexible Gas Connection into Gas Appliance

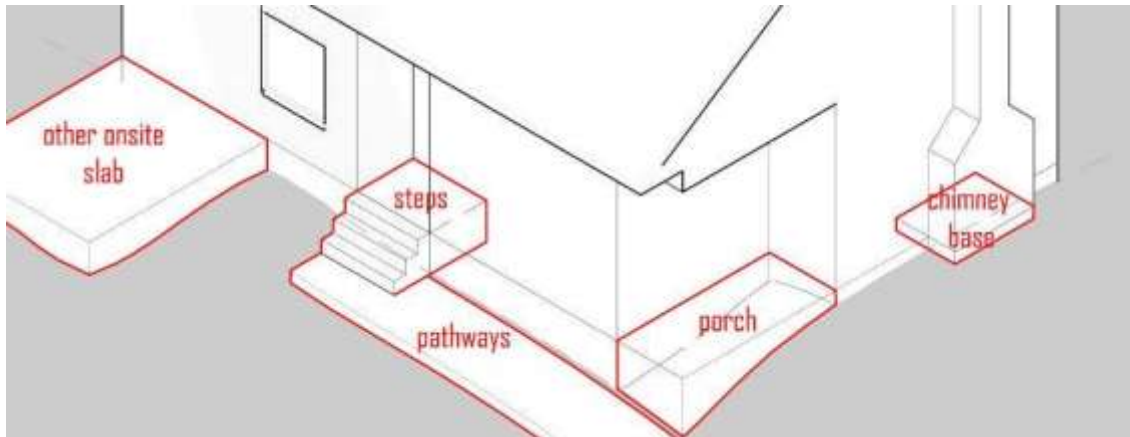
Although, not specifically noted in NZS3604, for the purposes of this study, anchors such as chimney bases, additional concrete slabs (common in renovations) and concrete porches were deemed to assist in the lateral bracing of a dwelling [Figure 5.2]. The relative dimensions of these concrete volumes were noted and used in bracing calculations mentioned above [refer Section 5.1].

Figure 0-2 Bracing showing Different Non-designed Anchor types in a Foundation

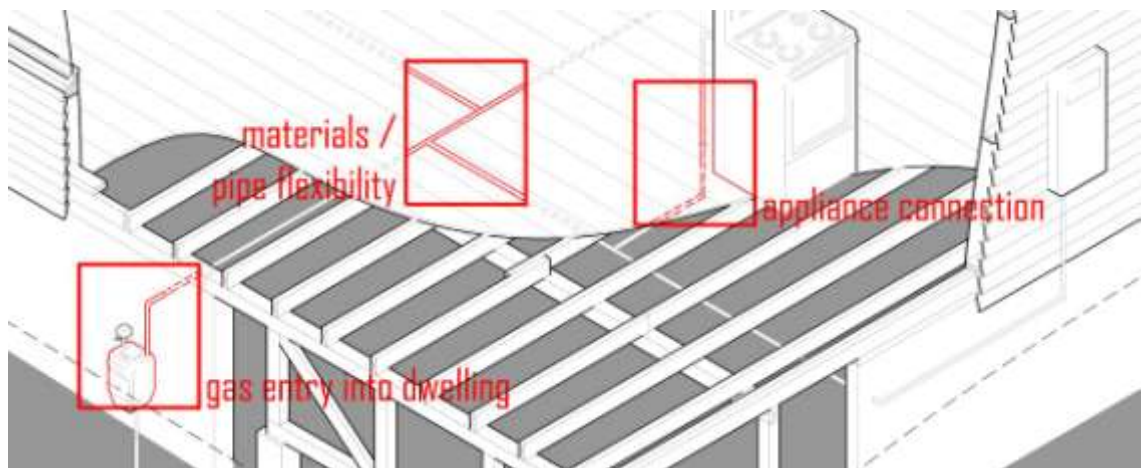
The flexibility of gas connections is a rather subjective determination, however would usually constitute a Corrugated Stainless Steel Tubing [“CSST”] between exterior gas lines and the dwelling exterior. In many dwellings this connection to the dwelling occurs in two places, the exterior sub-floor wall and then the flooring of the dwelling, which runs to the gas appliances. Also the material flexibility may affect the performance of reticulated gas describing whether pipe work is likely to rupture. Thus, the determination of flexibility is described on these three individual levels [Figure 5.4].

Figure 0-4 Locations in the Sub-floor where Gas Rupture may Occur

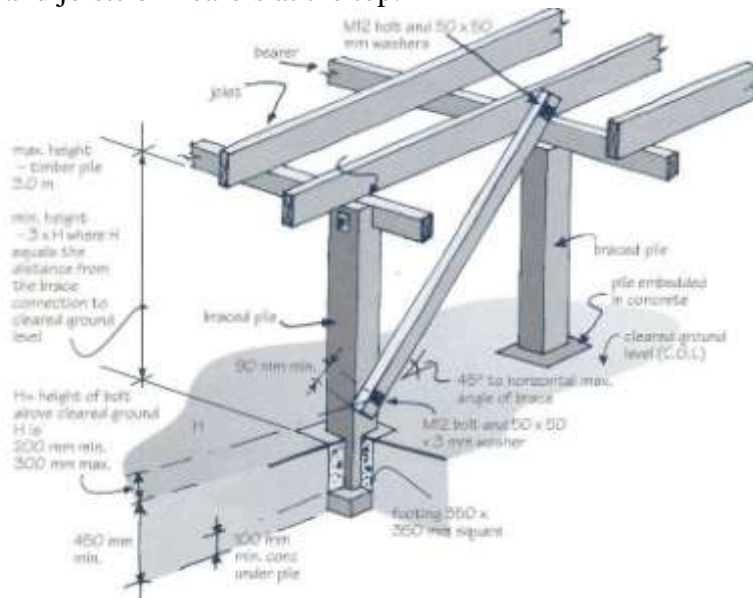
Figure B1 Braced Pile Solution, Braced from Pile to Joist (Source: BRANZ 2000)

The Braced pile solution is a system of where a timber brace spans between the pile bottom and joists or Bearers at the top.
