Fire and Emergency New Zealand Wildfire Investigation Report

| Fire Name: | Lake Ōhau Fire, Lake Ōhau Road |
| Fire Date: | Sunday 4 October 2020 |

Classification of Fire Cause: Accidental

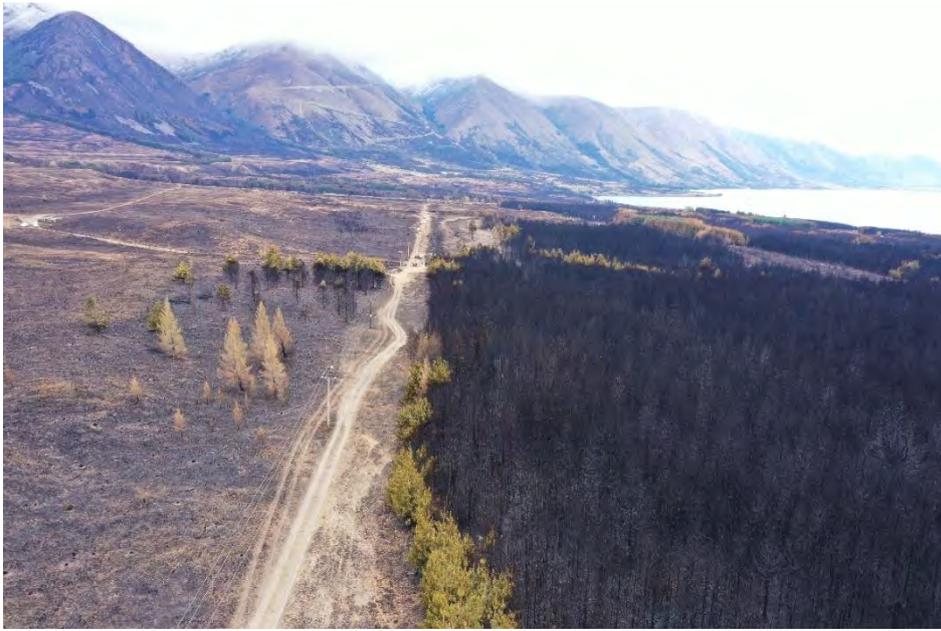
Fig. 2. Looking northwest from the south side of the Village. Grass fuels to the left / forest fuels to the right.

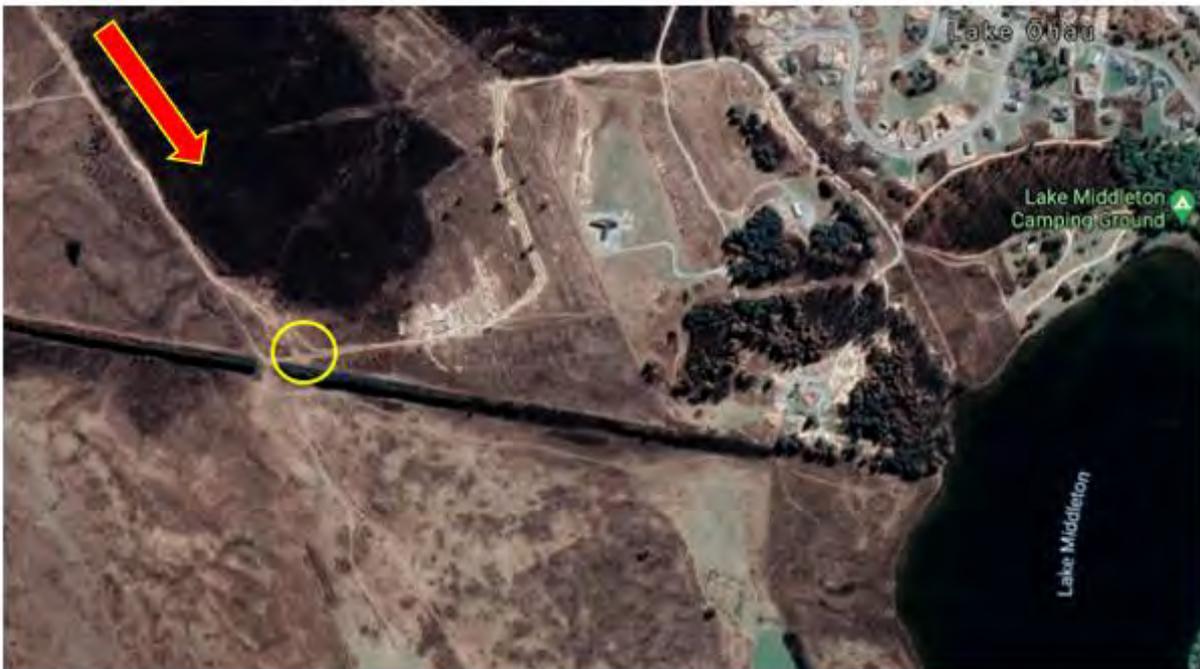
Fig. 3. The yellow circle in the image above is the location of where the investigation was started. The red arrow indicates the approximate direction one of the fire runs has come from.

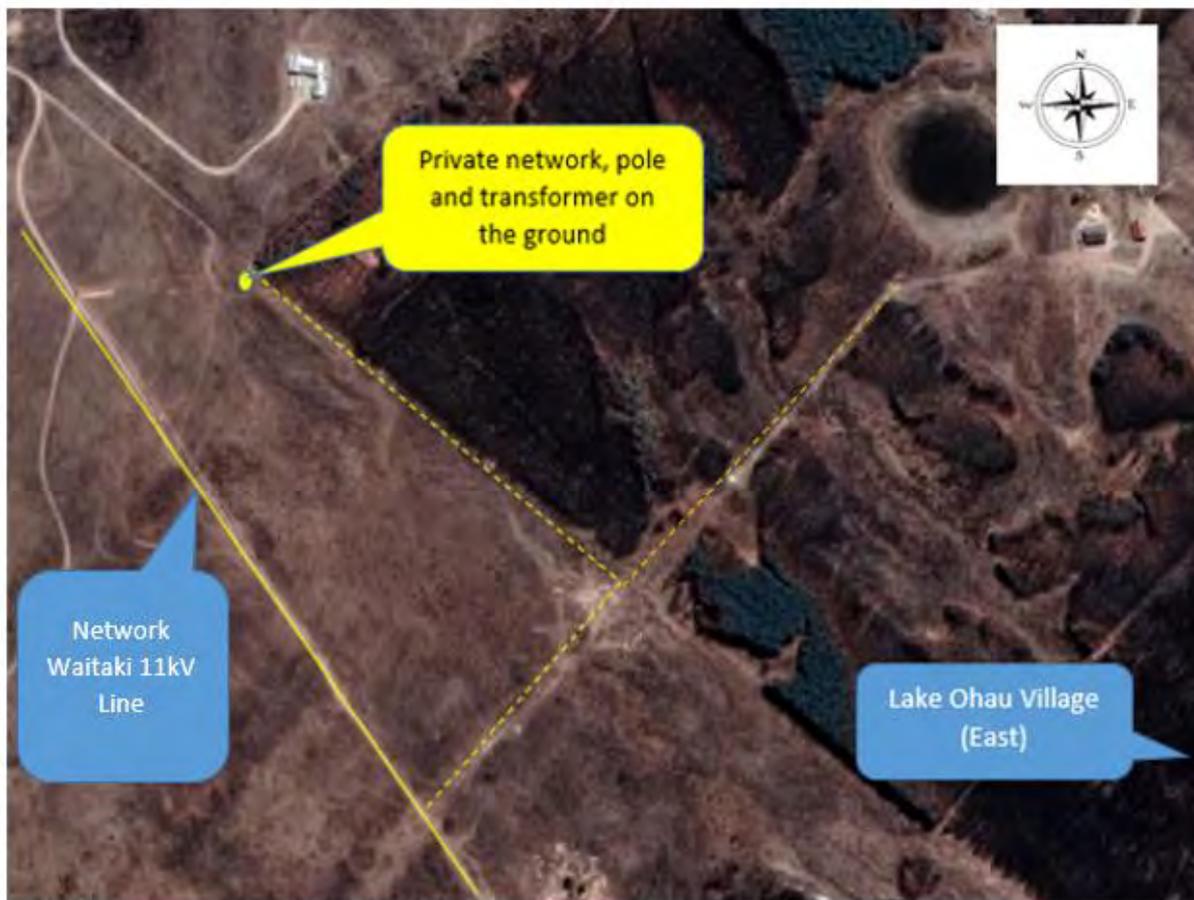
Fig. 4. Image above identifies Network Waitaki 11kV lines (solid yellow line) and the private network (dotted yellow lines). The Network Waitaki infrastructure was positioned along the maintenance track used to access the investigation start point.

Following the Fire patterns, we came across a fallen power pole HF2879/T5723 with a transformer attached (refer to Fig.4). The pole was situated at the end of the private line running behind a plantation of trees. A number of other poles along this line were damaged and the lines themselves were laying on the ground.

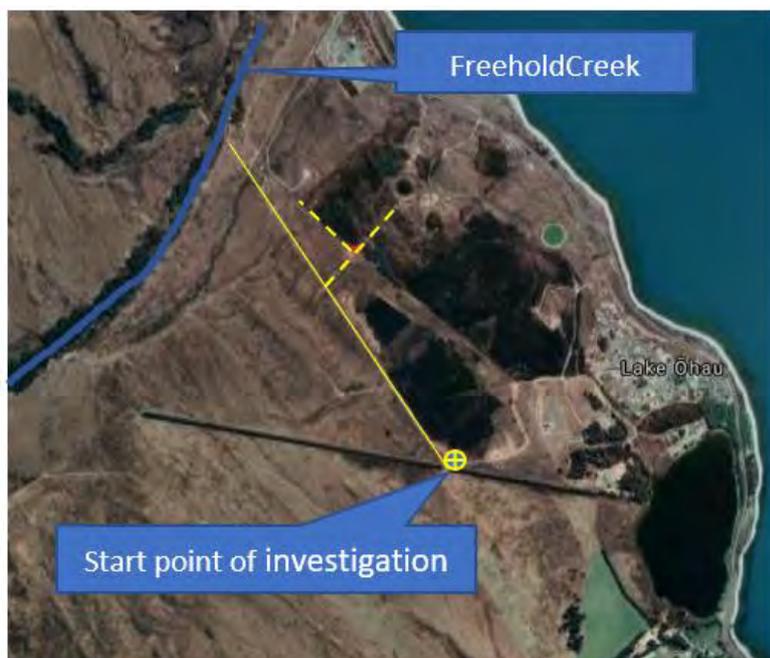
Fig 5. Left identifies the starting point of the scene investigation. While travelling into our starting point there were a large number of macro burn indicators. Macro burn indicators are the larger more obvious indicators that appear on objects such as trees, fences and rocks.

On inspecting the area around our starting point, fire pattern indicators such as protection, freezing, angle of char and white ash were all visible and indicating the fire had come from a west/northwest direction.

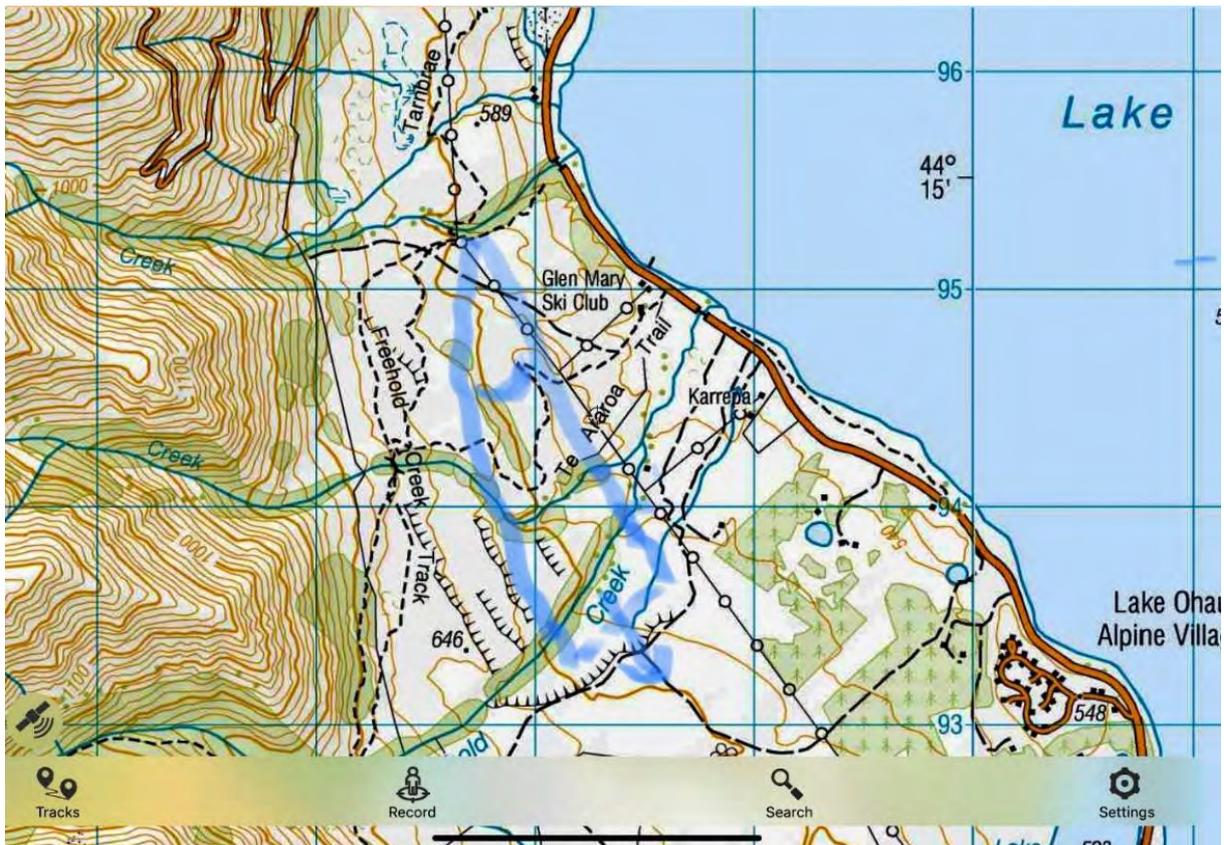
Fig. 6. Drawn by Witness 4 on the 5 October at 13:43hrs.

Witness 4 described the fire as being on the east side of Freehold Creek out on the flats and moving very fast in a southeast direction (refer to Fig.6 following page).

Witness 4 was then asked if they could draw a location of where they saw the fire at the time using a mapping programme provided by John Foley called Fire Mapper. They then drew the image on the following page to the best of their knowledge (refer to fig .6).

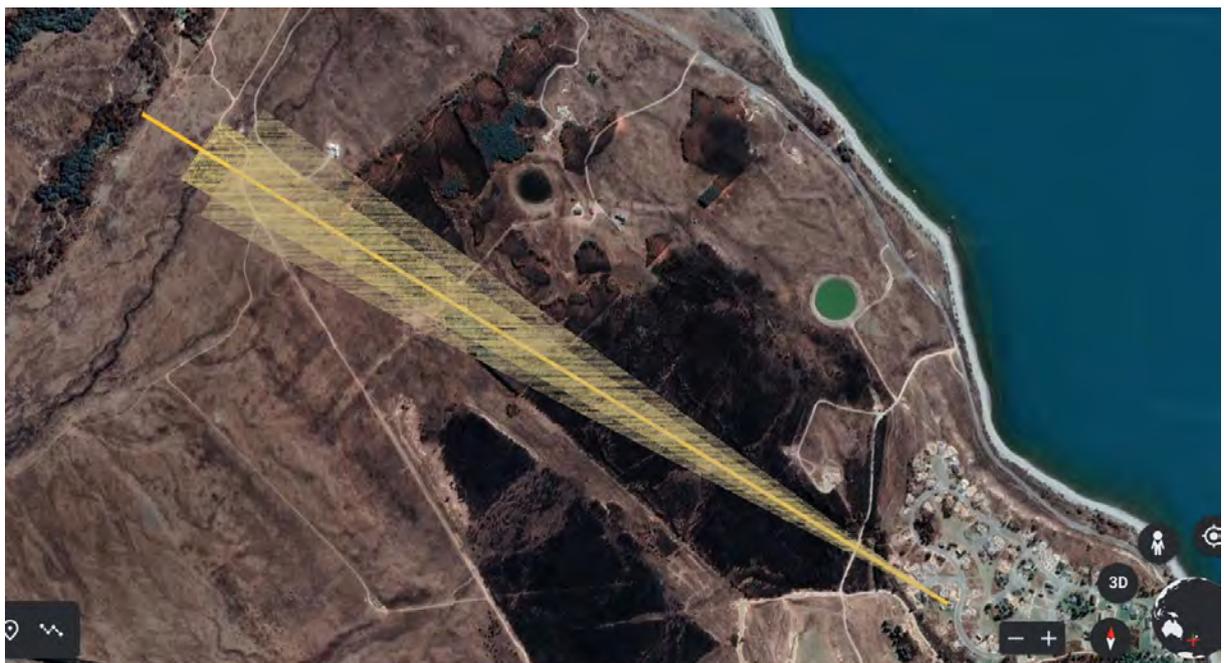
Fig. 7. Drawn by Witness 2.

The first 111 call was made at 03:06hrs. Witness 2, also living at the same address as Witness 1, has provided the image below (fig 7) of where they believe the direction of the fire was at the time of the 111 call. Witness 1 believes the fire was out near the end of the yellow shading, maybe on the end of the furthest trees. This places it in the general area Witness 4 indicated.

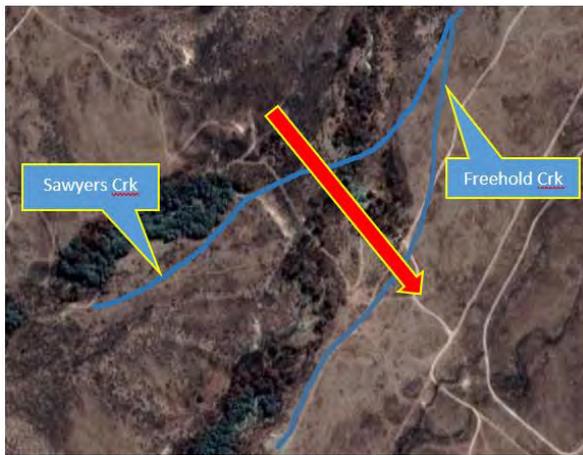
Fig.8. Left shows the short distance between Sawyer's and Freehold Creeks. This area was not walked through due to access issues.

Burn indicators in the area identified the fire had travelled from a WNW direction above Sawyer's Creek.

The red arrow identifies the direction of travel the head fire took burning across both Sawyer's and Freehold Creeks towards the Village.

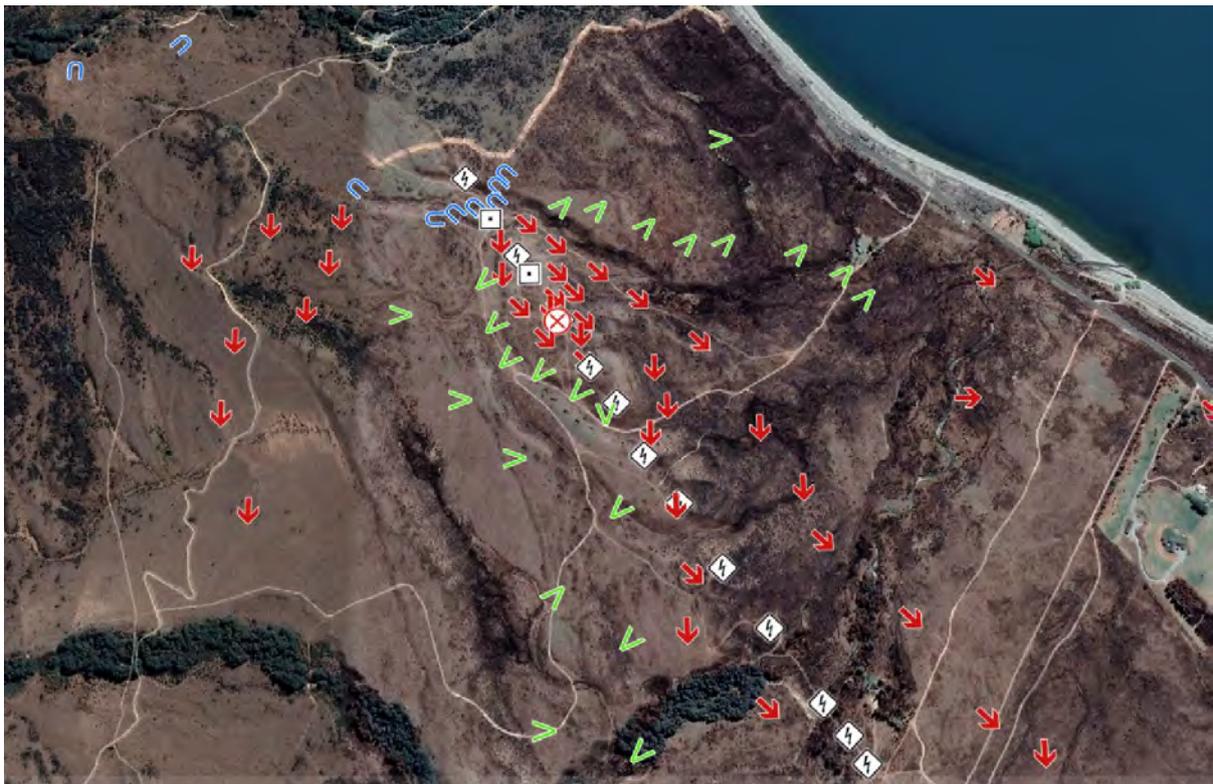
Fig. 9. Fire direction Red arrow – head fire, Green V – flanking fire (Standard colour for flanking fire is Yellow, the Fire Mapper Programme has changed these colours to green), Blue U - backing fire, White diamond power pole locations, White square area of interest, and Red circle specific origin area.

Zig zagging our way across the landscape from Sawyer's Creek in a northerly direction, we mapped head fire runs and areas where the fire has transitioned into flanking fire (refer to fig.9).

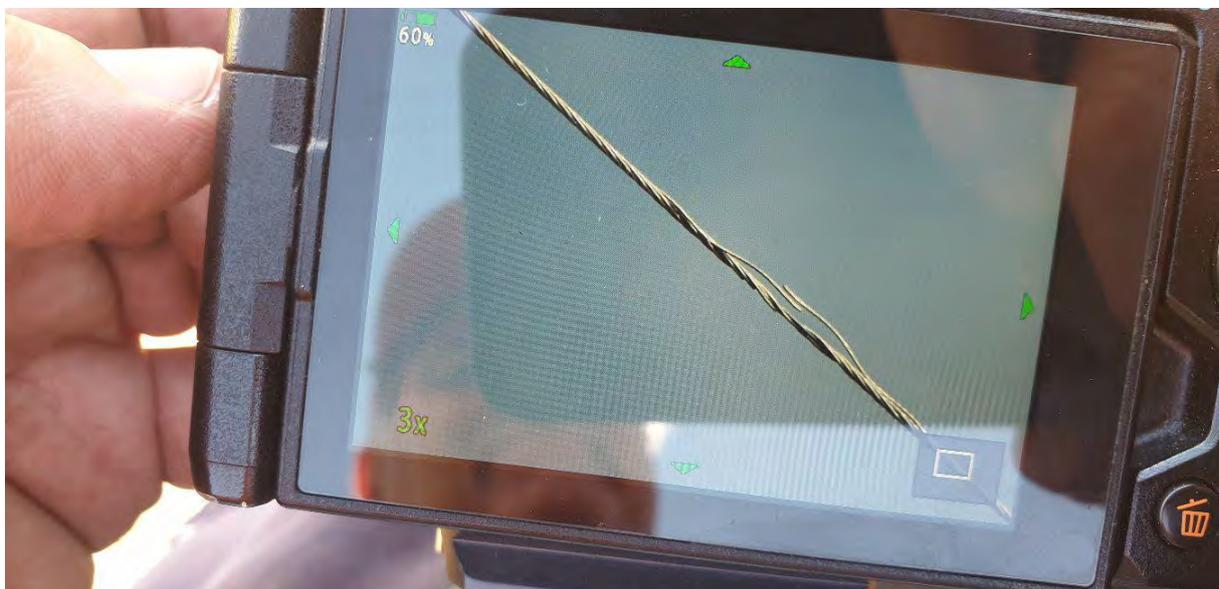
Fig. 10. Rear of electrical engineer's camera.

He identified himself as an electrical engineer and had located what he thought may be the cause of the fire. He told Murray he had photos and showed him the photo on the back of his camera. The photo clearly showed some form of damage to an electrical conductor (refer to fig. 10). Two other Fire and Emergency specialist Investigators were also present at the time, Darren Aitkin and Grant Campbell.

On looking at the lines overhead there was nothing obvious and certainly nothing that looked like the photograph they had been shown.

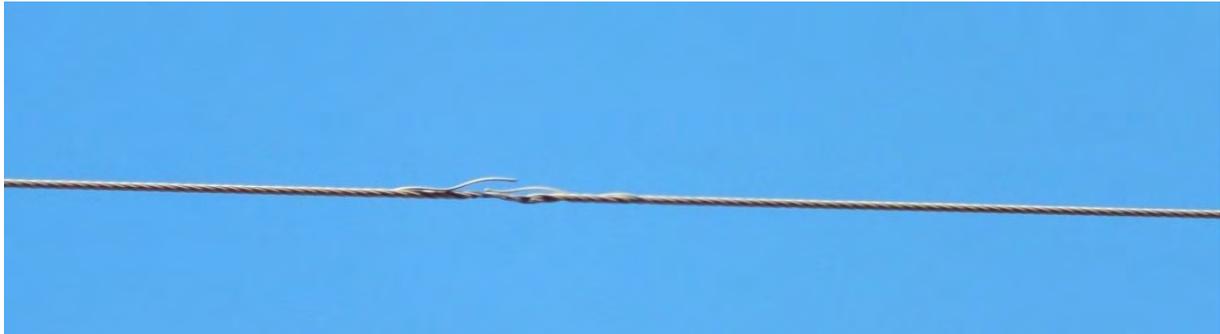
Fig. 11. Photo taken by John Foley the morning of the 7 October.

On returning to cell phone reception, John Foley phoned Geoff Douch, CEO of Network Waitaki, to advise there had been damage located on the centre conductor. John Foley also advised he was not saying this was the cause of the fire just an area of interest that needed to be looked at.

A discussion was had around lowering the lines for a closer inspection. John Foley sent a follow up email to Geoff Douch the next day with a photograph and GPS reference attached to identify the exact location being discussed.

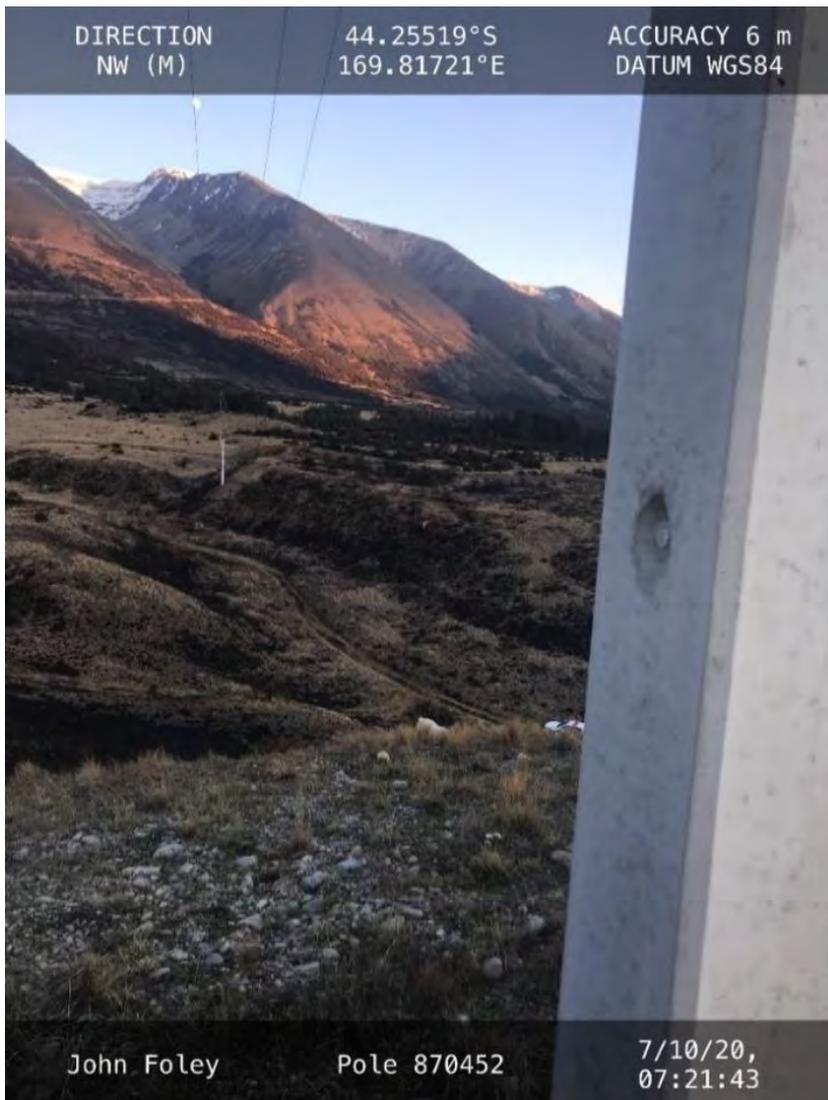
Fig. 12. Left is looking NW across the span of interest.

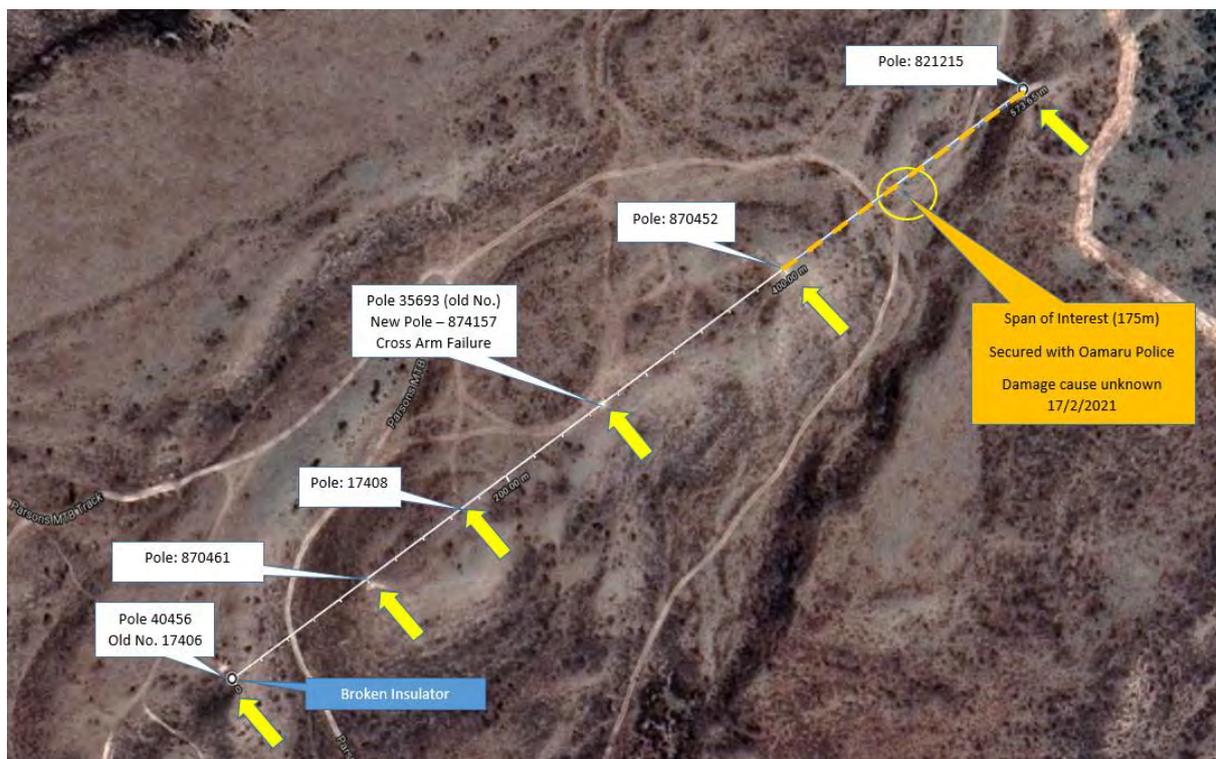
The investigation process at this point had identified a number of areas that required further investigation with the 11kV electrical network between Parson's Creek and Freehold Creek (refer to fig 13). The areas to be investigated further are noted below:

Fig. 13. Three areas of interest, span between poles 870452 and 821215, Pole 35693 and surrounding area, and pole 17406.

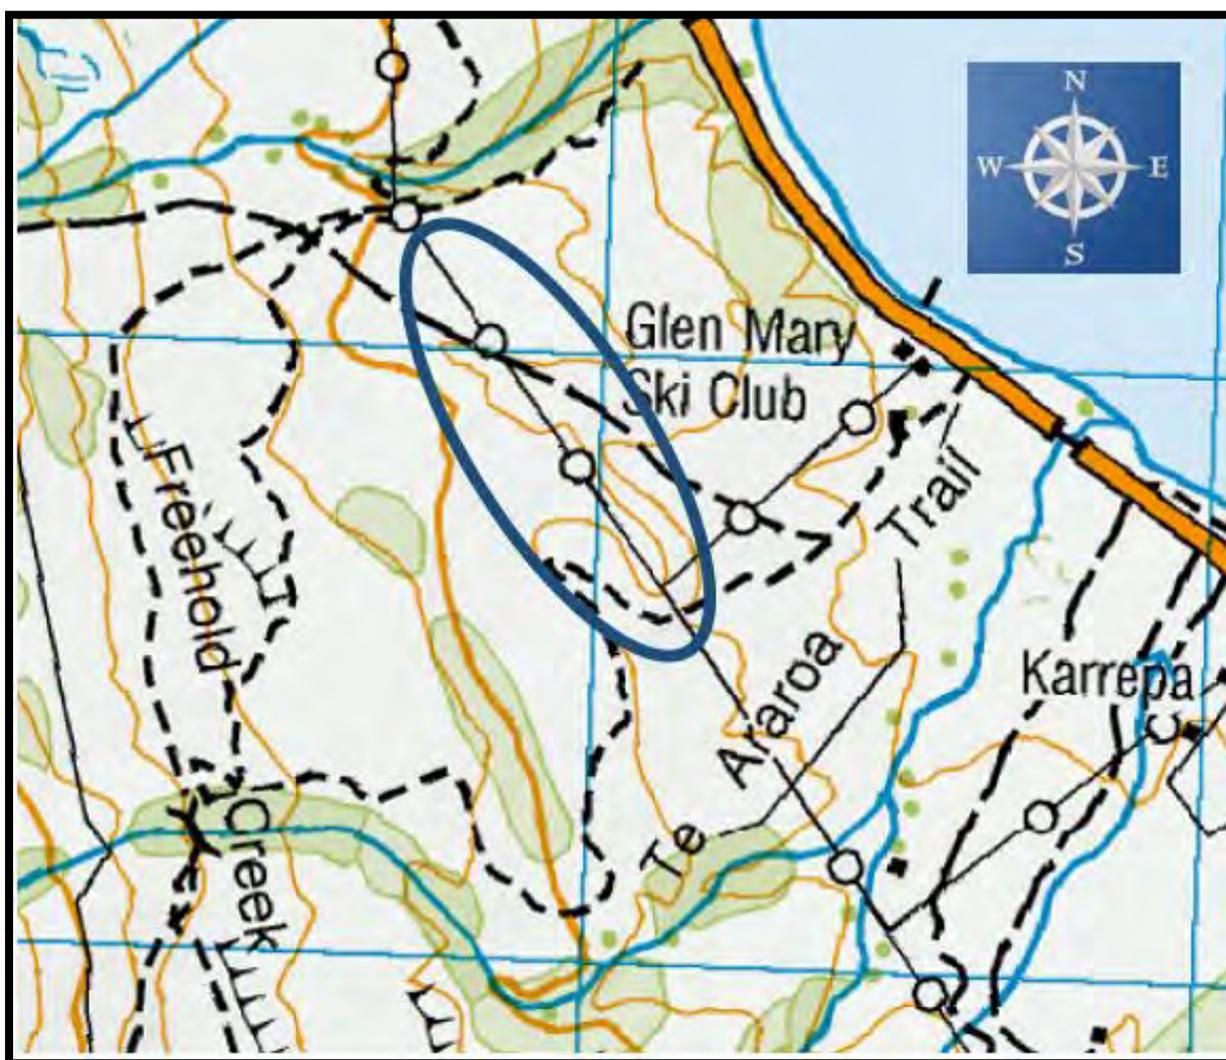
Fig. 14. Topographical map identifying General Origin Area (ellipse).

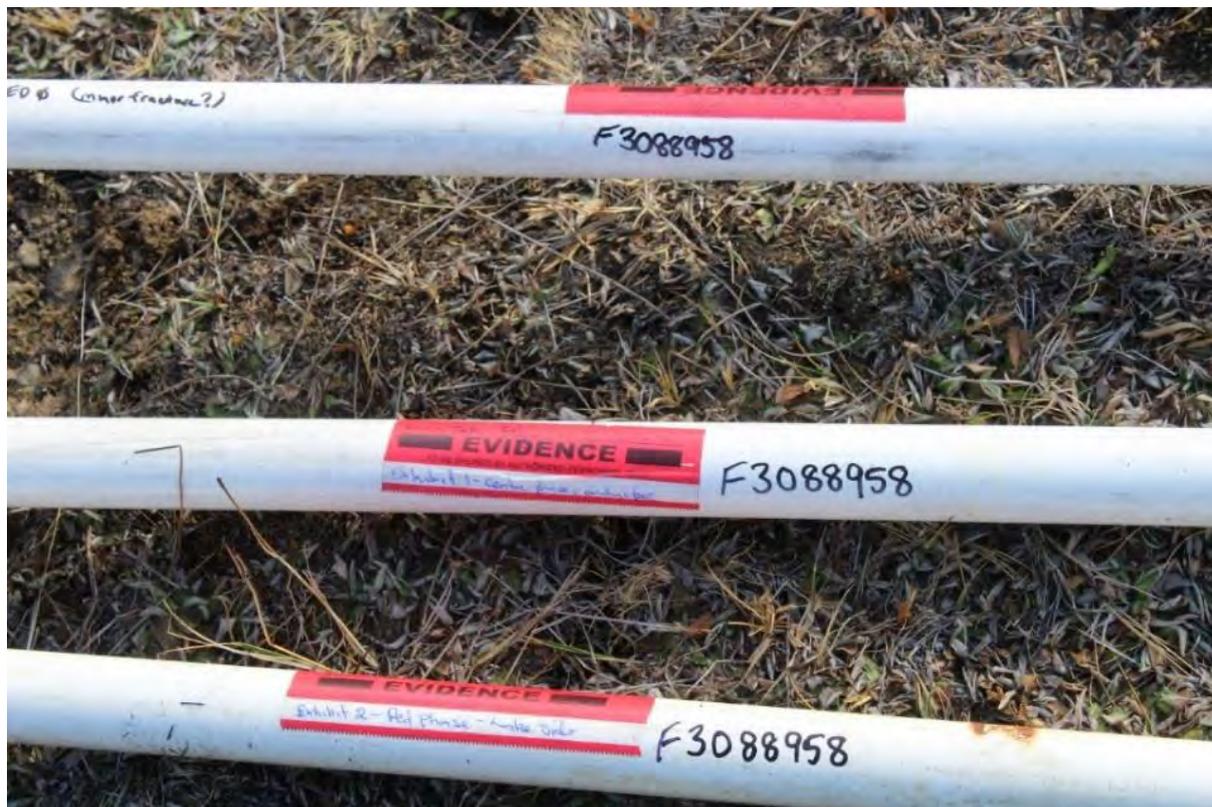
On inspecting the lines, John Foley requested through Geoff Douch CEO of Network Waitaki, that Fire and Emergency would like to secure the areas of damage on the conductors as separate exhibits along with the remaining sections of conductor. To maintain a chain of custody, it was agreed the exhibits would be held and secured by the Oamaru Police. Exhibits were secured in tubes and the coils wound up being handed to John Foley then to Police on scene. A total of approximately 500m of cable was secured (refer to Fig. 15 & 16).

Although there was damage to both the centre YELLOW phase (white tape) and minor damage to the lake side RED phase, none of this could be put down to an electrical arc until further expert opinion was sought. (Note: White tape was used to label the YELLOW phase as there was no yellow tape available.)

Fig. 15. Above exhibit cables secured in tubes.

- Eight (8) exhibits in total were taken from the site and secured with the Oamaru Police (refer to Fig.15/16).
- Exhibits 1-3 were cut from the conductors and stored in plastic conduit.
- Exhibits 4-8 were the remaining longer lengths of conductor which were coiled up and labelled.

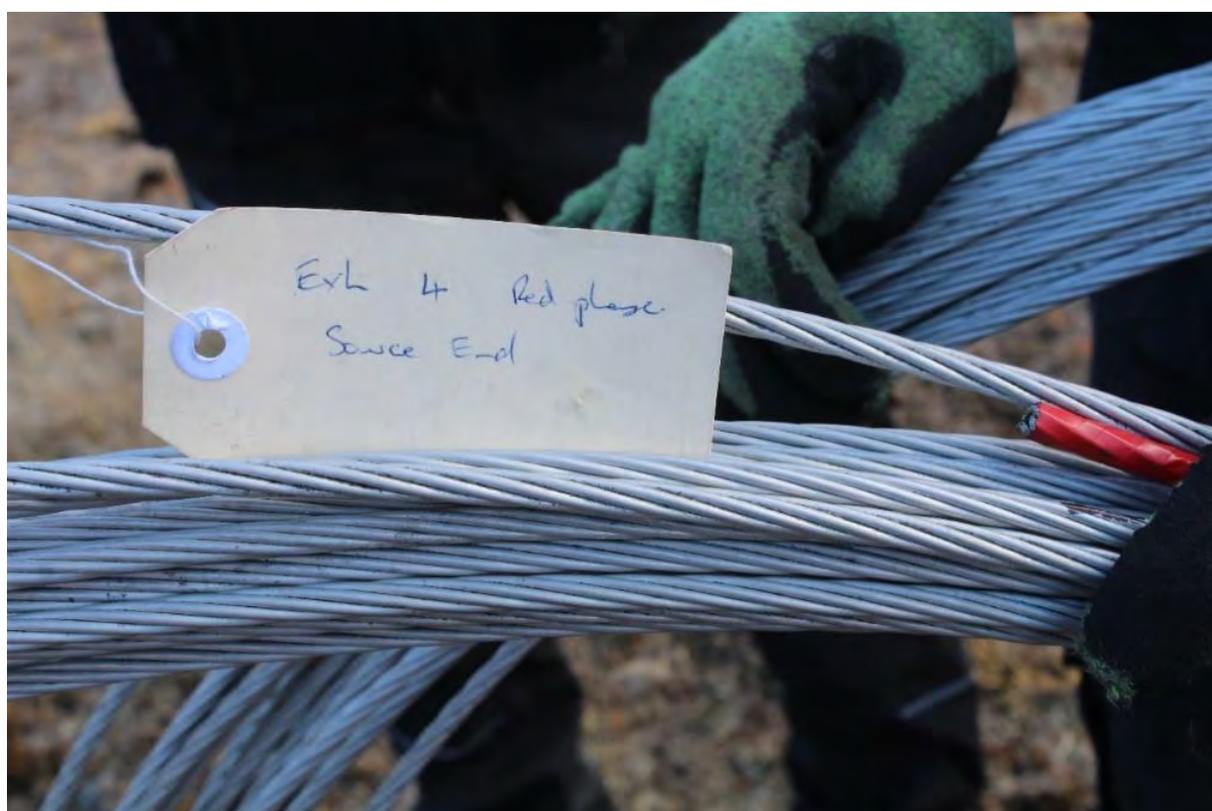
Fig. 16. Above longer lengths of coiled conductor.

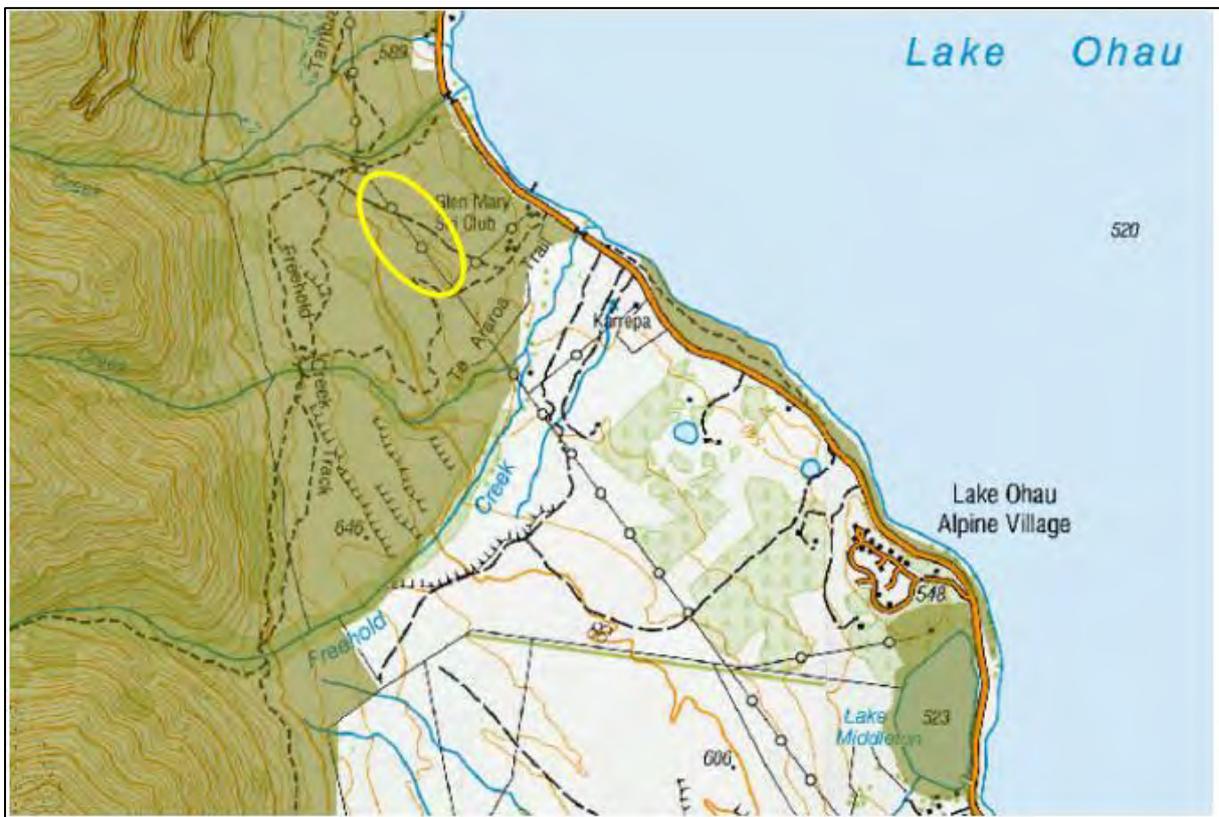
Fig. 17. The map above identifies the Department of Conservation Land (PCL) in dark green.

The yellow ellipse is the approximate location of the general origin area.

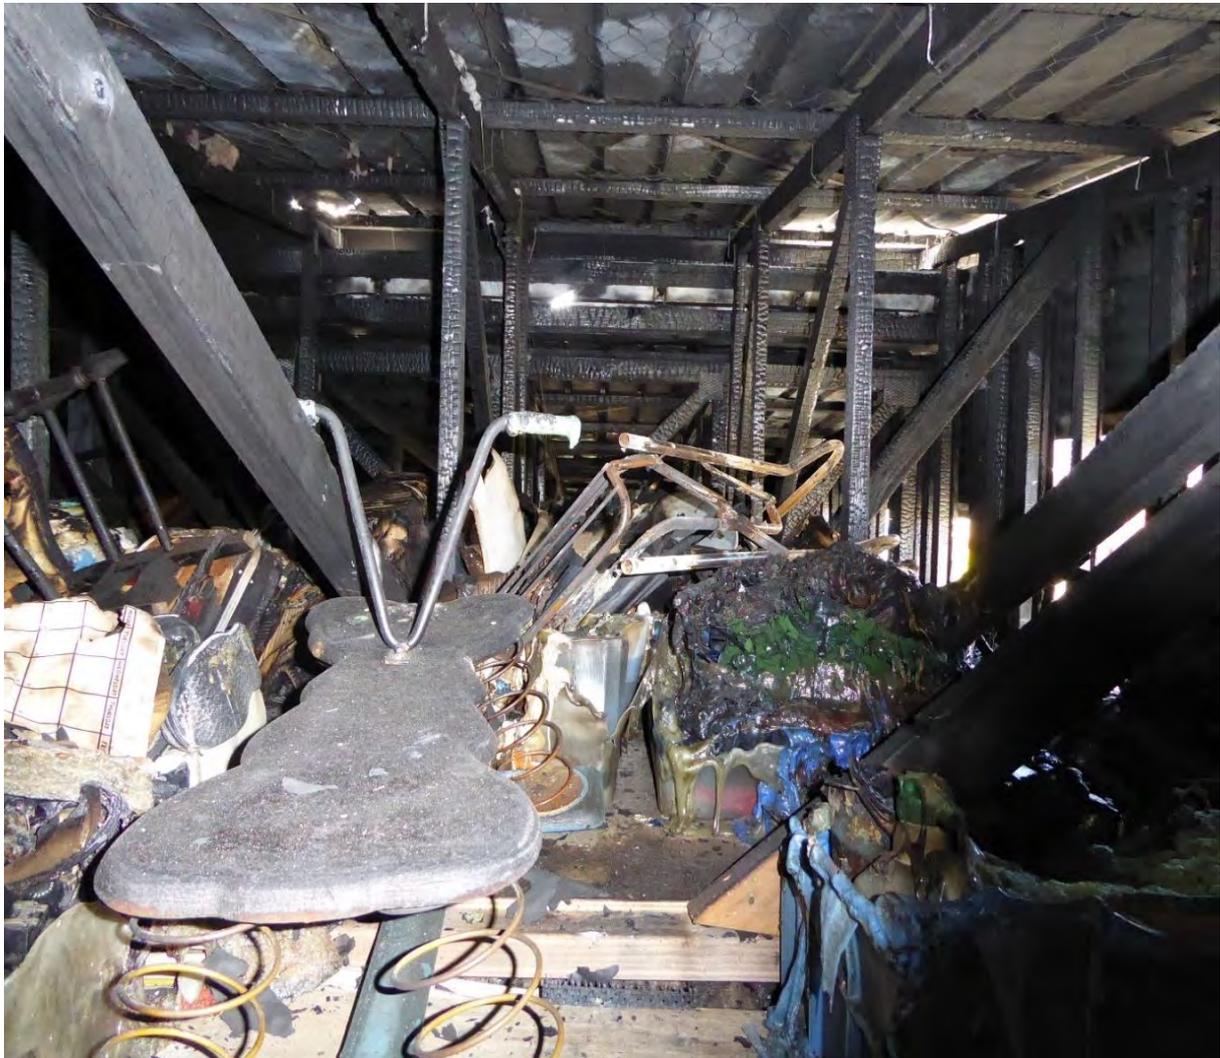
Fig. 18. A crew of firefighters entered this smoke-logged building, accessed the roof void by removing sections of ceiling in the lounge and kitchen and applied water into the roof space. This photo is taken in the roof space.

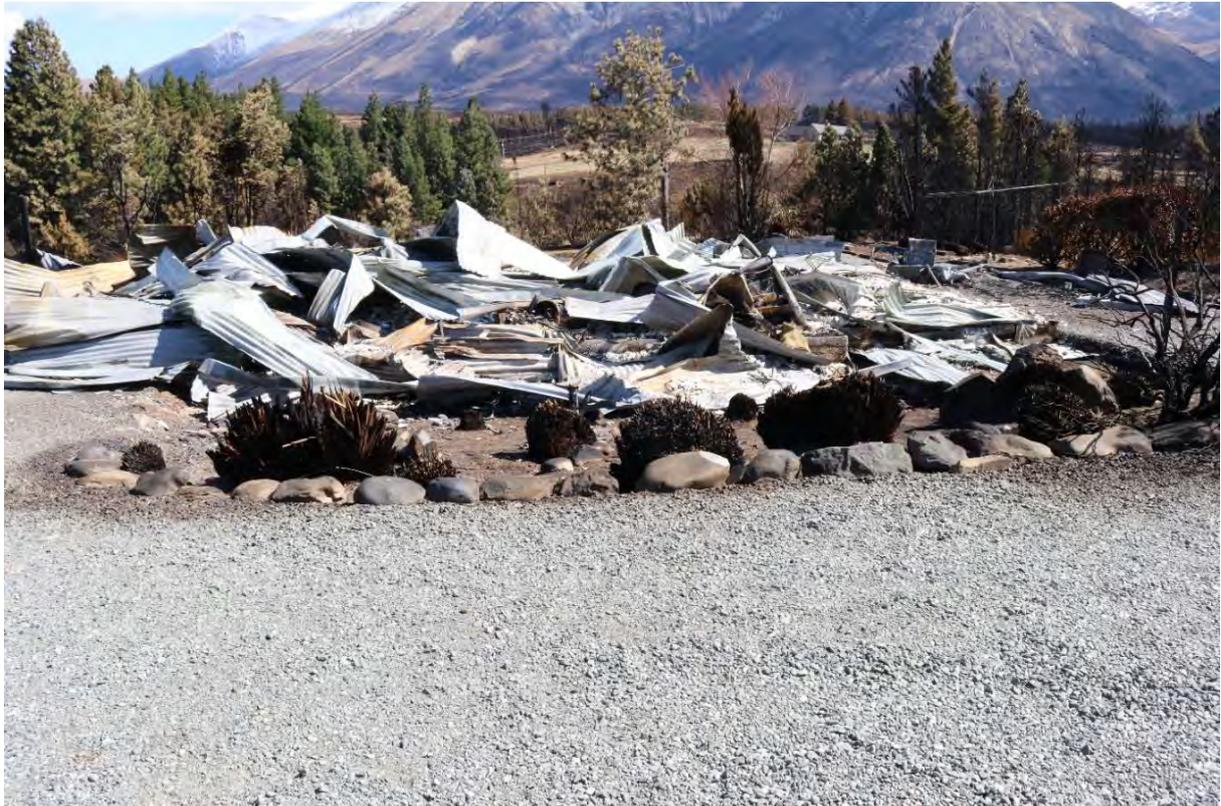
As identified above, there was varying damage to a variety of structures. This was (in the investigators opinion) primarily due to ember transfer travelling ahead of the main fire front that ignited plantings around buildings, flammable attachments such as decking, and fencing attached to buildings and roof spaces due to landing in guttering. All of which created enough heat transfer via radiation or conduction to ignite the structure.

Fig. 19. An example of a building that was destroyed.

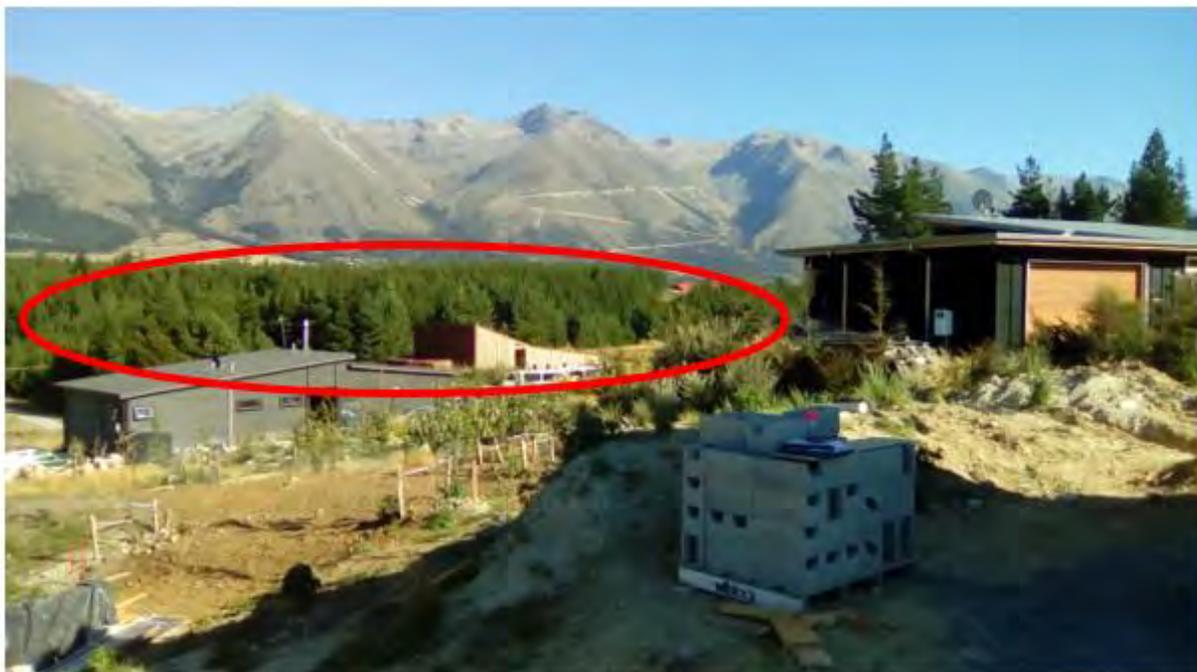
Fig. 21. Looking west/northwest toward the fire origin. Note: the ellipse identifies the heavy fuels the fire passed through at the rear of the Village that assisted in creating the extreme fire behaviour.

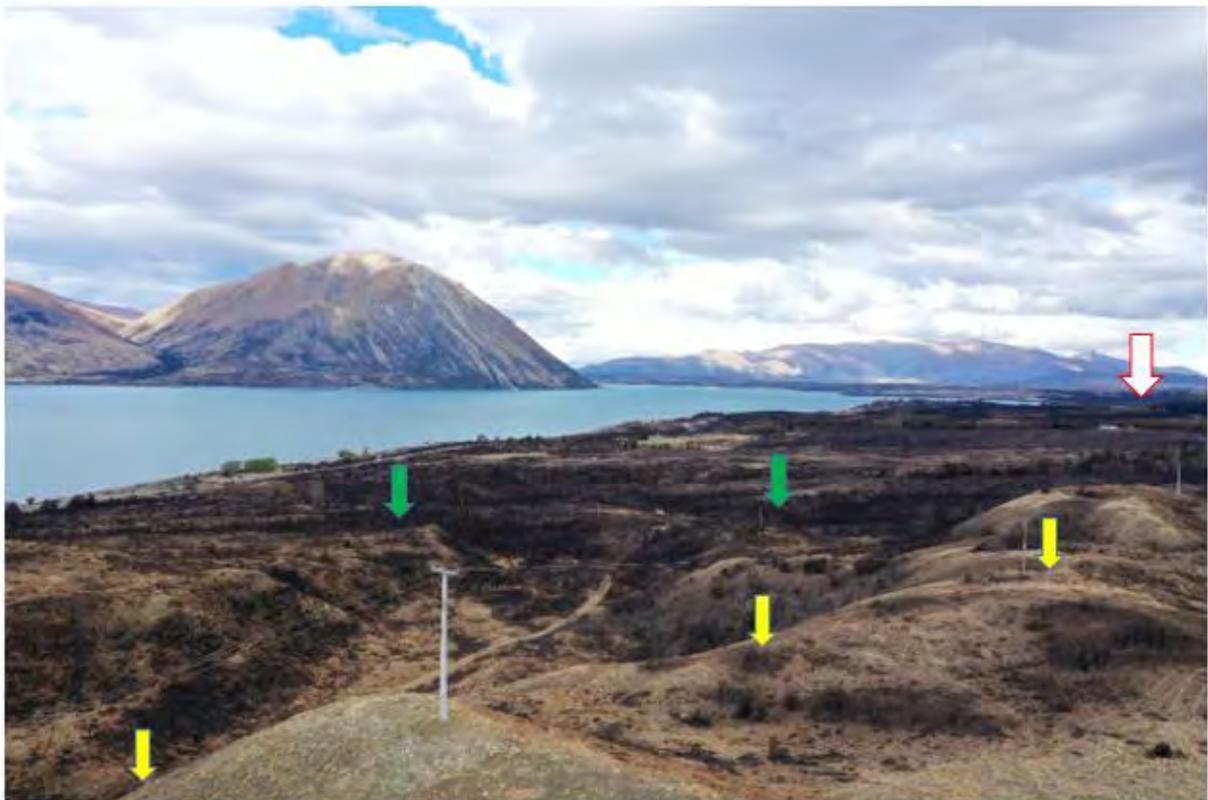
Fig. 29. Yellow arrows above indicate where the grass fuels were with the green arrows identifying the heavier scrub fuels. The white arrow identifies the approximate location of the Village.

The fire started in the grass fuels along the spur below the 11kV electrical network. With the wind blowing from the north down the lake and west through the gullies above the mountain range, the fire was pushed in an east-southeast direction towards the Village.

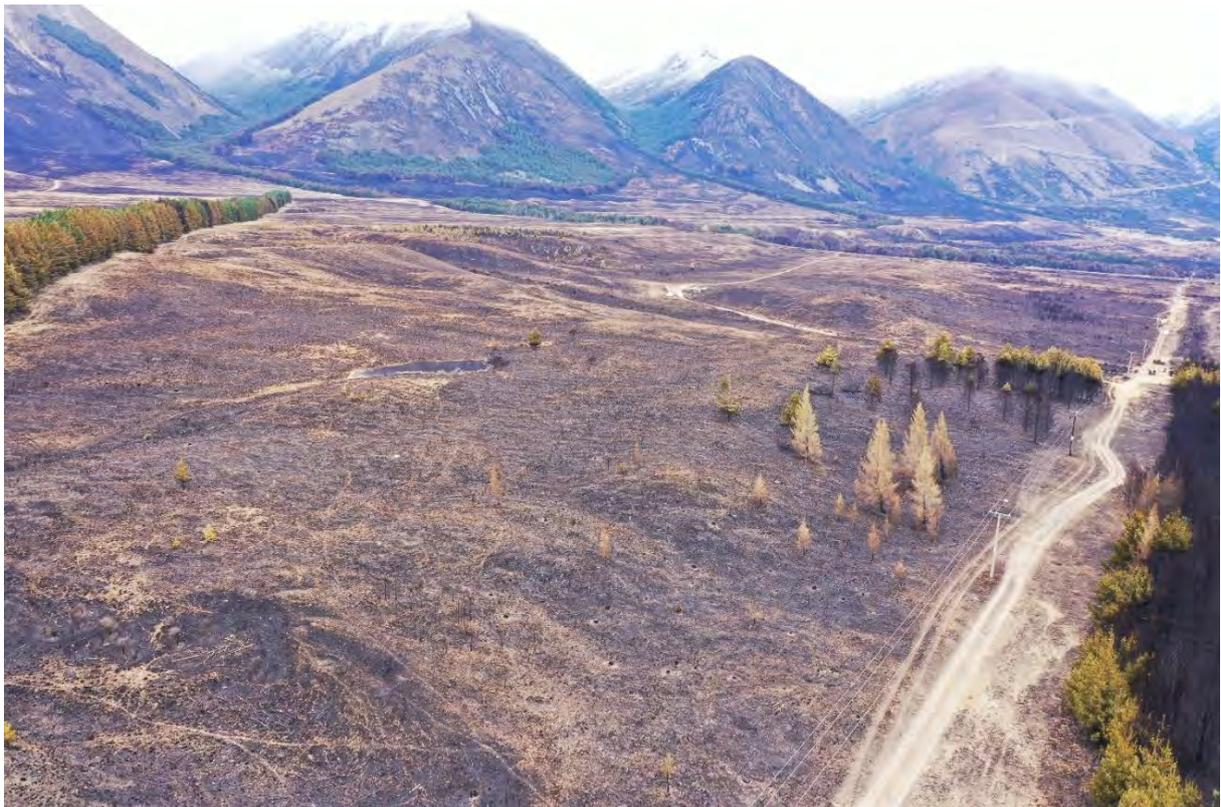
Fig. 30. Looking North West from behind the Village.

Large areas of grass and tussock spread in an east-southeast direction. This enabled the fire to spread quickly in the winds on the night. To the east northeast lay an area of planted trees along with areas of wilding pines. Once the fire burnt into the trees the fire dynamics changed creating a very intense head fire causing the fire to crown, creating an ember storm.

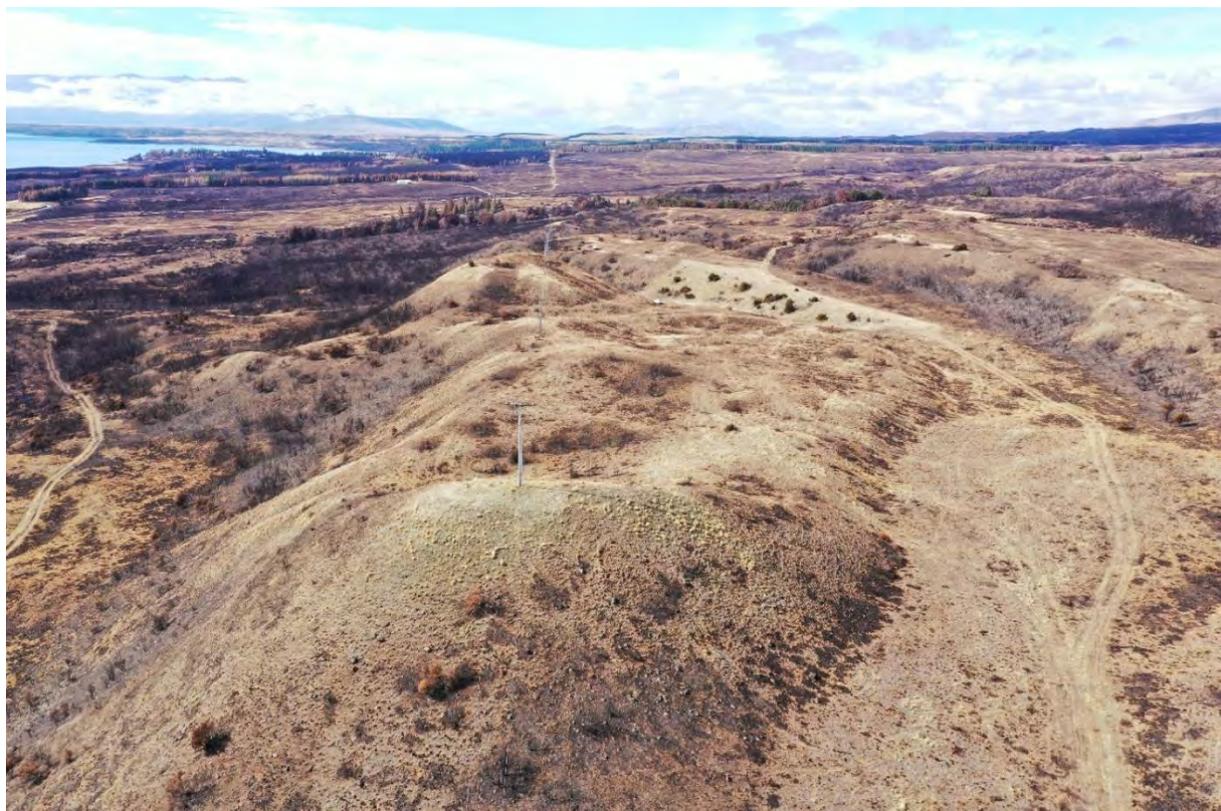
Fig. 33. General origin area predominately grass fuels.

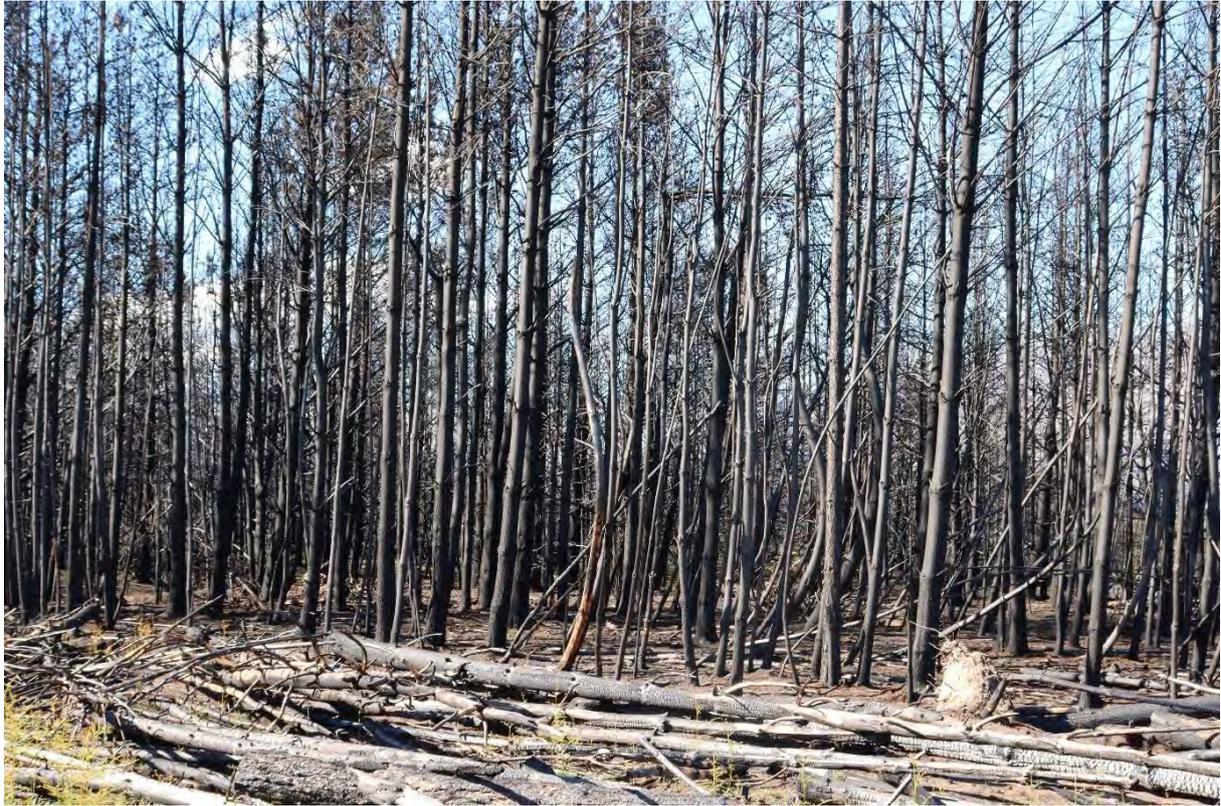
Fig. 34. The above photograph shows the very high fuel loading within the wilding pines.

The driving factor in this environment of elevated wilding pines, was the high volume of available smaller diameter fuels (5mm±) which naturally occur as they die off in the tight confines of the trees growing space. Being so confined, the trees are forced to grow up towards the sun, with the upper section of the tree holding any green canopy. There is at least a 2m strip of vertical dead fuel available to burn from the ground upwards.

This was a fast-moving intense fire in the pines, and in most cases the fire has burnt off the smaller diameter branches leaving the heavier fuel behind. From the air you can see large areas where the fire has produced a crown fire. Fire on the forest floor has not become deep-seated, and only burning the top layer of pine needles as the fire travelled through.
