Fire and Emergency New Zealand Wildfire Investigation Report

| Fire Name: | Lake Ōhau Fire, Lake Ōhau Road |
| Fire Date: | Sunday 4 October 2020 |

Classification of Fire Cause: Accidental

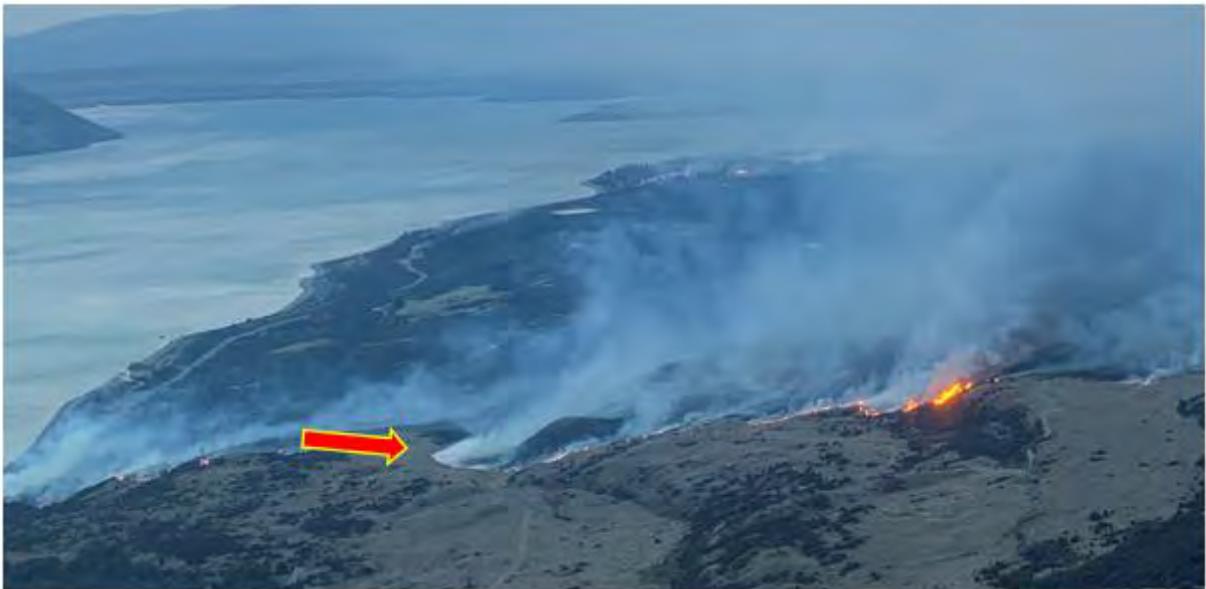
Fig. 38. Photo taken at 07:30 morning of the fire. Wind is blowing cross the span of interest.

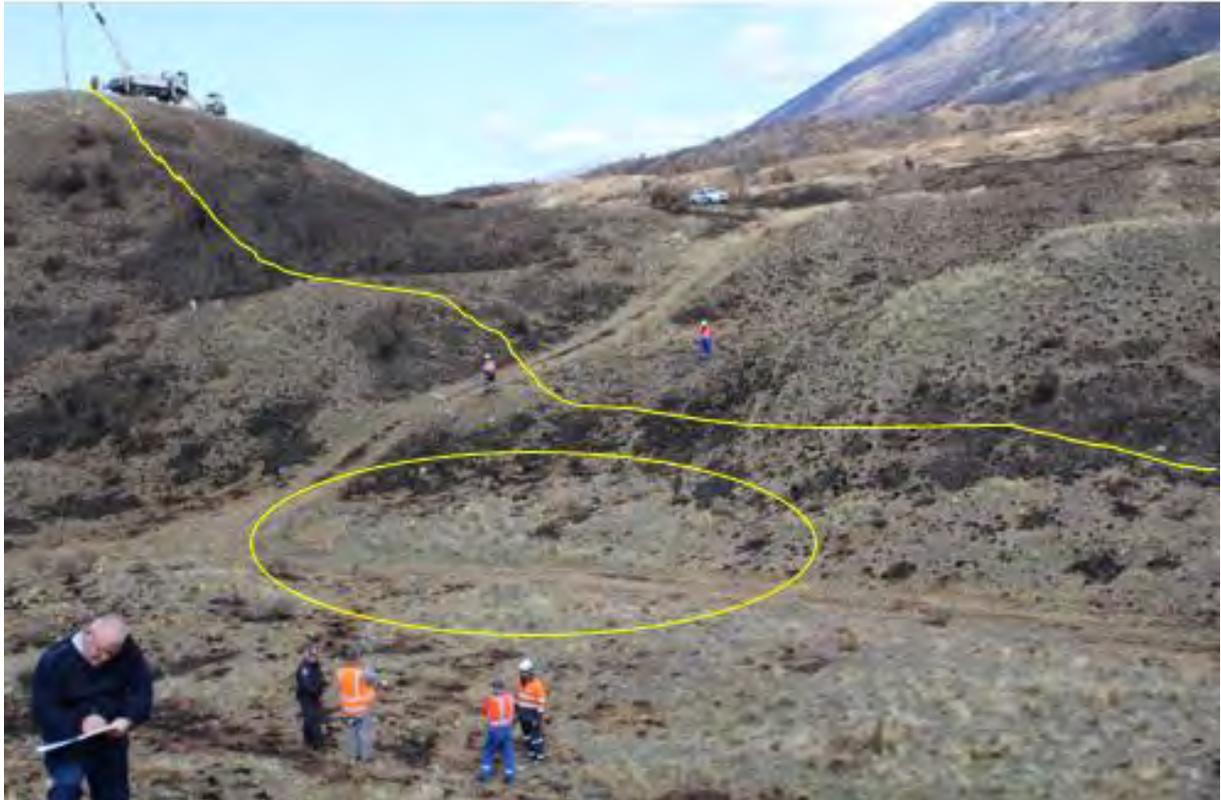
Fig. 39. Area of interest below damaged conductors between poles 870452 and 821215
Yellow line is identifying the conductors lowered to the ground.
Yellow circle is the area of interest below the damaged conductors

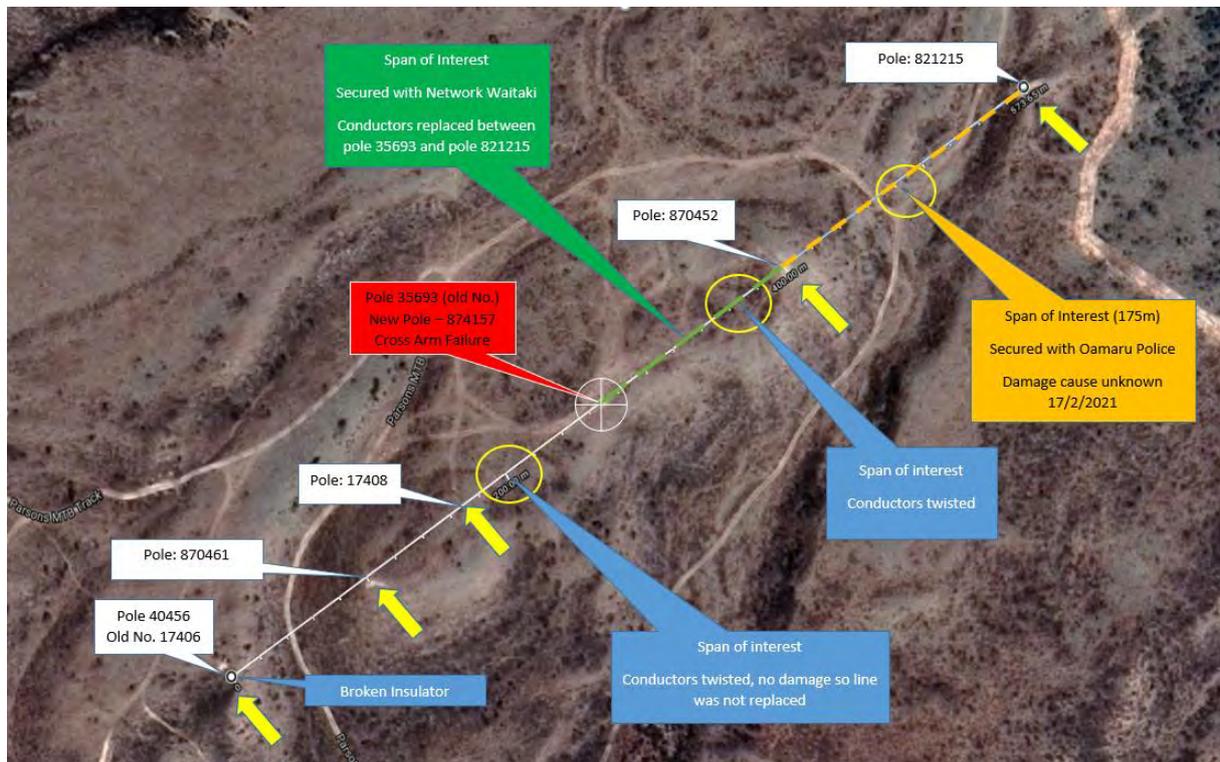
Fig. 43. Above – White circle identifies our primary specific origin area around Pole 35693 (874157).

A thorough investigation was undertaken to identify pole 35693 as the specific origin area and the faults that occurred at this pole being the most probable ignition source.

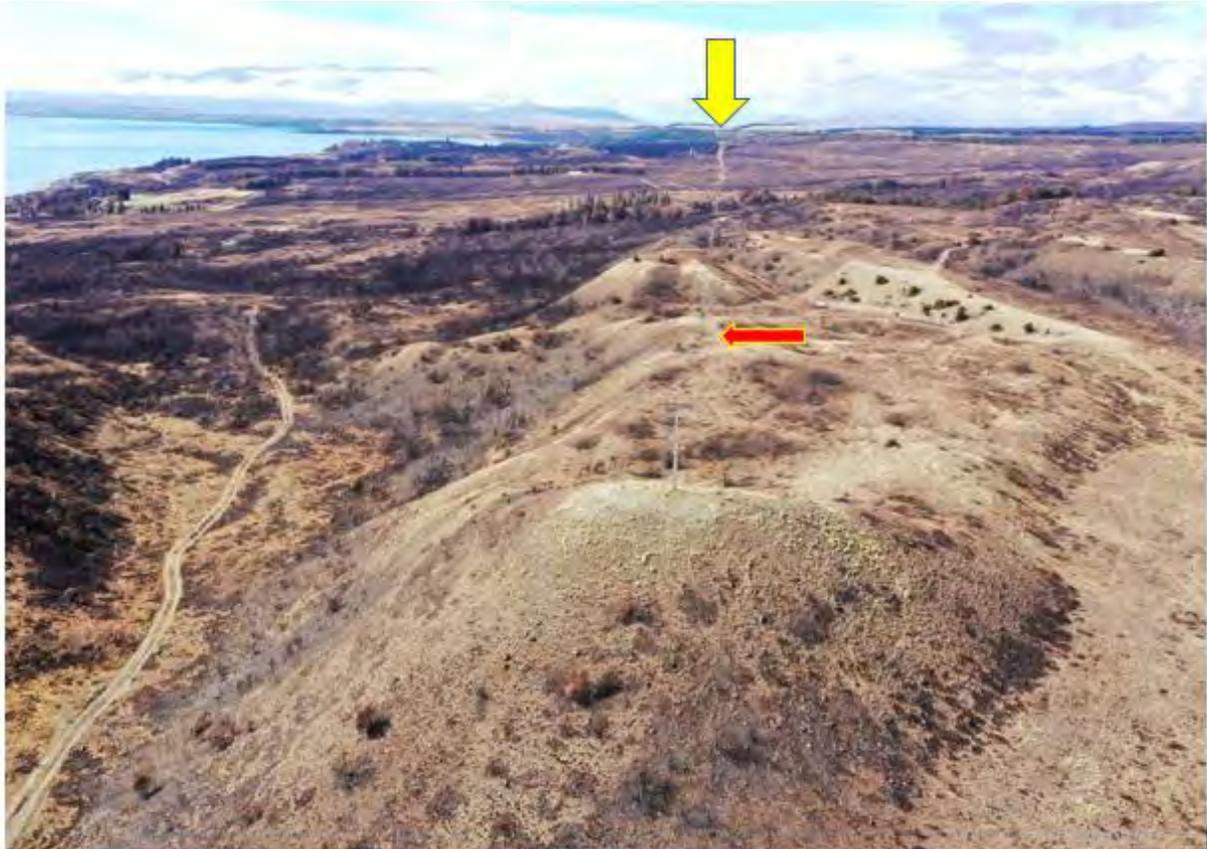
Fig. 44. Yellow arrow is the approximate area we initiated our investigation, following fire pattern indicators until we reached pole 35693 (red arrow)

A single arc mark on each of the metal stay arms attracted our attention at this location. There were also indications of low intensity burning to the fine fuels on the ground below the pole.

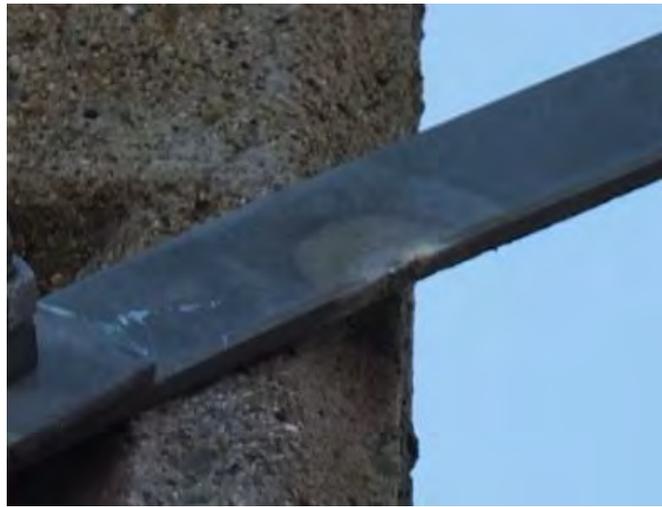
Fig. 46. Photograph (DSCF9365) above right identifies an arc mark on the hillside metal stay arm on the lower section close to where it is secured to the centre of the pole with a double nut.

The lower arc mark would be created when the metal stay arms conduct electricity that create an earth to the pole, consequently burning a hole in the concrete.

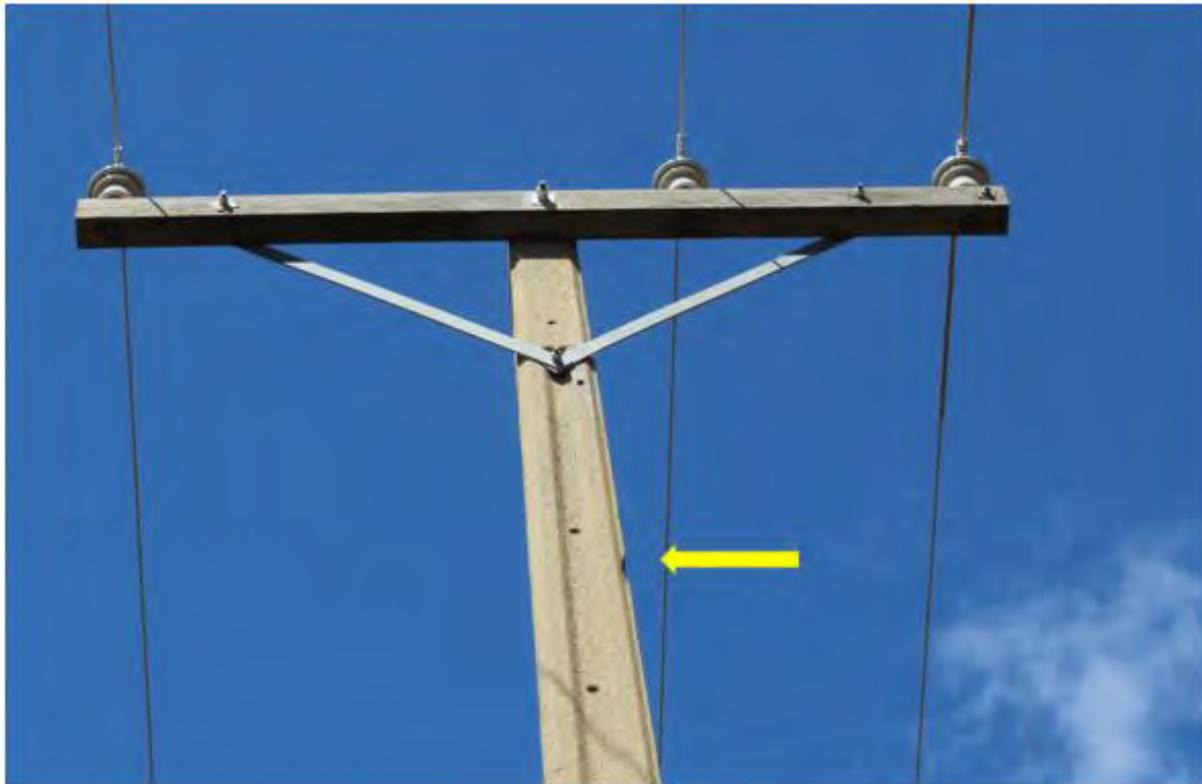
Fig. 47. Upper section of pole 35693 when it was located on 7 October.

Other than what appeared to be arc marks on the metal stay arms, the rest of the pole looked in good operational condition. There also appeared to be damage to the concrete pole below where the two metal stay arms are secured to the centre of the pole (yellow arrow). This appeared to be old damage.

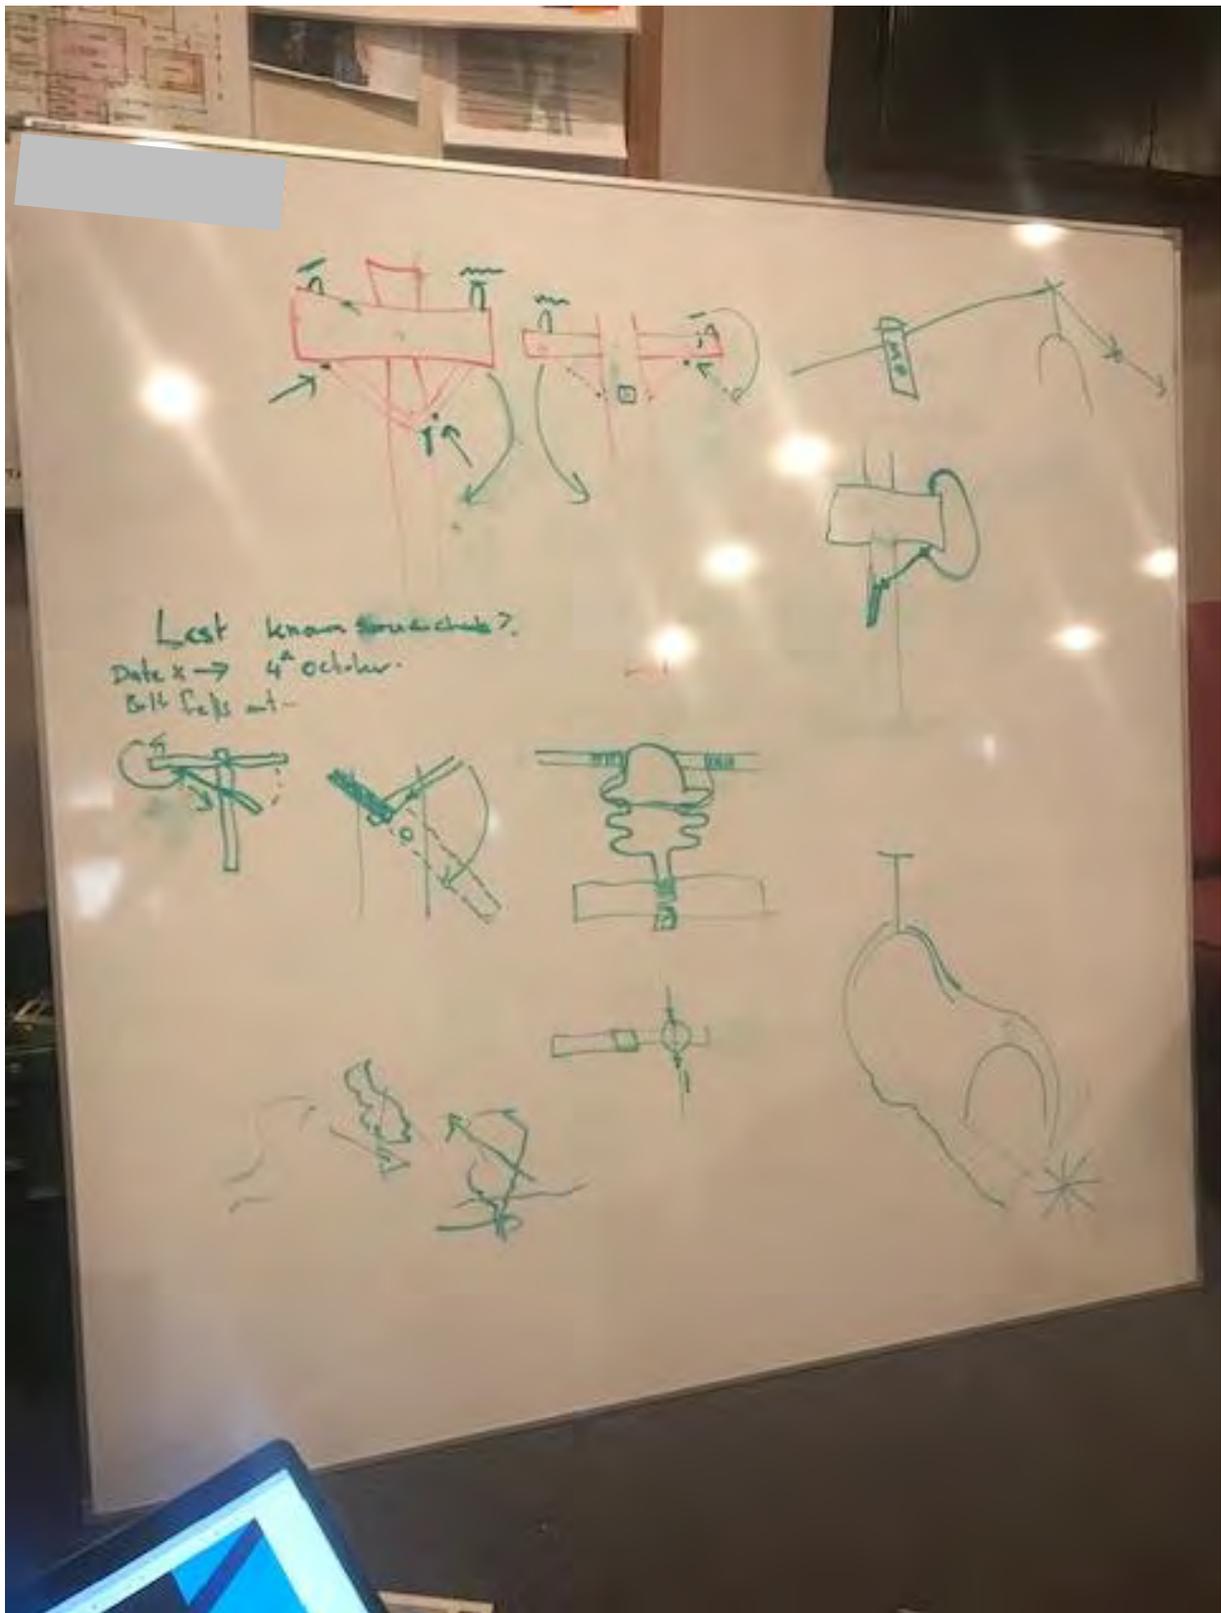
Fig. 52. Photograph taken at Twizel Fire Station on the 17 November 2020 @ 17:04hrs. (Iphone)

Figures 52 above and 53 below show drawings of our possible hypotheses on what occurred on pole 35693. Grey rectangle in Fig 52 is covering a crew members name, unrelated to this event.

allowing the live conductor to swing underneath the lakeside metal stay arm creating a phase to earth fault causing the upper arc mark.

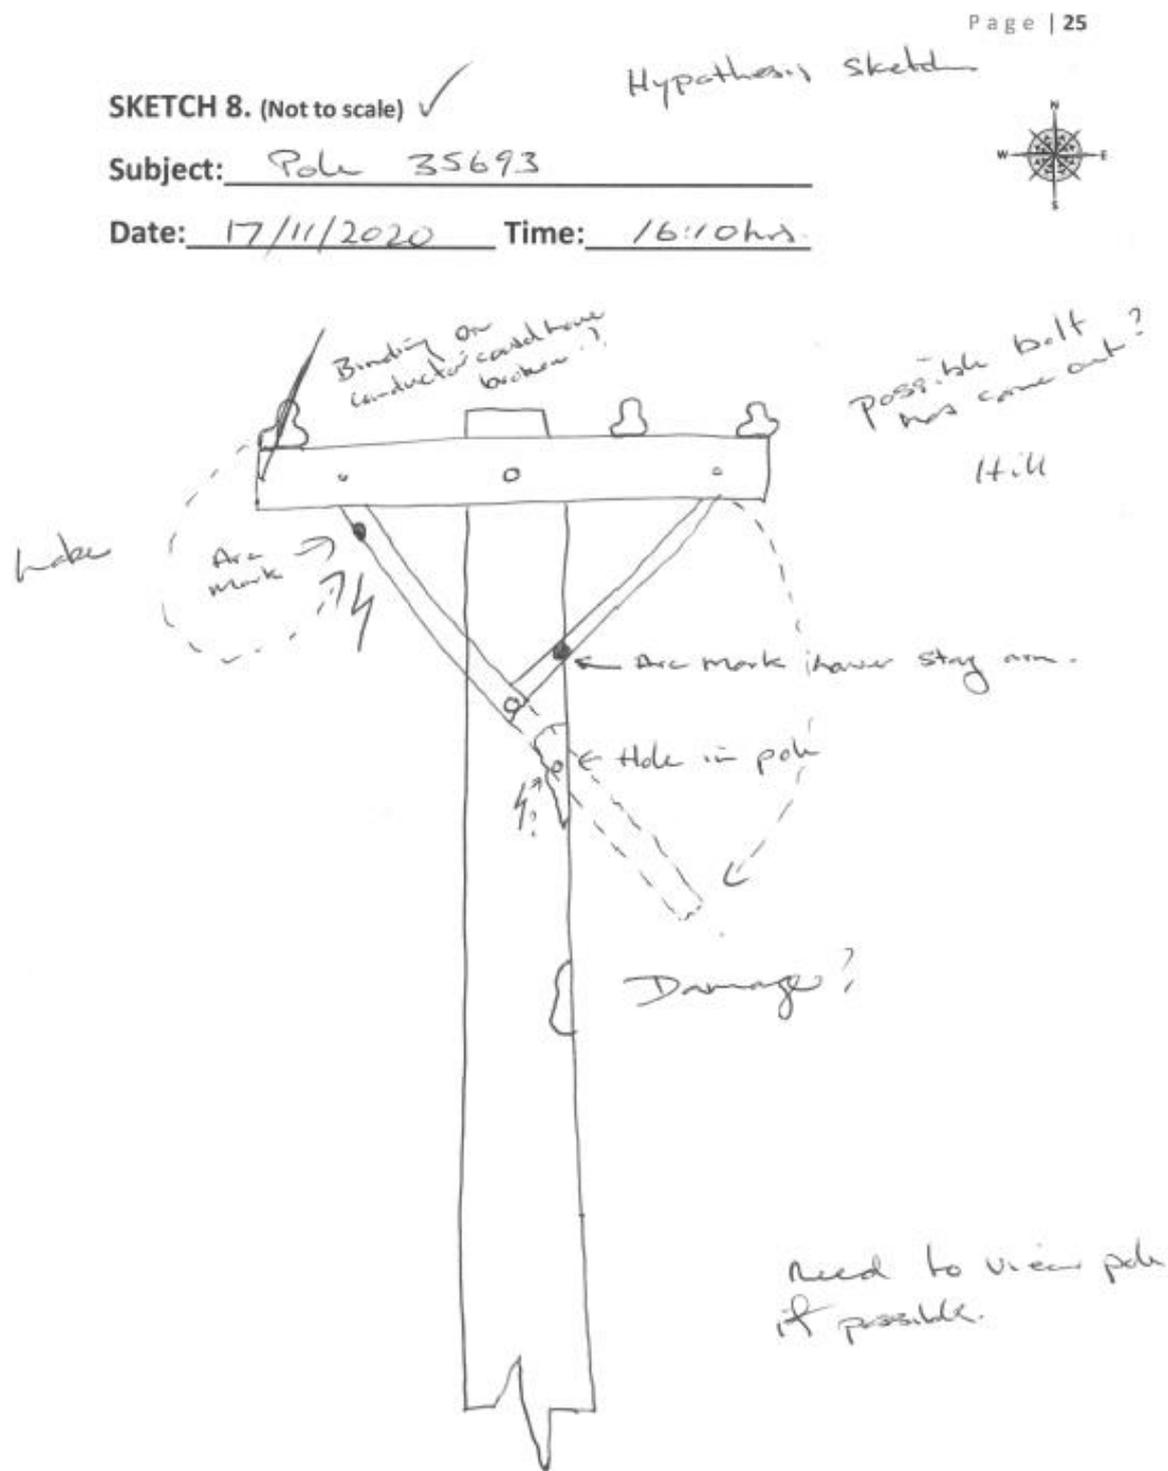
Fig. 53. John Foley drew the sketch above indicating what we thought may have occurred at pole 35693 as a result of our drawings from the white board above.

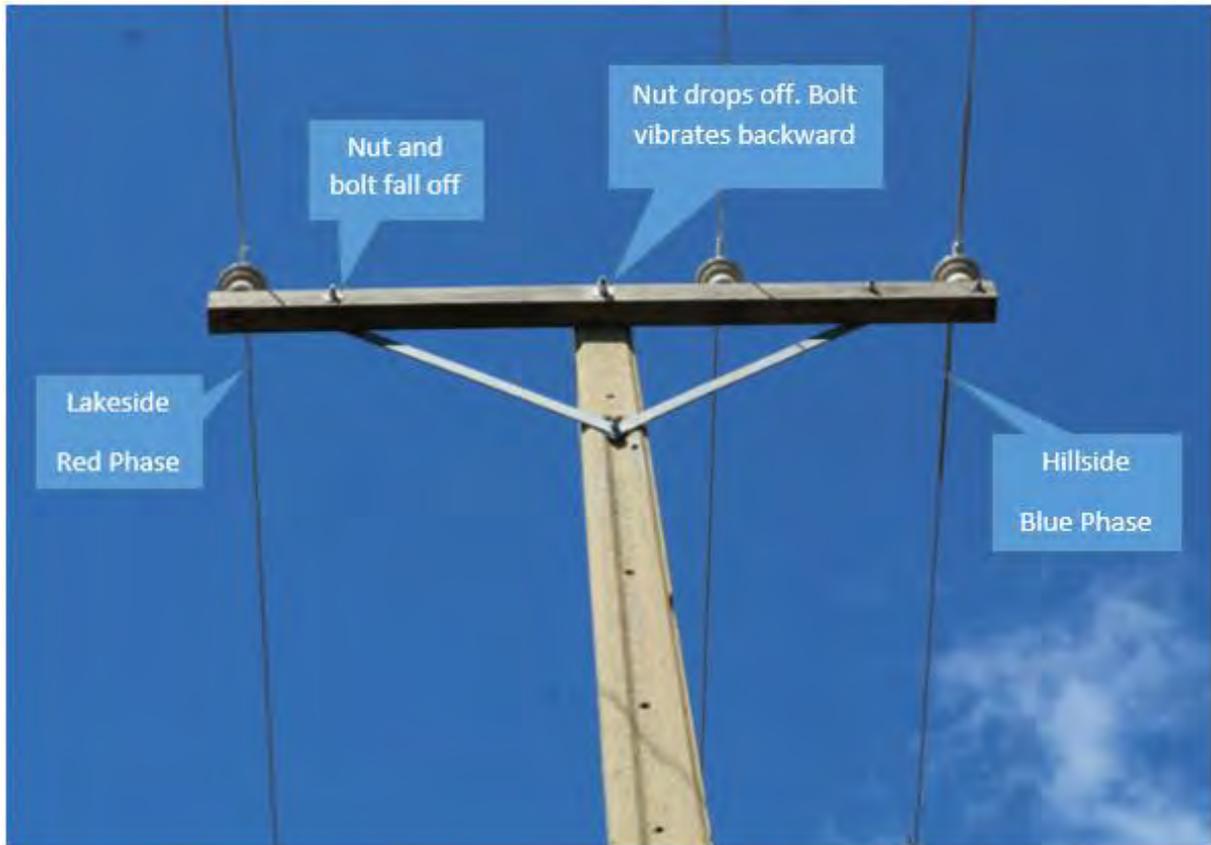
Two bolts have vibrated backwards on pole 35693 at a date unknown. The lake side metal stay has remained in position being held by the tension of the lower centre bolt. The wooden crossarm has dropped down and come to rest on the centre bolt holding the metal stay arms. This may have occurred on the morning of or sometime before 4 October 2020 (refer fig's 57 & 58).

1. At some point the lakeside metal stay arm that was fastened to the wooden cross-arm has lost the nut and over time, the bolt has vibrated backwards and eventually dropped out.

Fig. 57. Identifies Phases, and nuts and bolts that have moved.

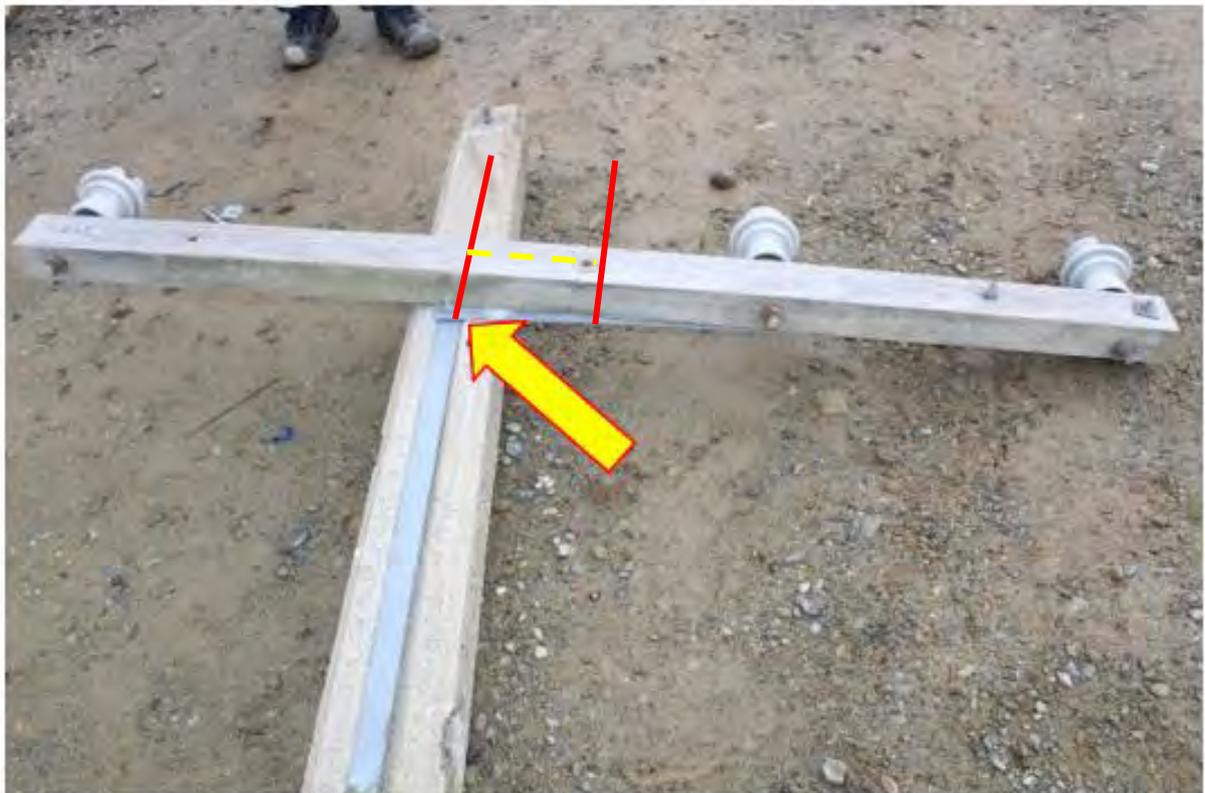
Fig. 59. Above, balancing position of wooden cross-arm after centre bolt vibrated backwards. Note: crossarm has displaced towards the hill side (right of pole) by approximately 250mm off centre.

2. With the nut and bolt now gone, the metal stay arm has remained at its 45° angle.
3. At an unknown time/date the centre bolt holding the wooden cross-arm has vibrated backwards allowing the arm to drop down and come to rest on the lower centre bolt holding the metal stay arms (Fig. 60).
4. When the wooden cross-arm has moved downward coming to rest on the centre bolt the cross-arm has moved approximately 250mm towards the hillside (Fig. 59 off centre). This has placed the RED phase below and within reach of the lakeside metal stay arm.
5. It is unknown how long the cross-arm would have been in this position. It is possible it may have been weeks, days or it occurred on the night of the fire.

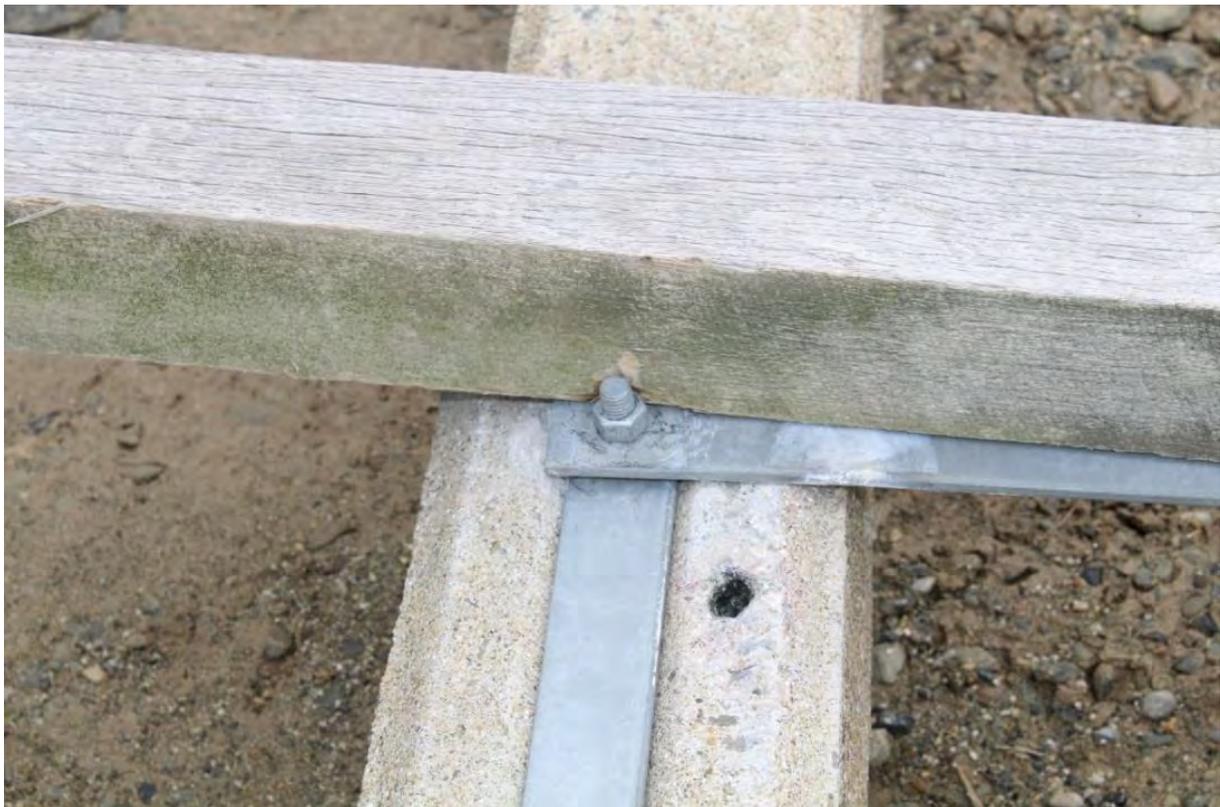
Fig. 60. Close up of cross-arm resting on bolt.

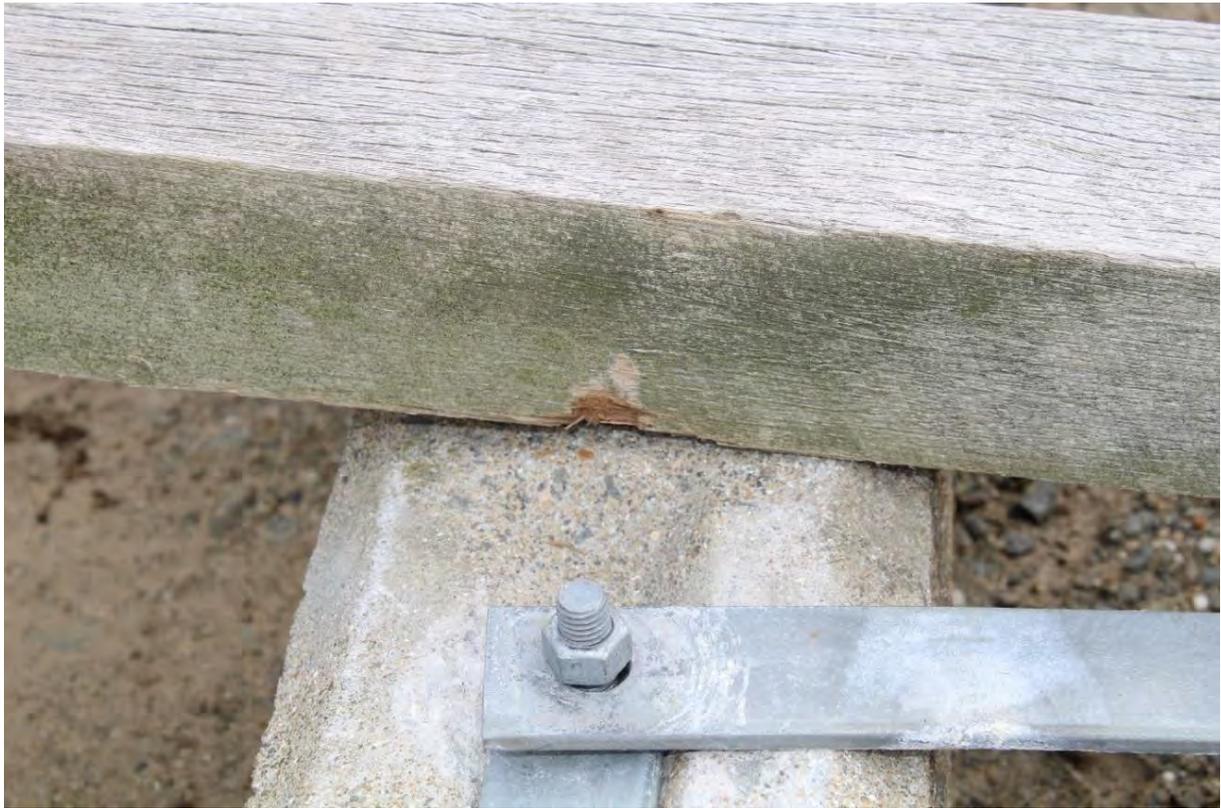
Fig. 61. Note fresh indentation in wooden cross-arm above bolt.

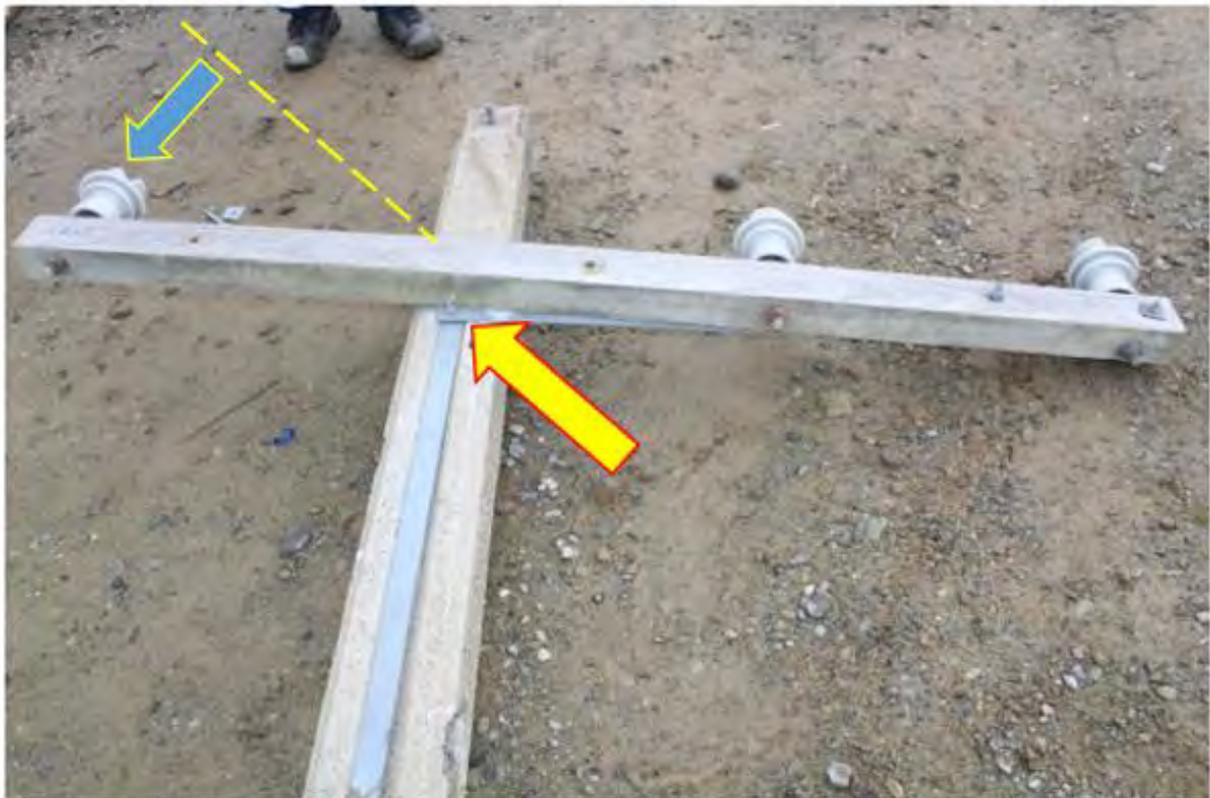
Fig.62. Above, position of metal lakeside stay arm above the RED phase. Held by tension on centre bolt.

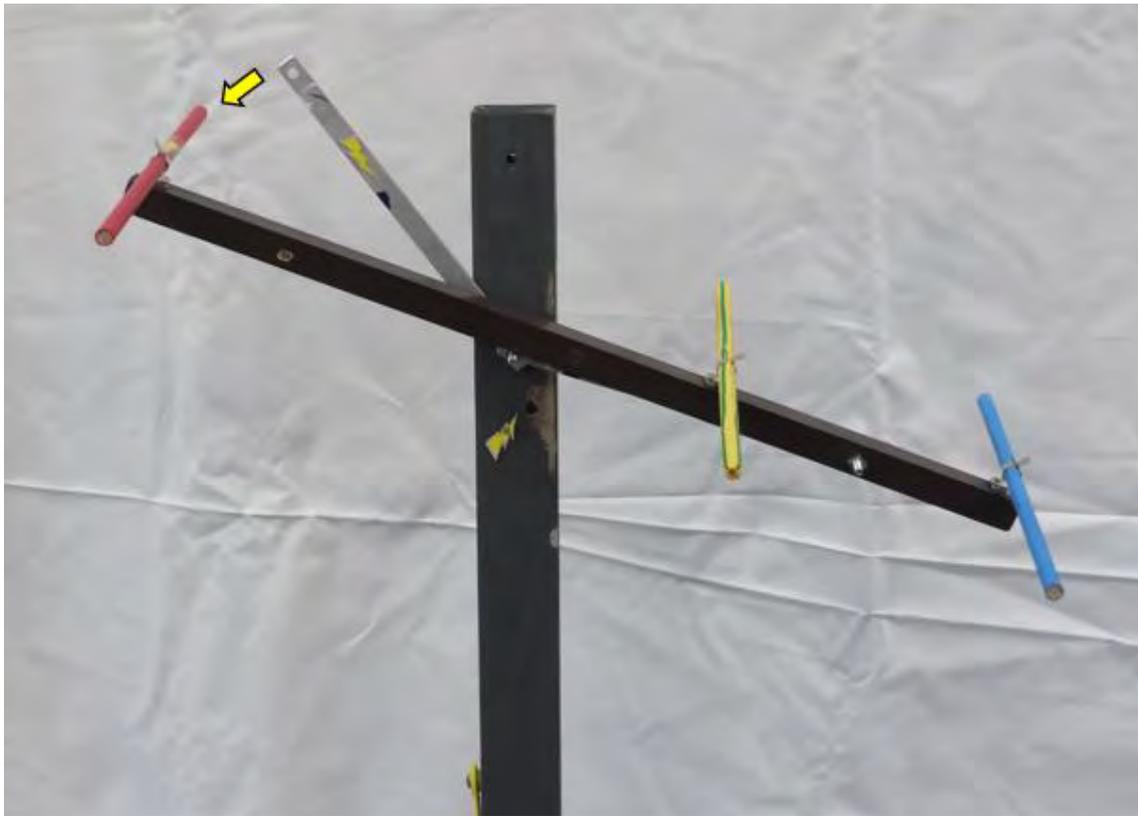
Fig.63. Not to Scale. Model represents how we believe the metal cross-arm has contacted the RED phase.

6. With the storm now impacting the Ōhau area, wind pressure on the conductors has begun to move the cross-arm resting on the centre bolt. As the cross-arm has rotated upwards the RED phase has contacted the underside of the lakeside metal stay arm. (Fig.63. Yellow arrow) eventually contacting the RED phase.

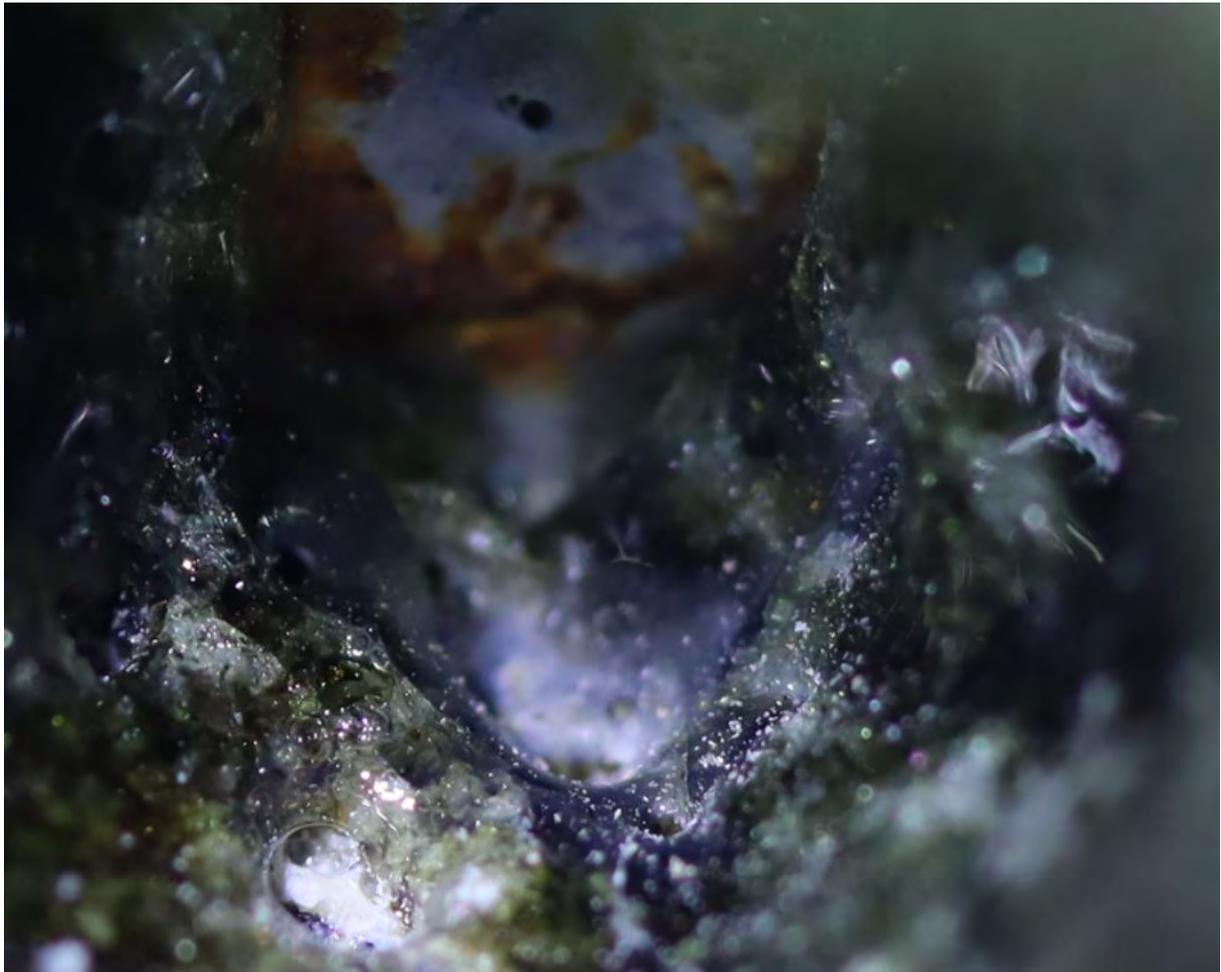
7. This contact has livened the metal stay arms causing a phase to earth fault and creating three burn holes in the concrete pole.
8. One hole on either side of the pole and one inside the centre bolt hole of the pole.
9. The two external burn holes are approximately 16mm in diameter with one 20mm deep and the other 27mm deep. The internal burn hole could not be measured.
10. R690 data provided by Network Waitaki shows a phase to earth fault was recorded at 02:10:03hrs and again at 02:11:15hrs. These may be two separate faults or one continuous fault. Scada also recorded an Earth fault at 02:13:00

Fig. 69. Cropped IMG 1475 – Looking into burn hole.

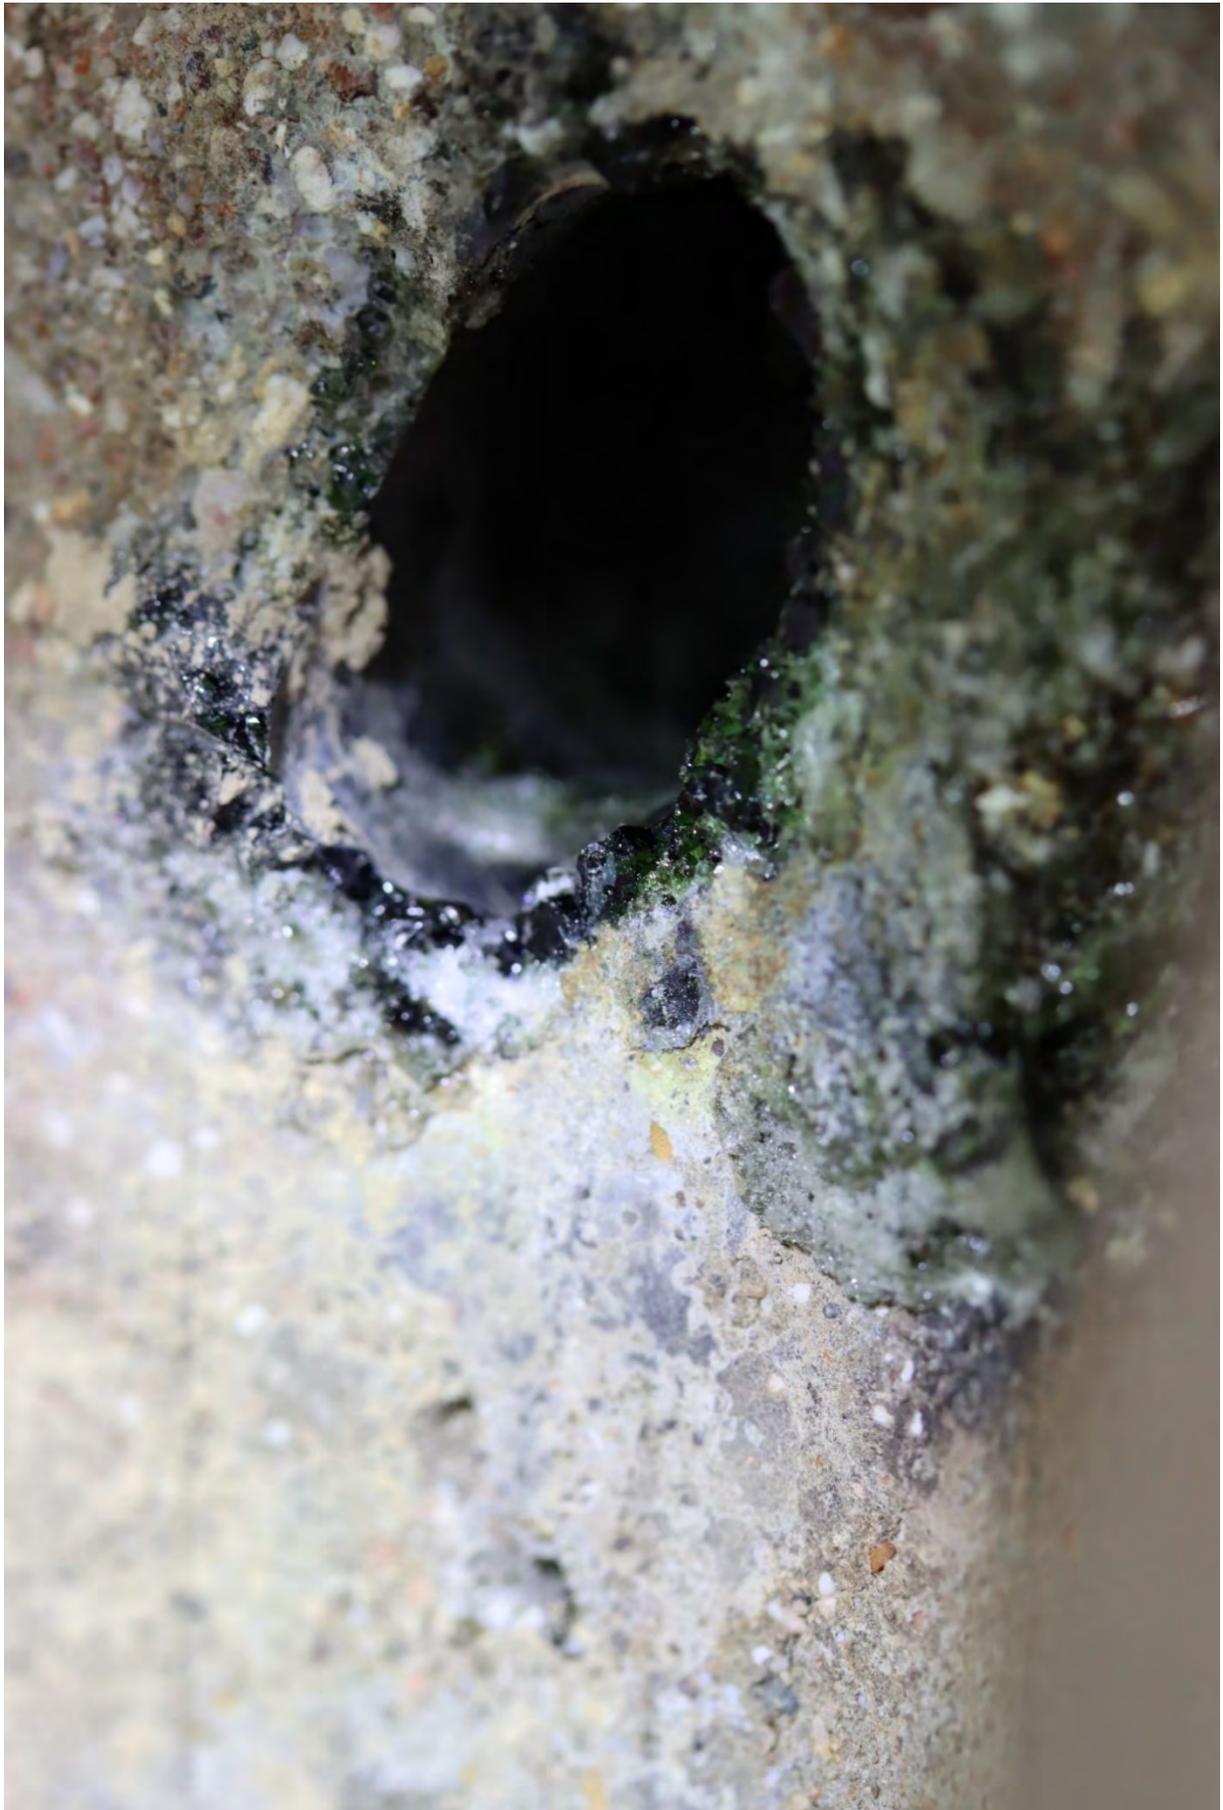
Fig. 72. Burn hole washer side of pole IMG_1452.

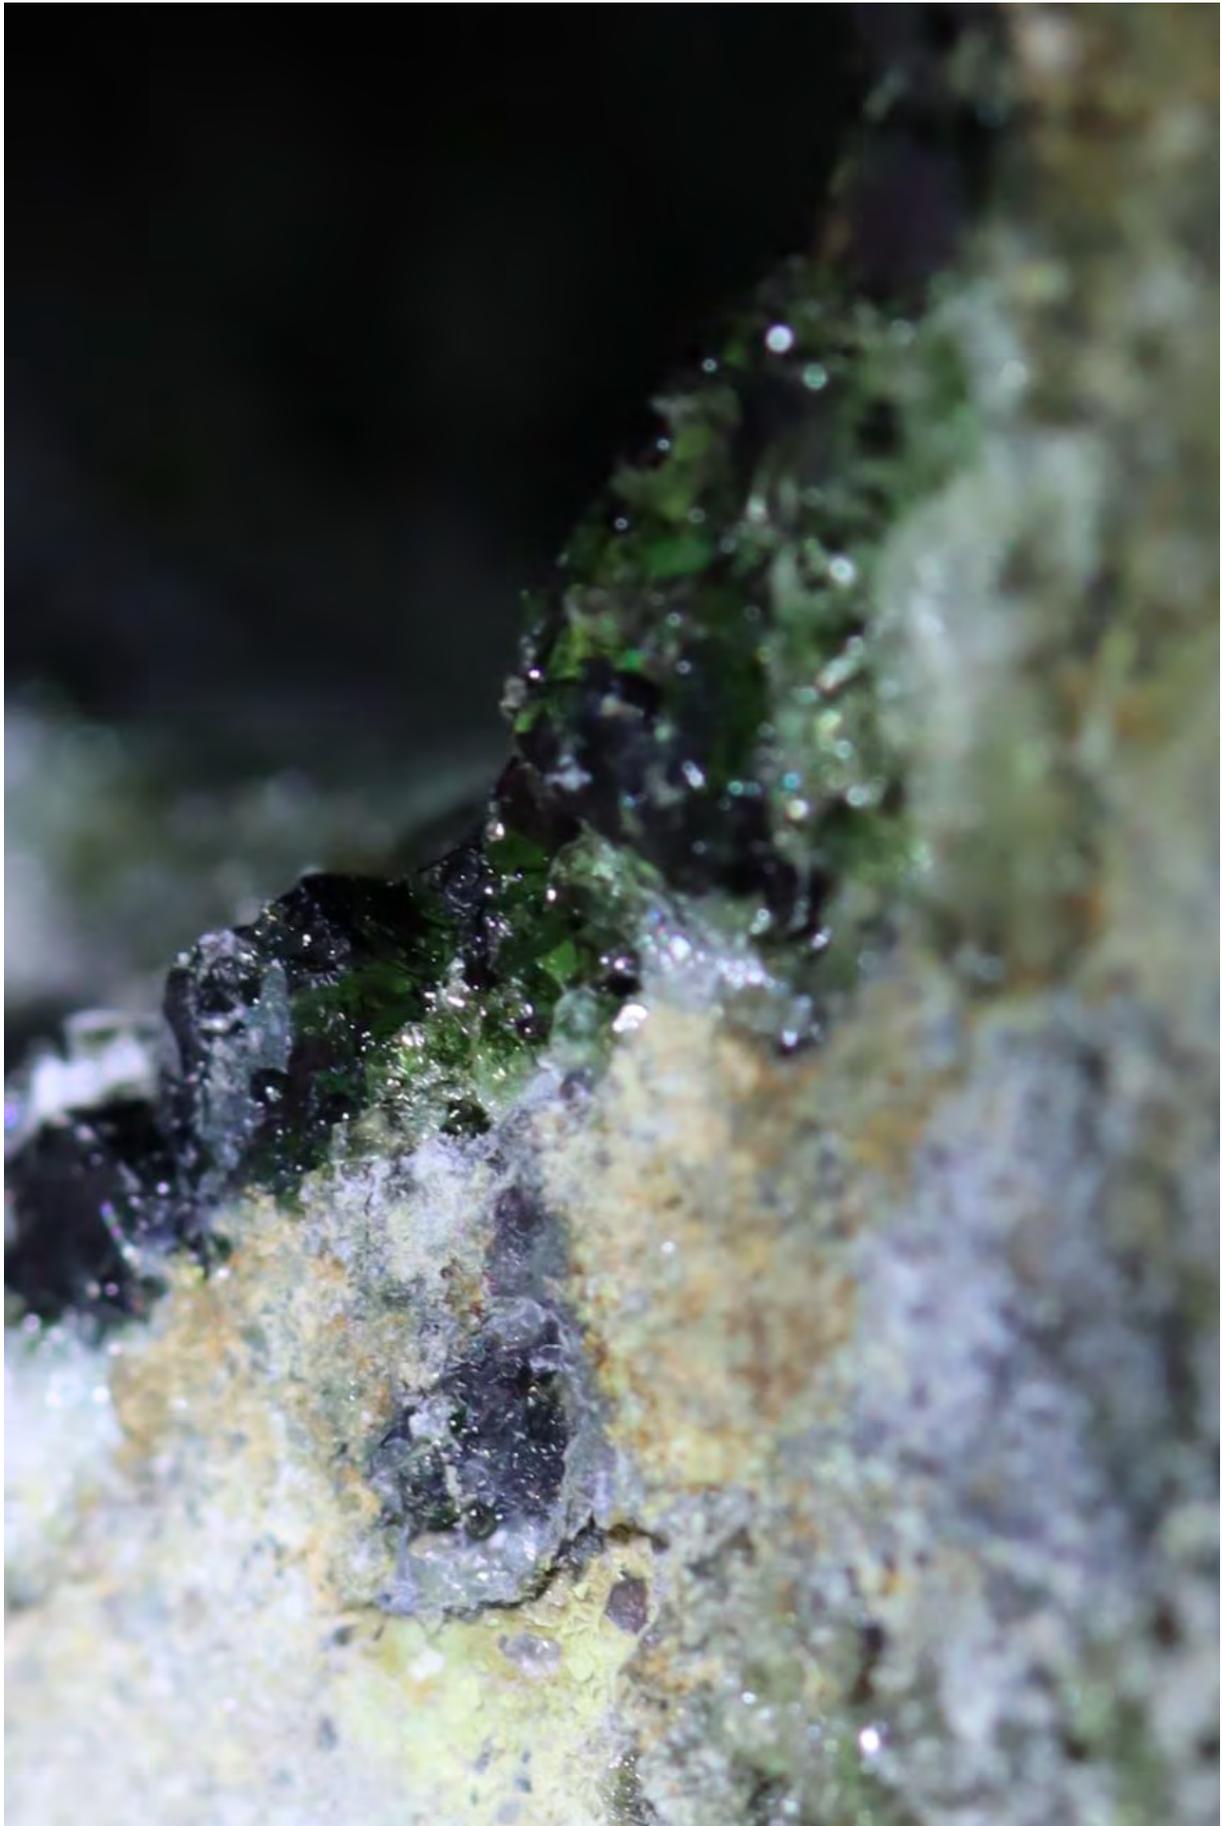
Fig. 73. Cropped photograph of IMG_1452JPG.
