Fire and Emergency New Zealand Wildfire Investigation Report

| Fire Name: | Lake Ōhau Fire, Lake Ōhau Road |
| Fire Date: | Sunday 4 October 2020 |

Classification of Fire Cause: Accidental

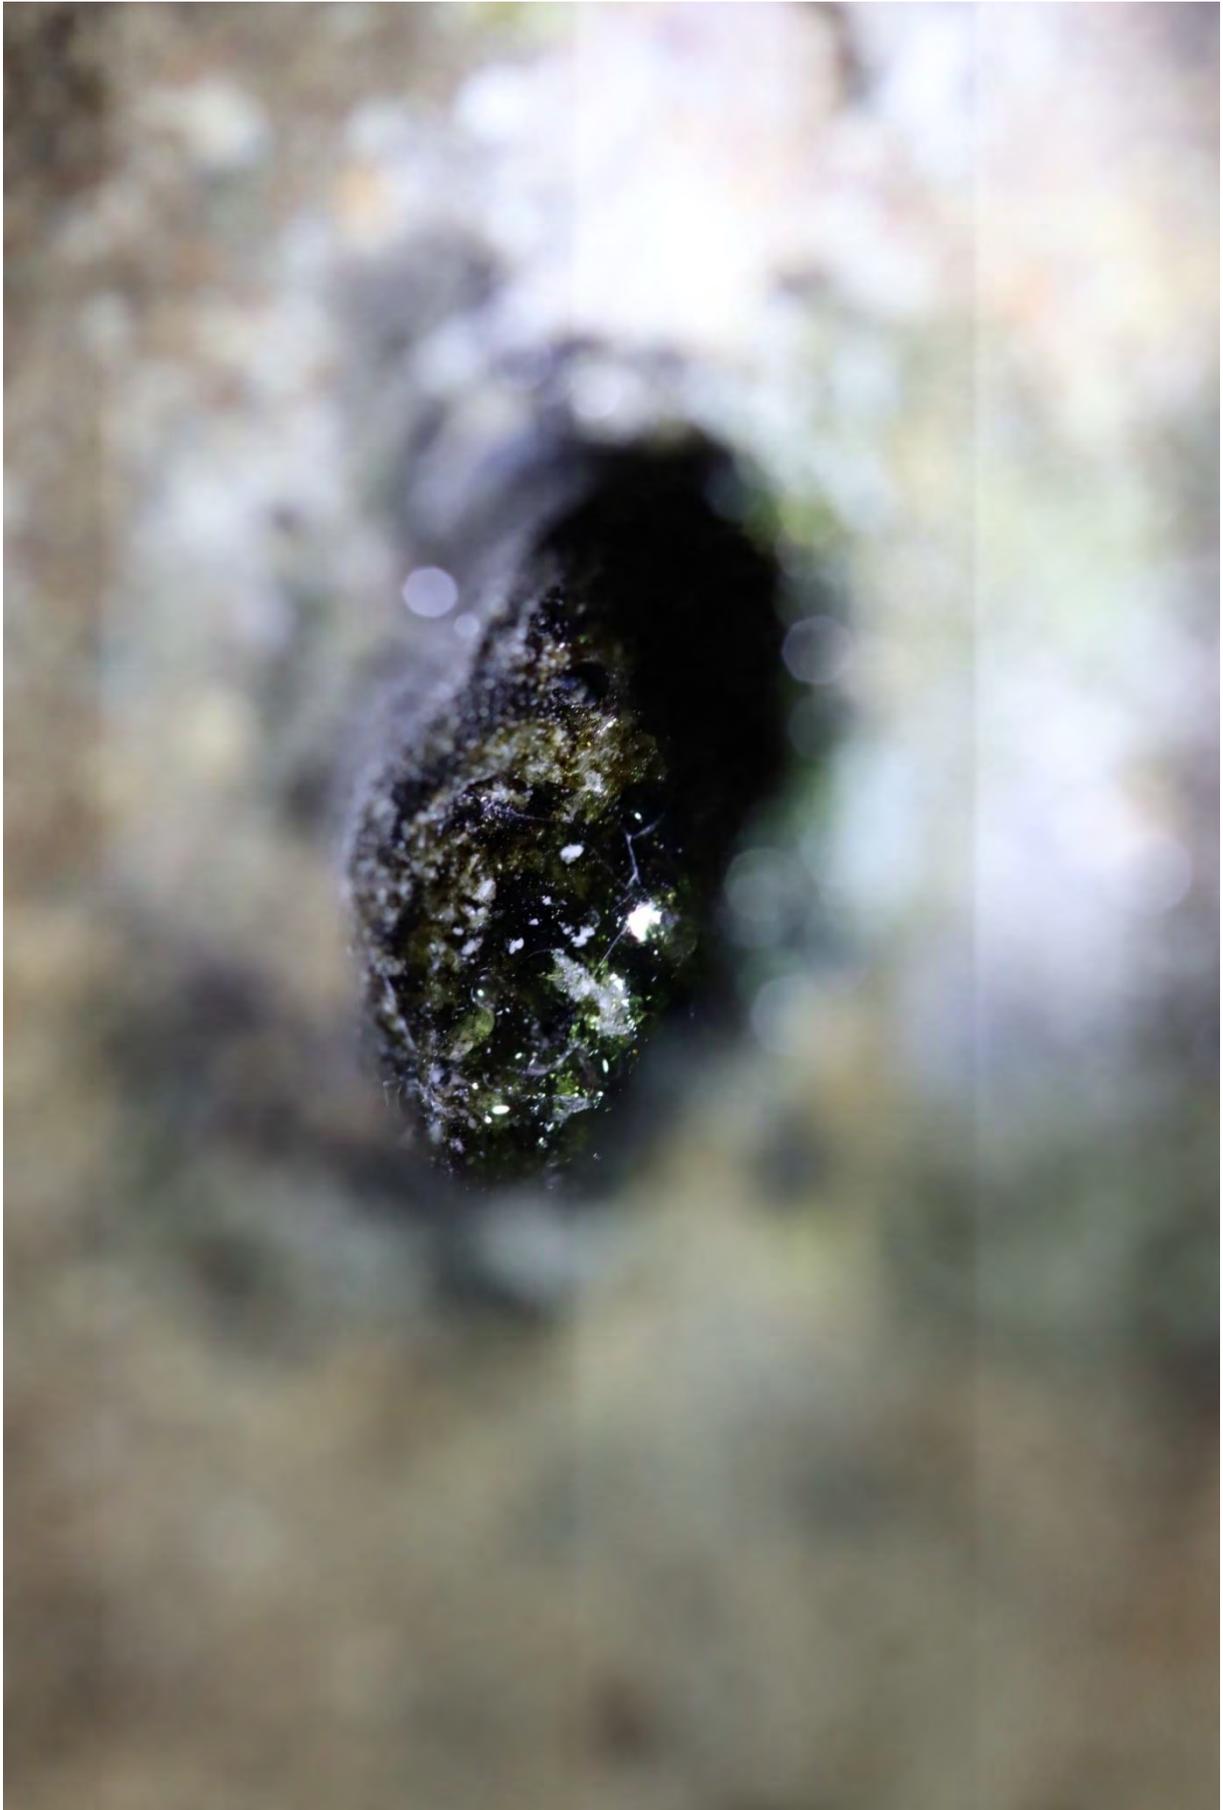
Fig. 75. Looking into burn hole IMG_1481.JPG.

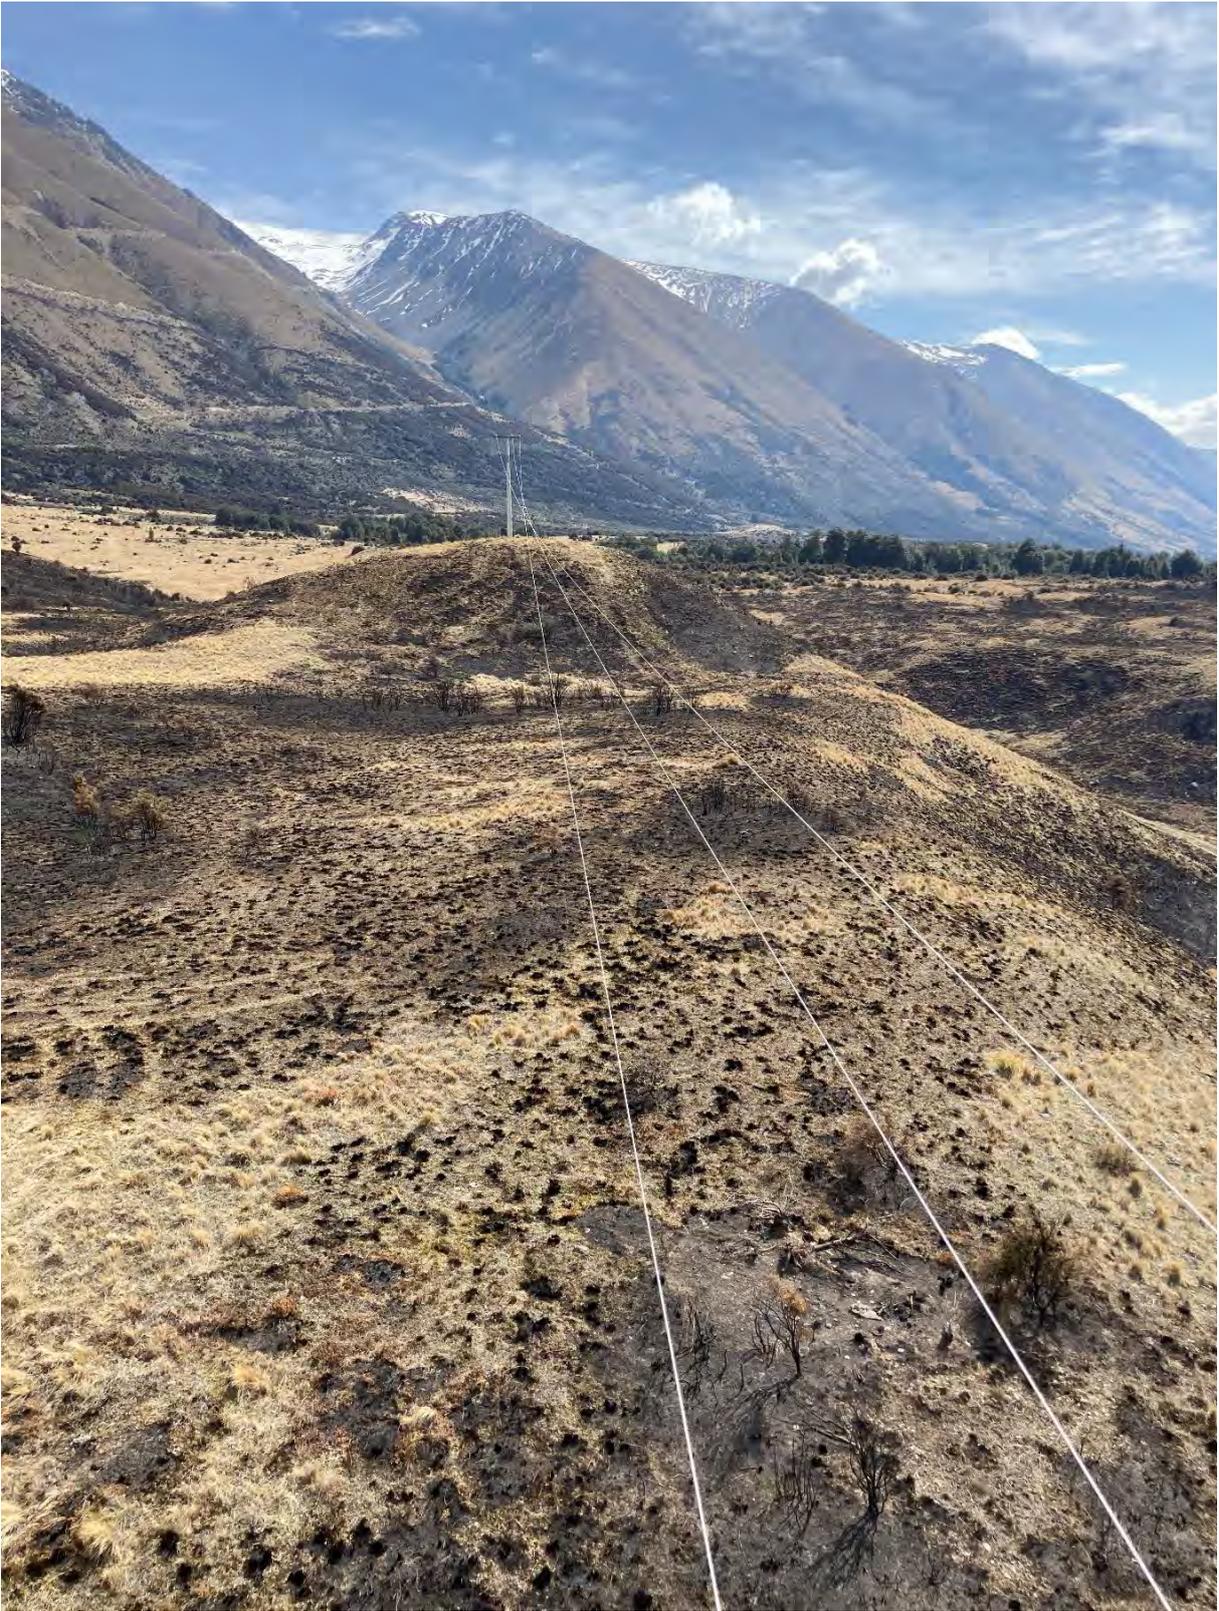
- This area included all three conductors which appear to have twisted together when the wooden cross-arm attached to pole 35693 rotated over, causing the lines to arc (refer to Fig 81).
- The conductors showed signs of arcing when they were examined at Network Waitaki's yard in Oamaru. The conductors are being stored by Network Waitaki (refer to Fig's 83-90).

A second electrical fault event occurred, due to the twisting of the conductors, due to the failed cross-arm, in the span north of pole 35693. This occurred at 03:23, approximately 1 hr 13 mins after the failure of the cross-arm. This may have resulted in another point of fire ignition.

Fig. 81. Photograph (IMG_1715.JPG) Although not clear it does show the twist in the lines.

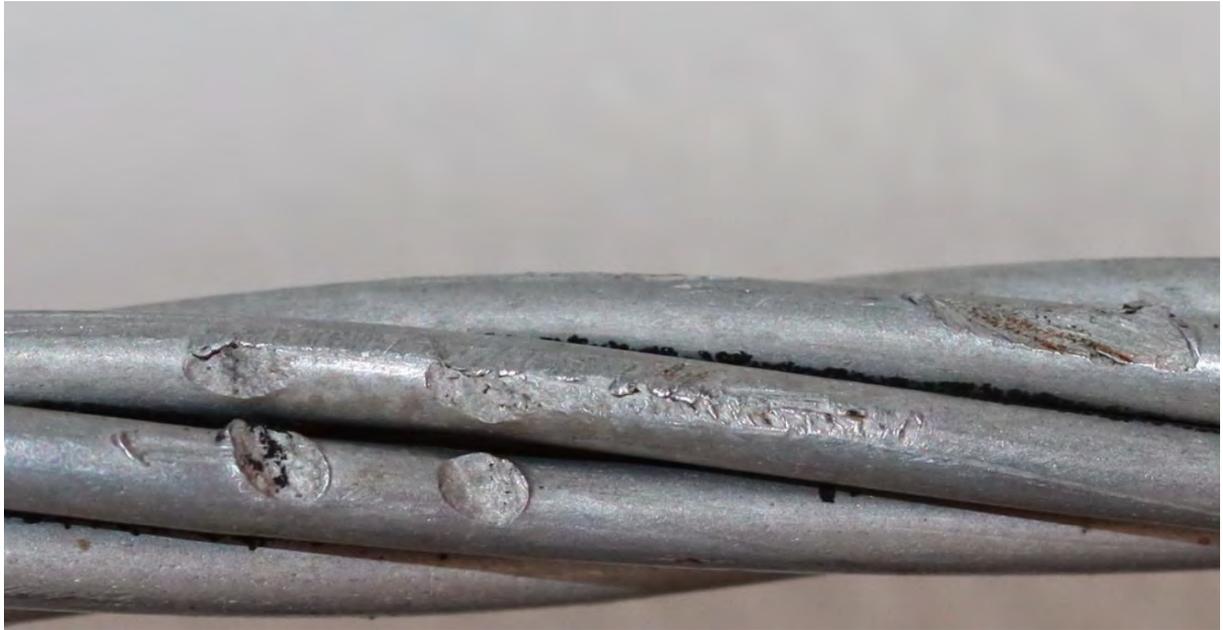
The twisting of the lines and subsequent arcing that occurred have possibly started a secondary fire. A fire starting by the twisted conductors would explain the fire pattern indicators that have come from north of pole 35693.

Fig. 83. Close up of arcing on twisted conductors IMG_1568.

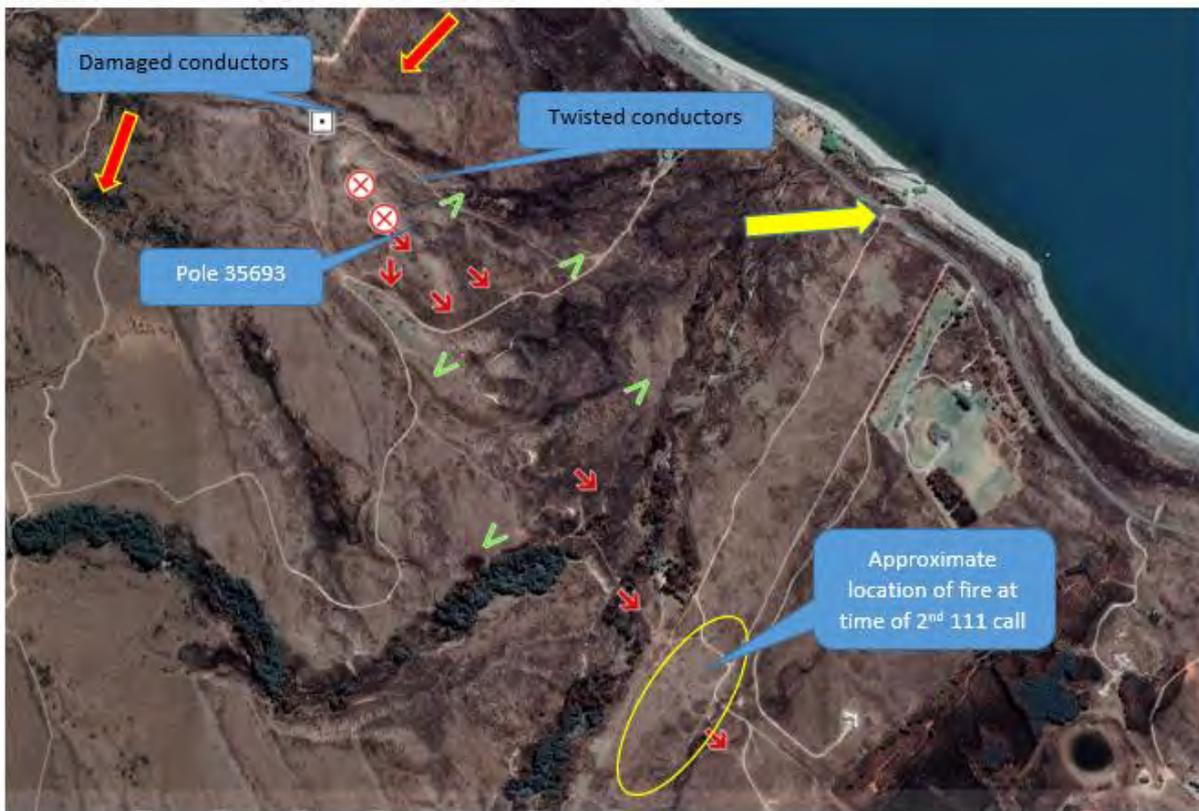
Sketch 1. Fire spread from Specific Origin Area.

Red X identifies two specific origin areas.

Red arrow with yellow boarder identifies fire run when the weather changed pushing the fire south.
