Fire Research Report

**What impact has the change
in building materials and
design in housing had on the
cost damage of fires?**

BRANZ

Housing design changes and fire damage

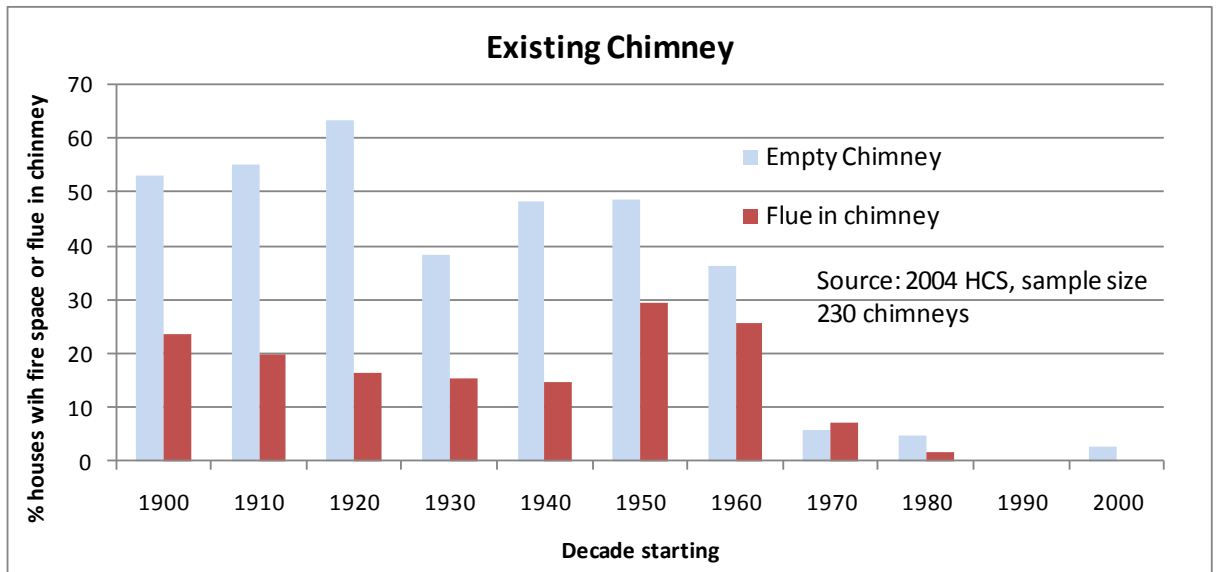
Figure 6 Chimney incidence by age group

The incidence of chimneys is shown in Figure 6. Open fires have a high incidence in housing up to the 1960's. The existence of a chimney and fireplace does not necessarily indicate an open fire is used. However Figure 7 reports on space heating appliances, in use at least occasional, and suggest that a quite high proportion of these fire places are used for open fire heating.

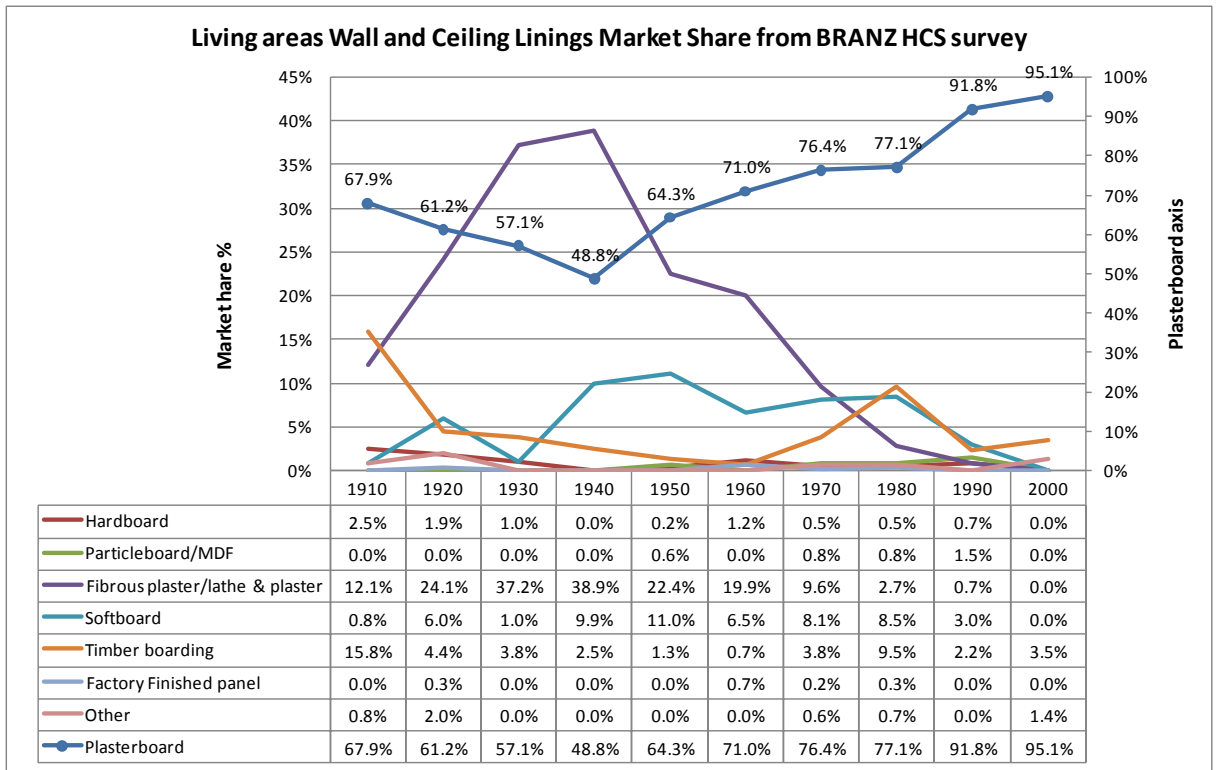
Figure 16 Wall and Ceiling Internal Linings of stand-alone houses

Figure 16 below shows living areas (lounge, dining, family rooms) and bedrooms wall and ceiling internal linings in stand-alone houses over the decades. About 37% of fires originate in these areas of the house (NZFS FIRMS database, July 2000 to March 2009). Plasterboard over the decades has steadily risen, with almost all houses from 1990s onwards made up of plasterboard. Timber linings (hardboard, particleboard, softboard, timber boarding) overall have decreased (especially over the last 20-30 years) with plasterboard becoming more popular.
