Improving the Fire Performance of Polystyrene Insulated Panel in New Zealand

BRANZ

April 2004

BRANZ Report No. FCR 9

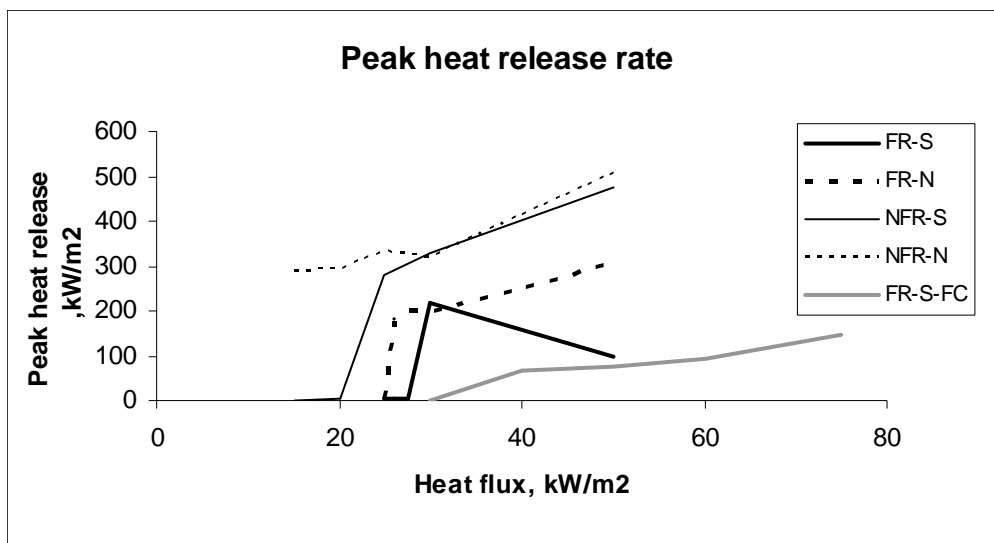
Figure 4.2: Peak heat release rate.

The results are presented in Table 4.2, Table 4.3, Table 4.4, and Table 4.5 and graphs of the results are shown in Figure 4.1, Figure 4.2, Figure 4.3, and Figure 4.4. The more significant parameters are time to ignition and total heat release, peak heat release is inconclusive. This is due to some spikes/peaks and these correspond to the critical heat flux and a difficulty in

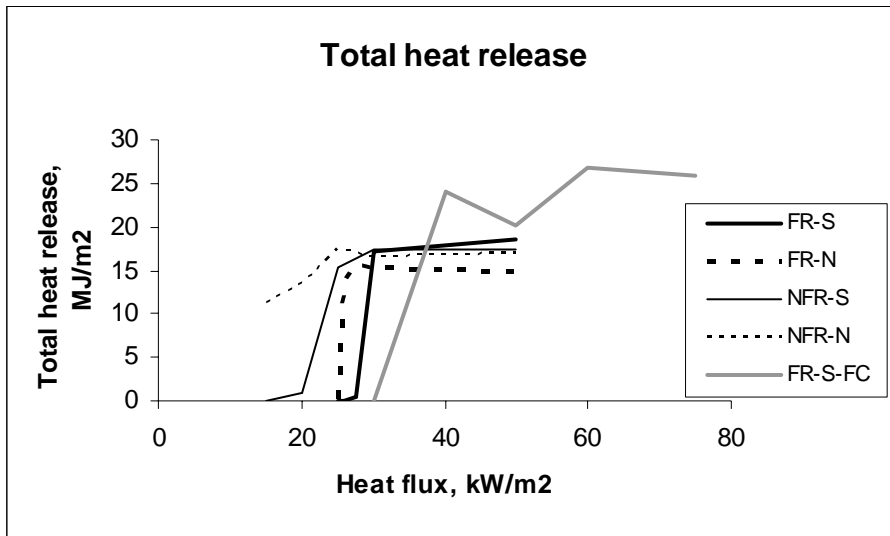
Figure 4.3: Total heat release.

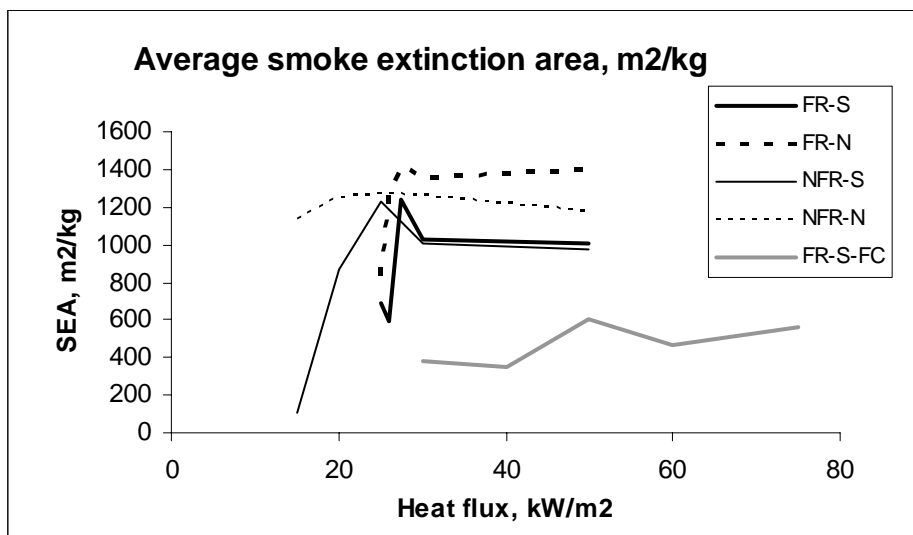
Figure 4.4: Average smoke extinction area.

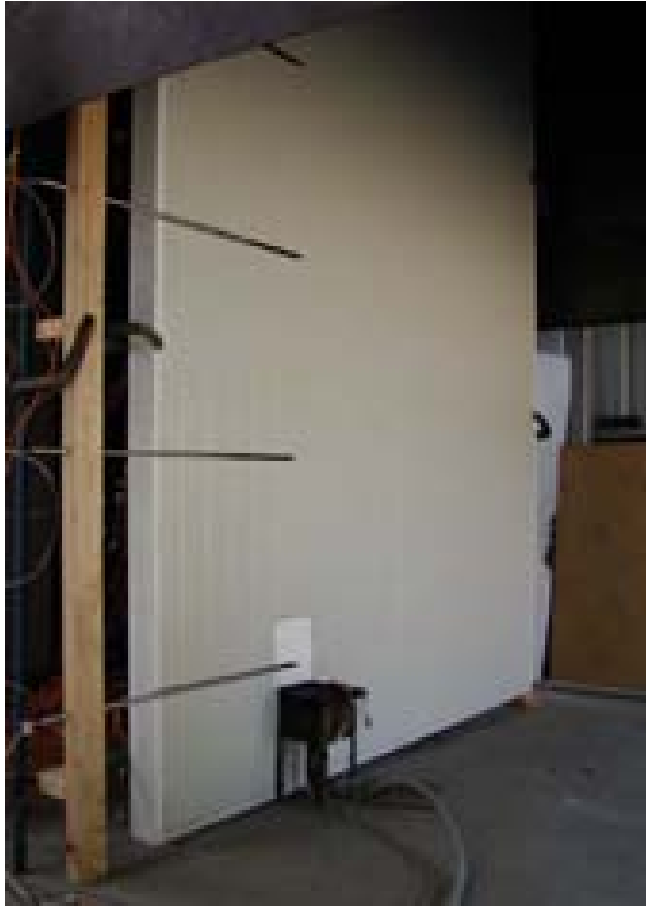
Figure 4.6: Vertical panel for trial 1 and 2 to evaluate fire spread in cavities.

Figure 4.6 illustrates the 4000 mm high vertical panels used for trials 1 and 2, showing the 170 mm x 170 mm burner and a 200 mm x 200 mm hole in the panel skin. The horizontal tubes above the burner contain sheath thermocouples at 600 mm intervals, coinciding with the height of the thermocouples inside the panel, to record the flame temperatures that the panel is exposed to.

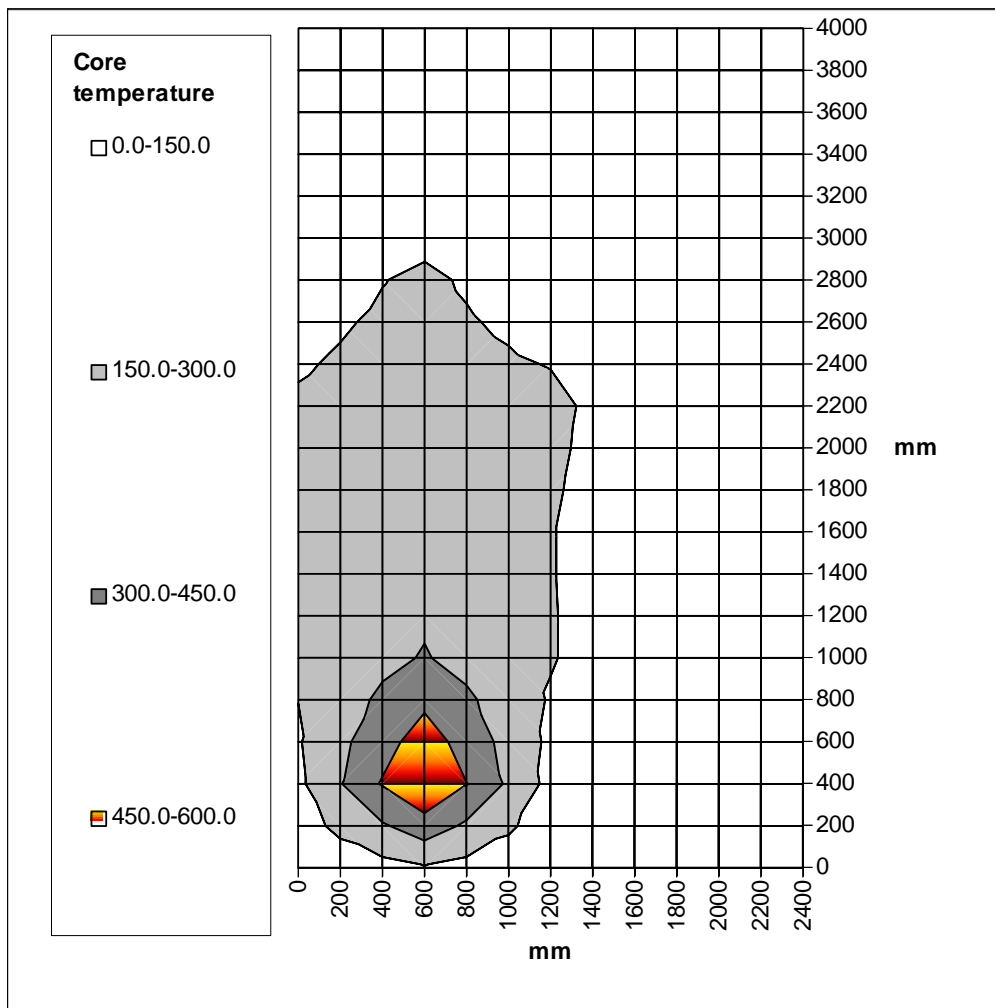
Figure 4.7: Temperature contours after 60 minutes exposure at 40 kW in trial 1, EPS core 35% melted.

In trial 1 the 40 kW exposure was intended to show whether low level heating would initiate fire spread within the panel. Only minimal melting within the panel resulted in a loss of about 35% of the panel core in 60 minutes, as shown in the contour map in Figure 4.7 based on interpolated thermocouple temperatures. The light grey region shows the extent of melting of the EPS core and it is assumed that the molten/liquid flowed downward toward the flame and ignition source at the opening where some burning occurred heating the panel internally. At the conclusion of the trial, no appreciable fire spread within the panel beyond the heated zone was evident.

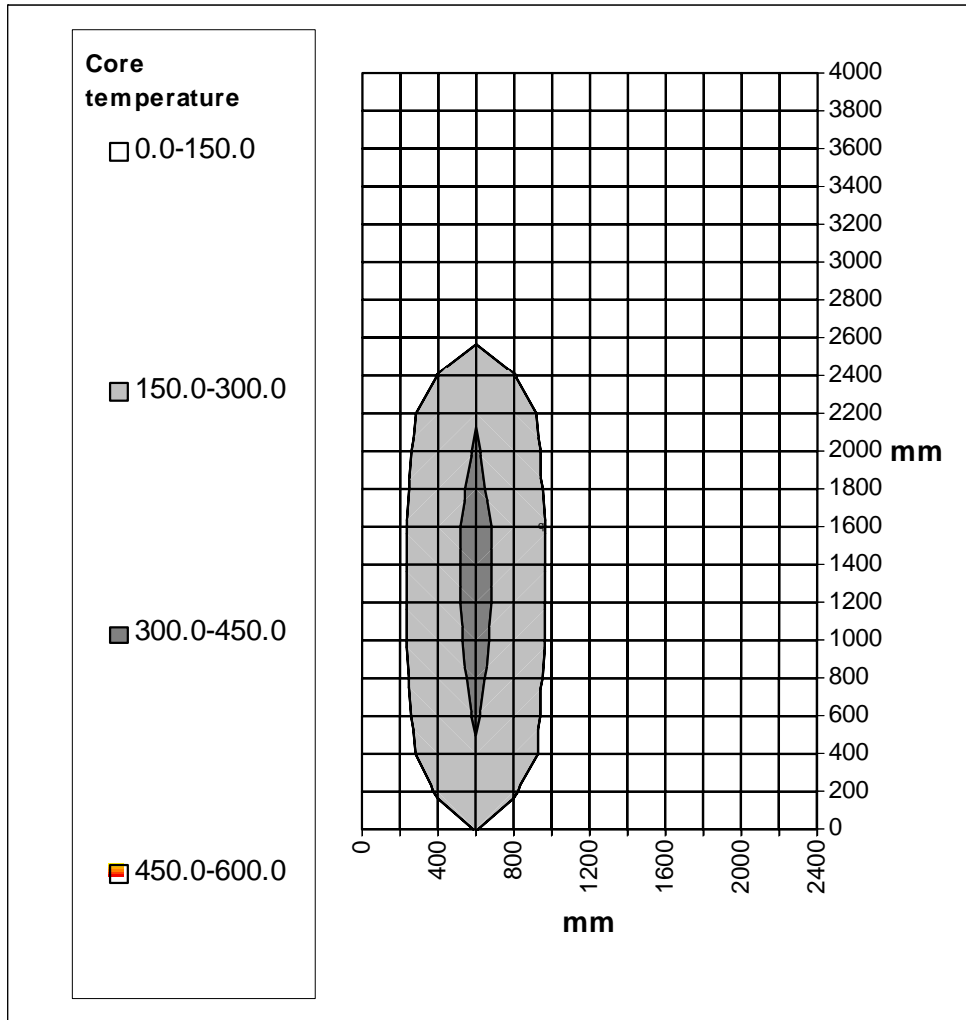
Figure 4.8: Temperature contours after 10 minutes exposure at 100 kW in trial 2, EPS core 18% melted

After 10 minutes exposure there were no visible signs of fire spread or heating on the panel reverse side beyond the limited light grey contour shown in Figure 4.8, which matches closely with the boundary of the flame in the photograph in Figure 4.9.

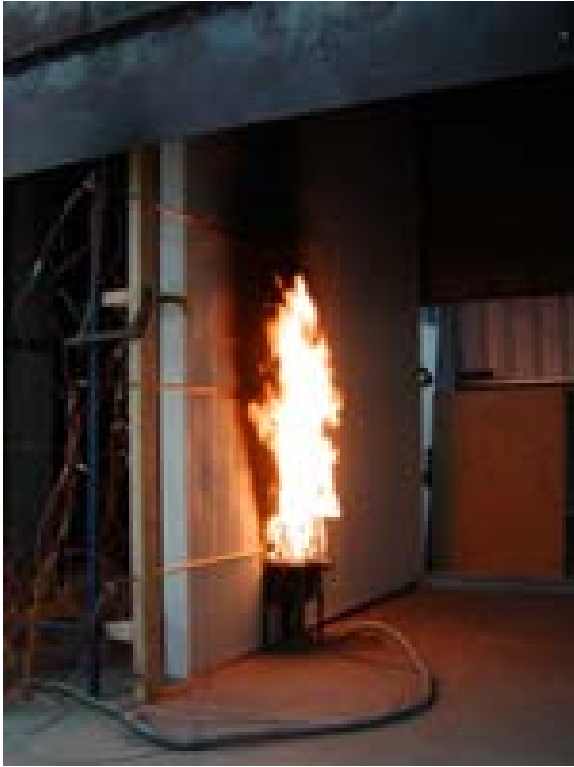
Figure 4.9: Trial 2 after 10 minutes at 100 kW.

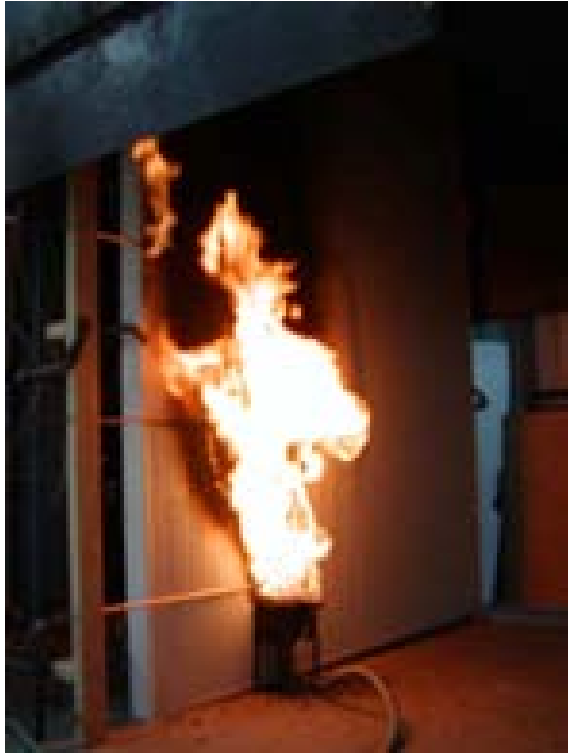
Figure 4.11: Trial 2 at 20 minutes at 200 kW.

Similarly, at 20 minutes and 200 kW another stable condition was reached as indicated in Figure 4.10 and confirmed by boundaries of the flame in Figure 4.11. The extent of the melting and consequently the EPS available for burning had increased to 31% this was limited by the boundary of the heat affected zone. Apart from some slight rippling and buckling of the panel surfaces on both sides no opening of the joint or edge capping was evident.

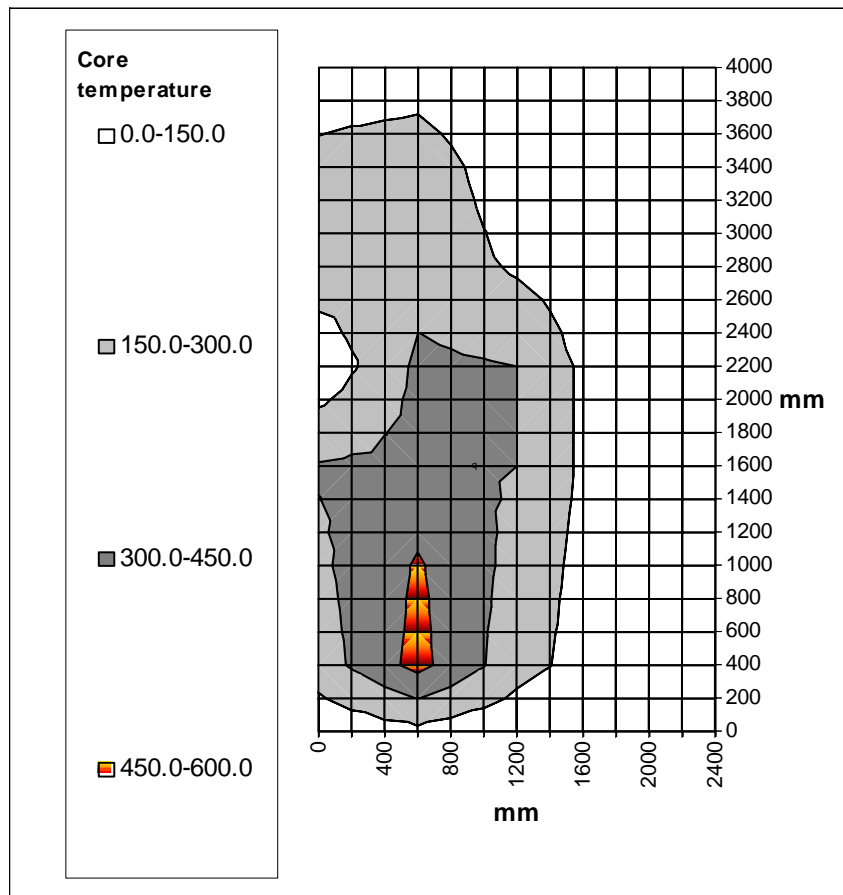
Figure 4.12: Temperature contours after 30 minutes exposure up to 300 kW in trial 2, EPS core 48% melted.

When the output of the burner was increased to 300 kW after 20 minutes and continued until 60 minutes further melting occurred reaching 48% at 30 minutes and 70 % at 60 minutes as shown in Figure 4.12, Figure 4.13 and Figure 4.14. In the process of this happening, buckling of the panel skins around some of the perimeter occurred and the skins became detached from the end

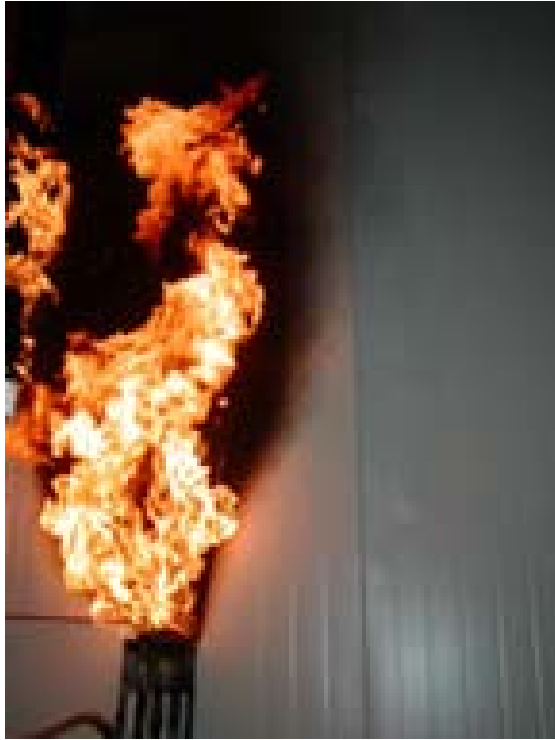
Figure 4.13: Trial 2 at 30 minutes exposure 300 kW (reverse angle) taken from RHS front side of specimen.

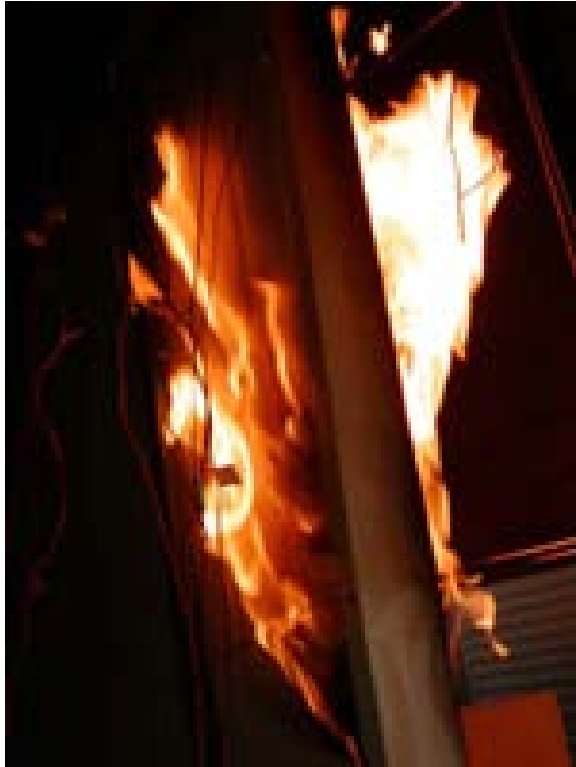
Figure 4.15: Trial 2 at 60 minutes exposure, flaming on the unexposed side (left in picture) due to ignition of gases escaping from gaps in edge capping.

capping as the rivets melted and sheared. In addition, the un-riveted central panel joint opened on each side allowing air to enter and gases to escape. This resulted in flaming on the unexposed side at 60 minutes as shown in Figure 4.15

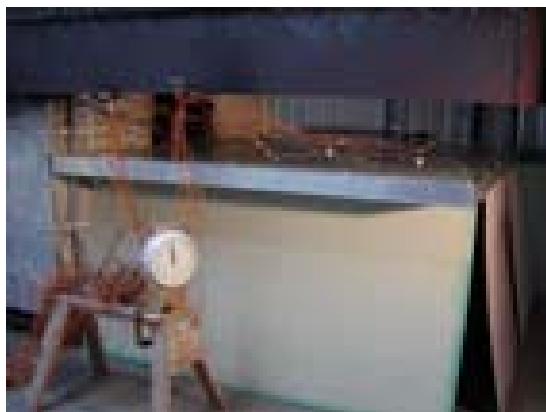
Figure 4.16: Horizontal panel.

In trial 3, the same 100 mm thick panel was exposed from below and the behaviour was different for a number of reasons. In order to accommodate the panel under the extraction hood the 4000 mm dimension had to be reduced to 2900 mm so that the gases could be captured and prevent the laboratory filling with smoke. Additionally, the sides were confined with fibre-cement board to similarly prevent escape of the smoke, as shown in Figure 4.16. This had the effect of containing the heat under the panel and contributed to a more severe test than trial 2.

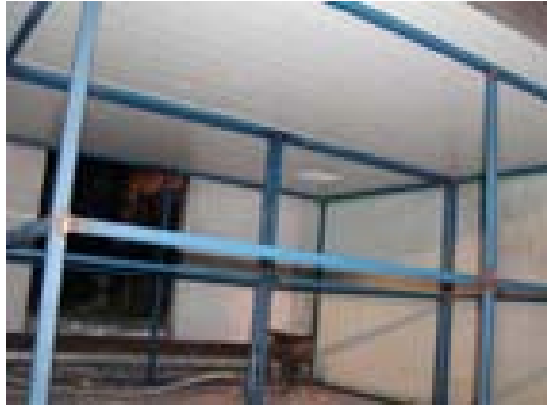
Figure 4.17: Location of burner and cut out in panel.

Figure 4.17 shows the location of the burner and cut out under the panel. Figure 4.18 and Figure 4.19 show the burner at outputs of 100 and 300 kW respectively.

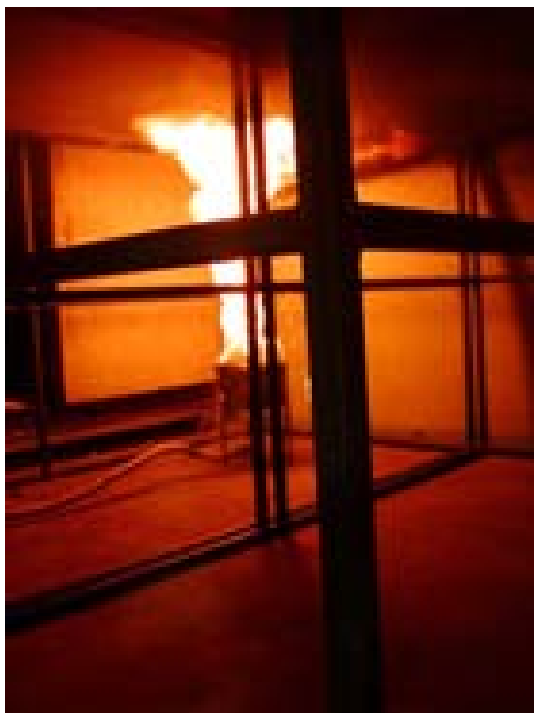
Figure 4.18: Trial 3 at 2 minutes and 100 kW.

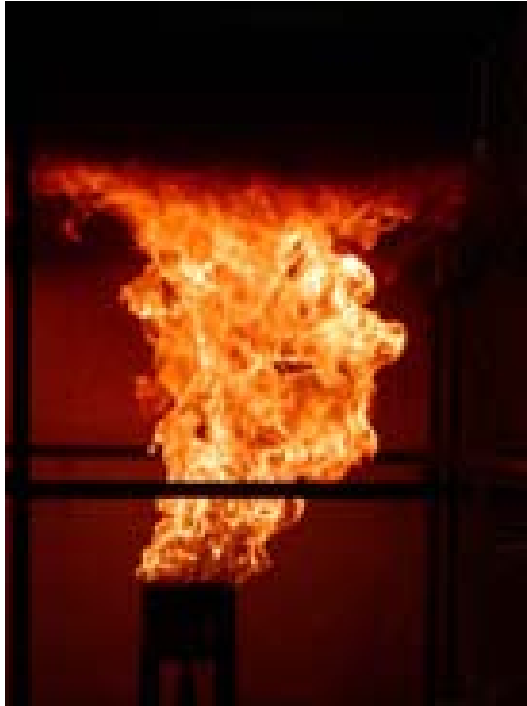
Figure 4.19: Trial 3 at 22 minutes and 300 kW.

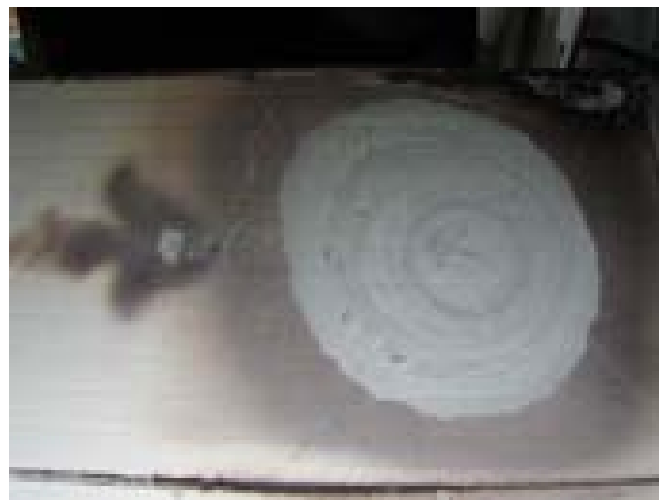
Figure 4.22: Trial 3 top side of panel, showing heat affected zone.

Figure 4.22 shows the upper side of the of the ceiling panel and the burnt steel skin in the region of the cutout.

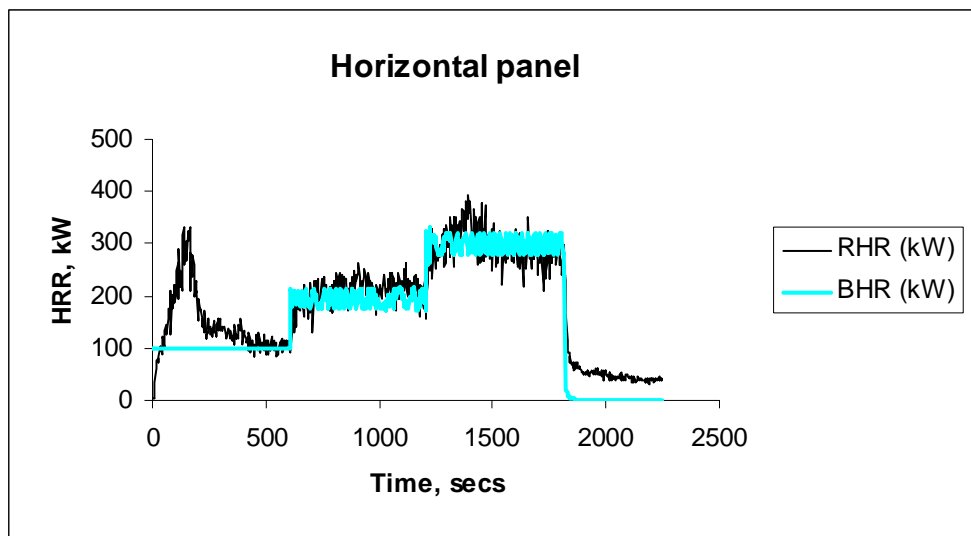
Figure 4.24: Trial 3 heat release rate and spikes due to molten EPS flowing onto fire and increasing the heat release rate.

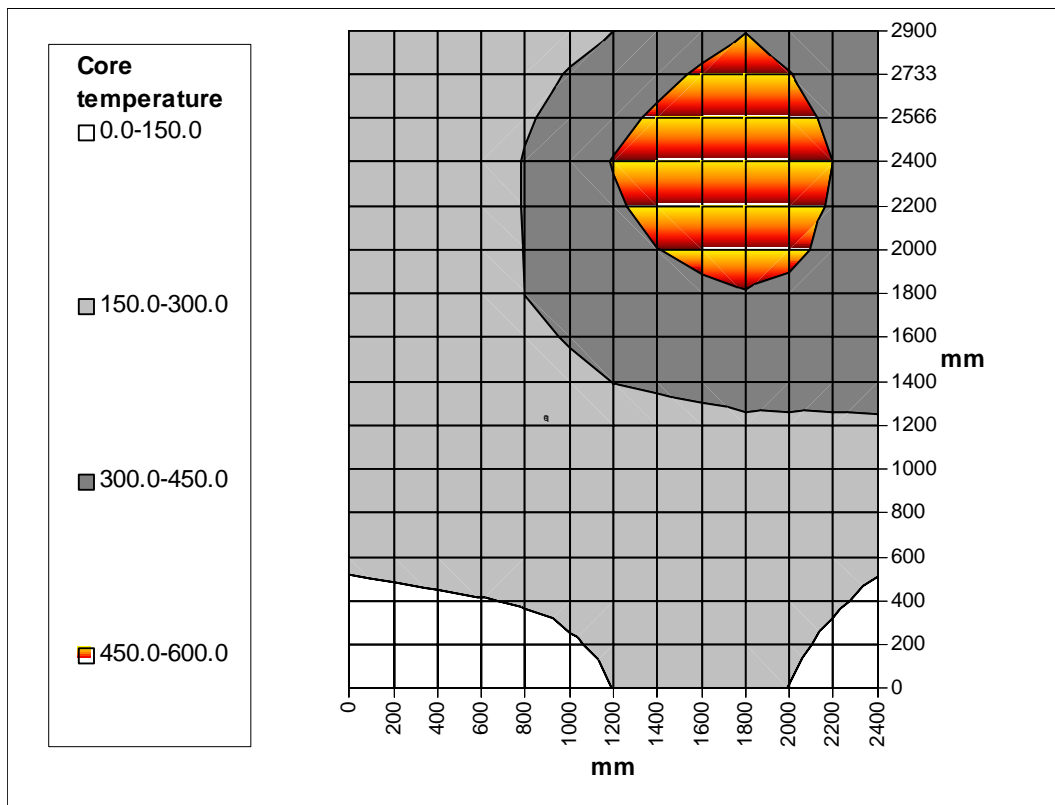
Figure 4.27: Temperature contours after 30 minutes exposure up to 300 kW trial 3, EPS core 91% melted.

The temperature contour maps in Figure 4.25, Figure 4.26, and Figure 4.27 indicate a more severe exposure due to the more intense exposure because of the horizontal orientation, the ceiling plume, and the containment around the perimeter to limit the escape of smoke. Such containment can be justified because in real building situations ceilings are generally bounded by walls. The additional plume heating resulted in 30-40 % of the EPS core melting and becoming involved in the first 10 minutes, compared with 15-20% for the vertical panel with the same 100 kW HRR from the burner in the first 10 minutes.

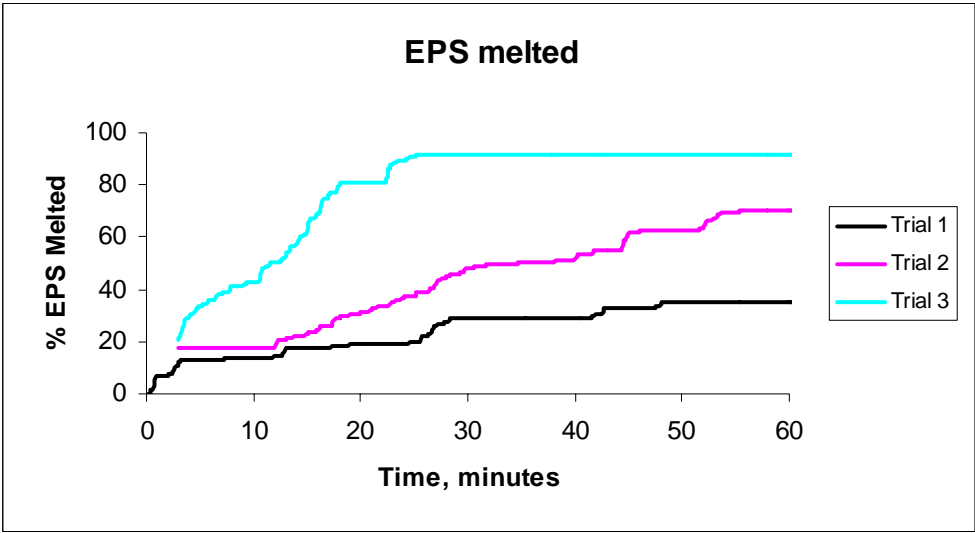
Figure 4.28: The extent of the melting of the EPS core in trials 1 to 3.

Figure 4.28 and Figure 4.29 show the progression of melting and burning of the EPS core in the three trials.

The graphs showing the percentage of melted (150°C) and burnt (450°C) EPS in the cores in Figure 4.28 and Figure 4.29 show that in the case of the vertical wall (1 and 2) the spread is dependent on the burner heat output. In the case of trial 1 the spread of the melted EPS region had only increased marginally from 30 minutes and a stable condition had been reached with only minimal fire spread up to 60 minutes. For the horizontal ceiling, the extent of the spread is significantly greater because of the more concentrated heat exposure on the panel surface. It is also significant that the difference between 90 % of the core melting compared with only 12 % reaching a combustion level temperature demonstrates that the EPS melted initially and flowed to an opening before flaming in the presence of air. The smoke production graph in Figure 4.30 indicates that in trial 3 significant burning of the EPS occurred external to the panel.

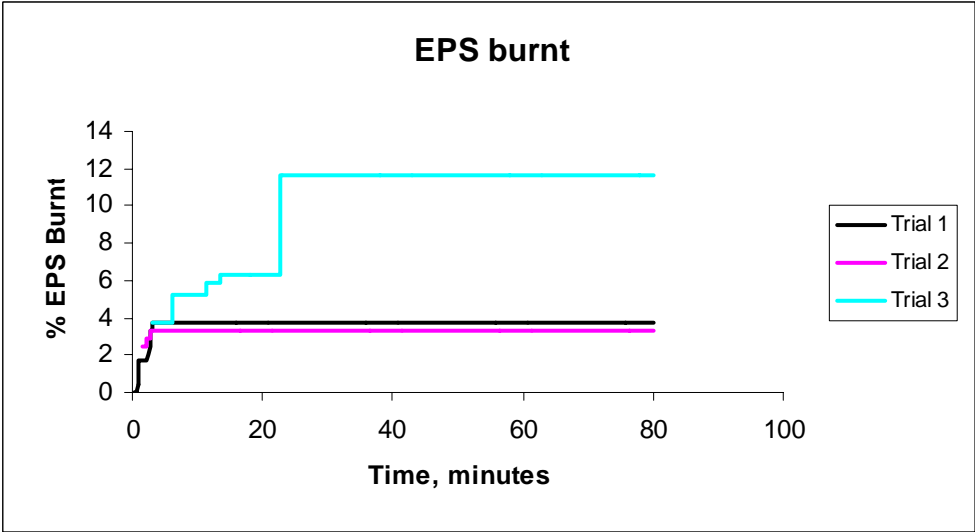
Figure 4.29: The percentage of the area where the temperature indicated burning of the EPS core within the panels.

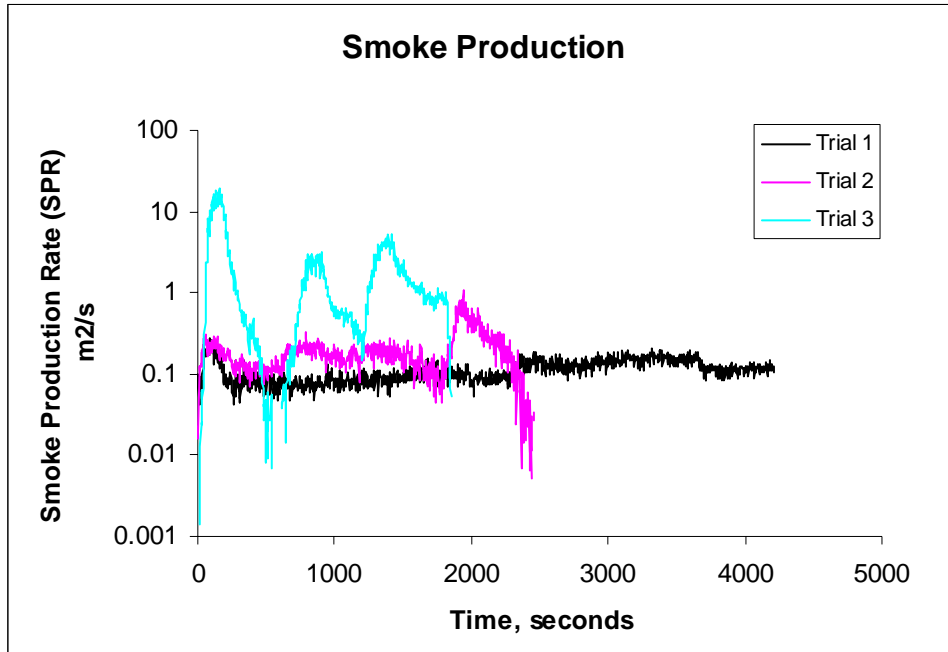
Figure 4.30: Smoke production in trials 1 to 3 on a logarithmic scale.

The spike in the graph in Figure 4.30 in excess of 10 m²/s (trial 3) coincided with the observation of thick black smoke and soot in the ceiling panel trial (3). For the two wall panel trials 1 and 2 the maximum smoke production was 1 m²/s and otherwise averaged 0.1 m²/s.

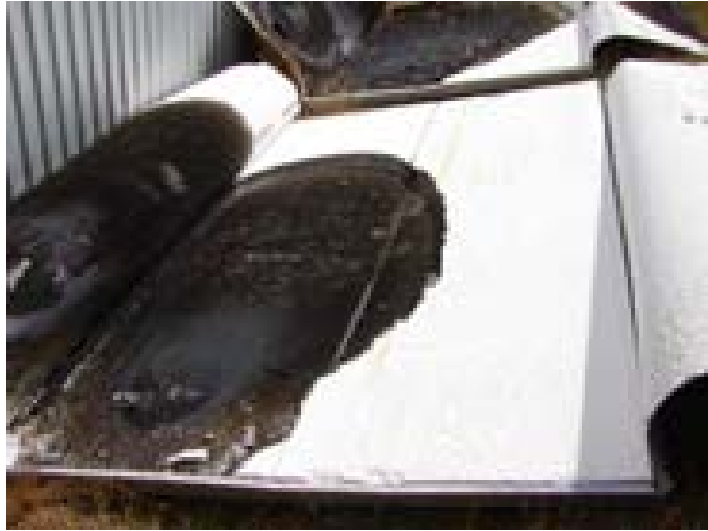
Figure 4.31: Remaining EPS core in trial 1.

For comparison purposes with the temperature contour maps and the percentage melted Figure 4.31, Figure 4.32, and Figure 4.33 show the remaining EPS when the panels were opened up for inspection. The remaining EPS matches that expected on the basis of the internal temperature measurements although the length of time the panel cores were exposed to the prevailing temperature could also be a factor accounting for some variation. It can clearly be concluded that fire spread within cavities is not self sustaining provided the joints remain intact.

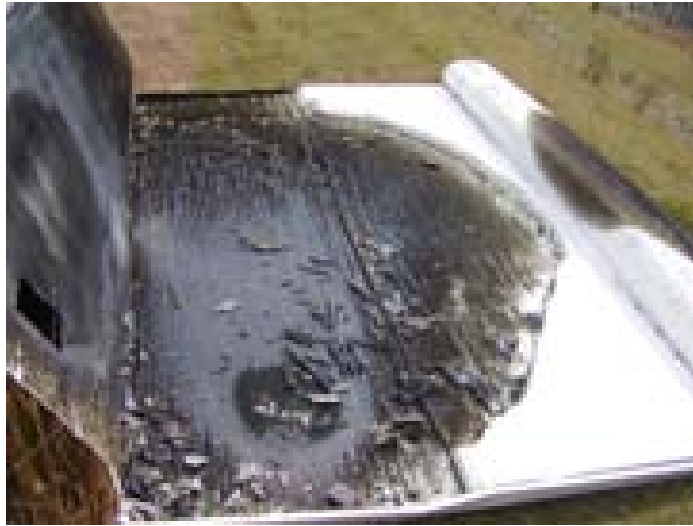
Figure 4.32: Remaining EPS core in trial 2.

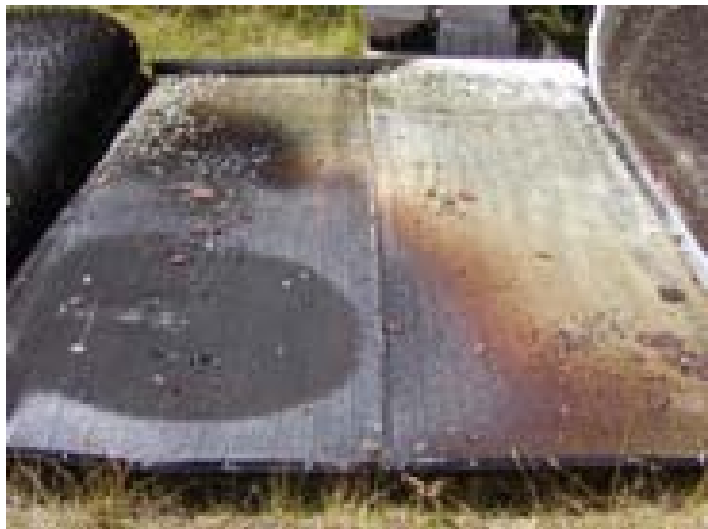
Figure 4.33: Remaining EPS core in trial 3.

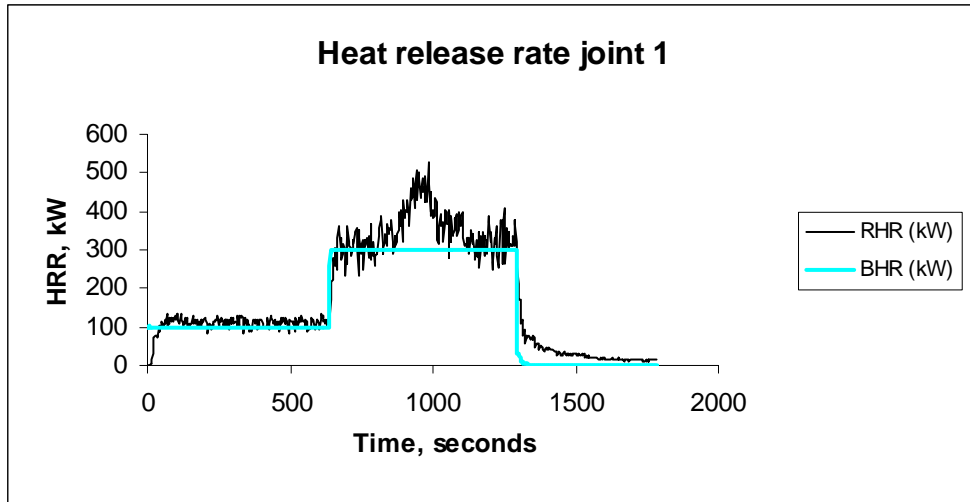
Figure 4.38: Heat release rate joint 1.

Individual graphs of the heat release rate are shown in Figure 4.38, Figure 4.39, Figure 4.40, Figure 4.41, and Figure 4.42, where RHR is the total heat release calculated from oxygen consumption and BHR is the gas burner heat release. The graphs indicate the increasing delay in the involvement of the core in the fire growth, characterised by the rate of heat release exceeding the burner output, and being attributable to closer rivet spacing for the interlocking

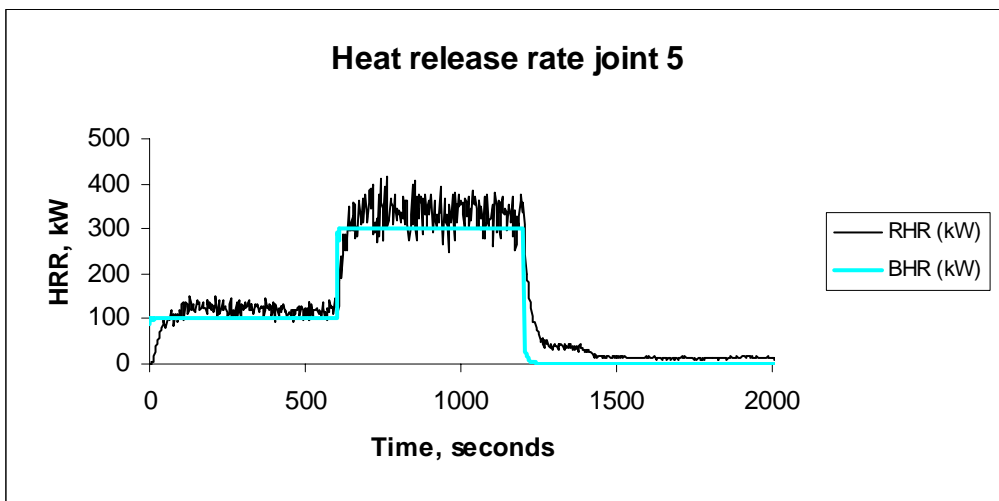
Figure 4.42: Heat release rate joint 5.

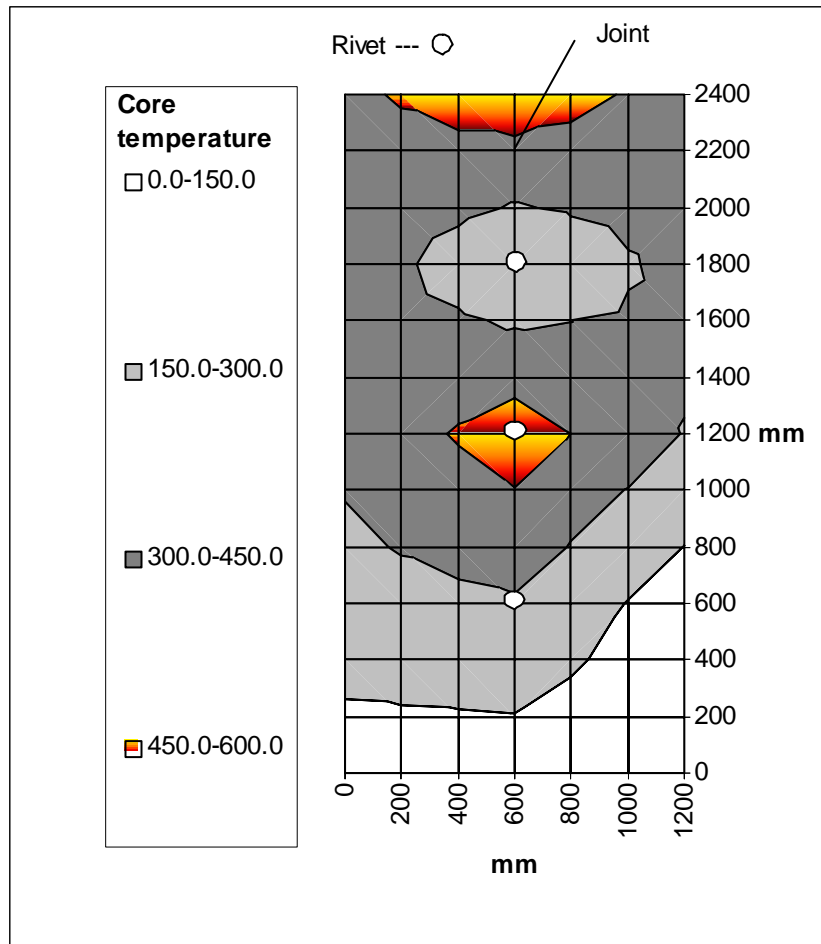
Figure 4.43: Temperature contours in joint 3 panel at 20 minutes.

Temperature contour maps were prepared for all five trials, with Figure 4.43 being an example for trial 3 with the 600 mm rivet spacing on the interlocking joint. The results of these analyses are shown in Figure 4.44 and Figure 4.45 giving the extent of core melting and burning based on temperature contours. Similarly, with the identical analysis of the cavity fire spread analysis in section 4.3 the actual burning, when it occurs happens over a relatively small area, and is generally confined to opening of the joints or edge capping.

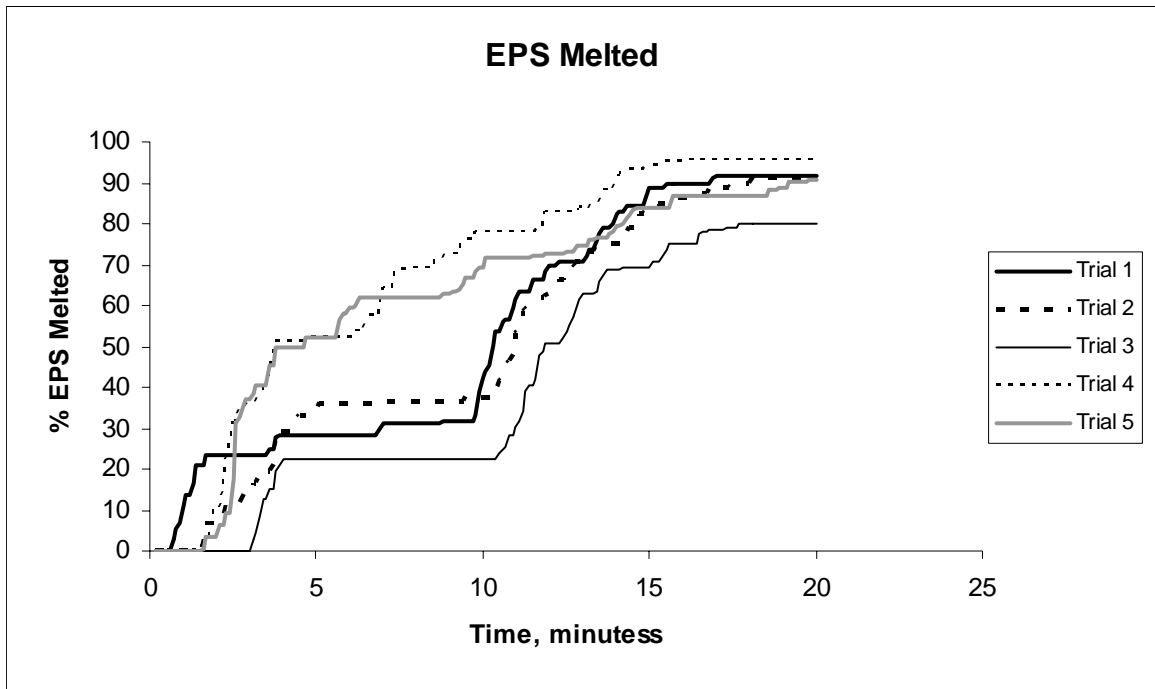
Figure 4.44: EPS core temperature greater than 150°C and assumed to be melted.

Internal inspection of the cavities showed less EPS foam remaining than would be indicated by the percentages given in Figure 4.44 after 20 minutes exposure. Some reasons for this include the isolated fires that continued to burn within the panel and the elevated temperature remaining in the ISO room for a period after the burner was extinguished. In all five trials, the post-test inspection revealed pools of solidified EPS in the bottom edge channel, the depths varied proportionately according to the contribution of the panel core to the overall heat release rate recorded. Table 4.10 records the depth of solidified EPS in the panel bottom channel of each specimen.

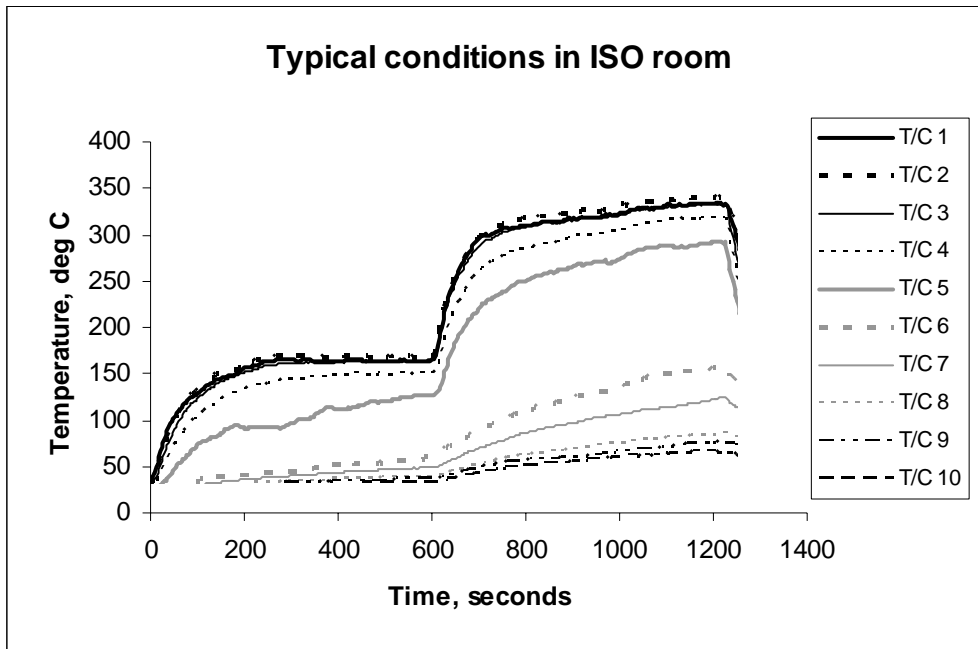
Figure 4.46: Conditions in ISO room trial 3.

Figure 4.46 shows the temperature conditions in the ISO9705 room at relatively evenly spaced heights where the legend numbers 1 to 10 represent thermocouple readings at the elevations indicated in Table 4.9. The thermocouples are positioned in the opposite corner to the burner and specimen at a distance of approximately 3000 mm. Trial 3 was the least severe exposure due to the limited involvement of the panel core in the fire so in the other trials 1, 2, 4, and 5 the temperatures would have been higher. Assuming that the EPS panel core melts at approximately 150°C, and then in the upper half of the room, where 150°C was exceeded significantly (indicated by thermocouples 1 to 5) it would melt over the entire horizontal length (width) of the panel independently of the burner flame impinging on the panel. As a result, the top half of the panels would not be expected to have any EPS remaining in the core, irrespective of the width.

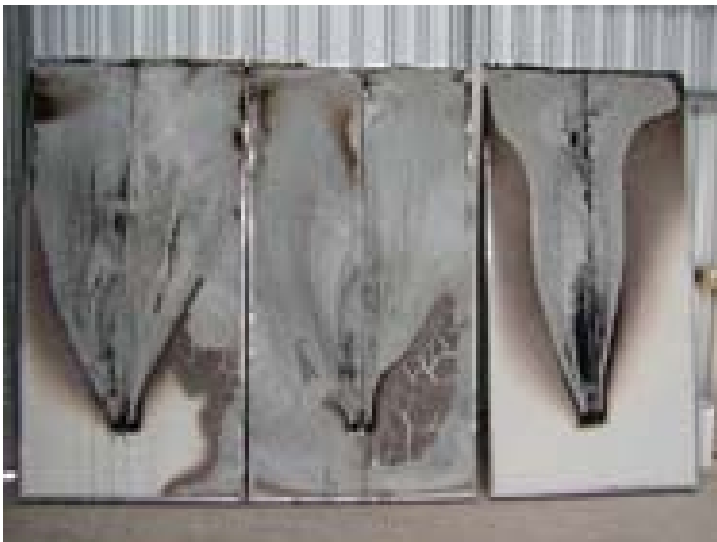
Figure 4.47: Interlocking joint specimens, fire exposed side, trials 1 to 3 from left to right.

The samples were inspected externally for the extent of damage after the fire exposure and Figure 4.47, Figure 4.48, Figure 4.49, and Figure 4.50 show the flame affected surface, but the actual degree of opening of joints is unclear.

On the fire-exposed side, the interlocking joint had opened up over 100% of the height above the burner (350 mm high) which is a distance of 2150 mm of the 2400 mm height of the panel. On the unexposed side, the joint had not opened at all over its entire height. The edge capping had opened up over 40 % of the perimeter, the entire length of the top edge and 30-40 % down each side.

On the fire-exposed side, the interlocking joint had opened up over 100% of the height above the burner (350 mm high) which is a distance of 2150 mm of the 2400 mm height of the panel the single centre rivet had sheared. On the unexposed side, the joint had opened approximately 50 % of its entire height, centred in the upper half. The edge capping had opened up over 40 % of the perimeter, the entire length of the top edge and 30-40 % down each side.

On the fire-exposed side, the interlocking joint had opened up over 50% of the height above the burner (350 mm high) which is a distance of approximately 1200 mm in height. Of the three rivets, the top two had sheared. On the unexposed side, the joint showed no sign of opening, but the soot marks in the right hand specimen in Figure 4.48 indicate there was some leakage and ignition of the gases from the pyrolysed core. The edge capping had opened up over 40 % of the perimeter, the entire length of the top edge and 30-40 % down each side.

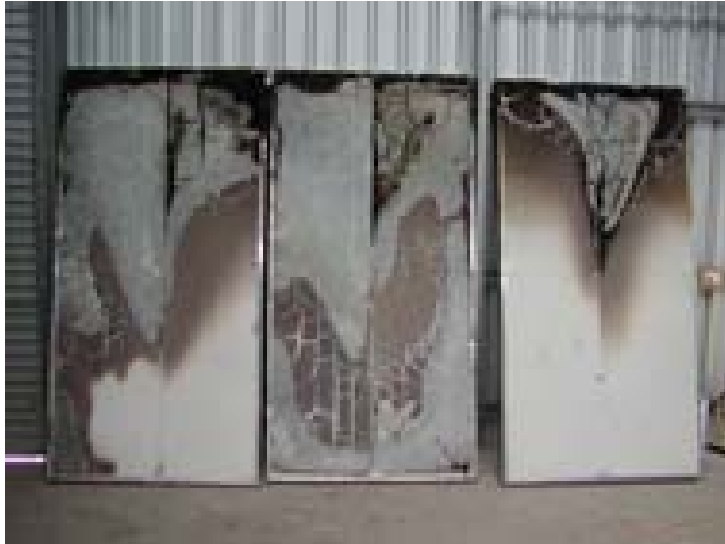
Figure 4.48: Interlocking joint specimens, unexposed side, trials 1 to 3 from left to right.

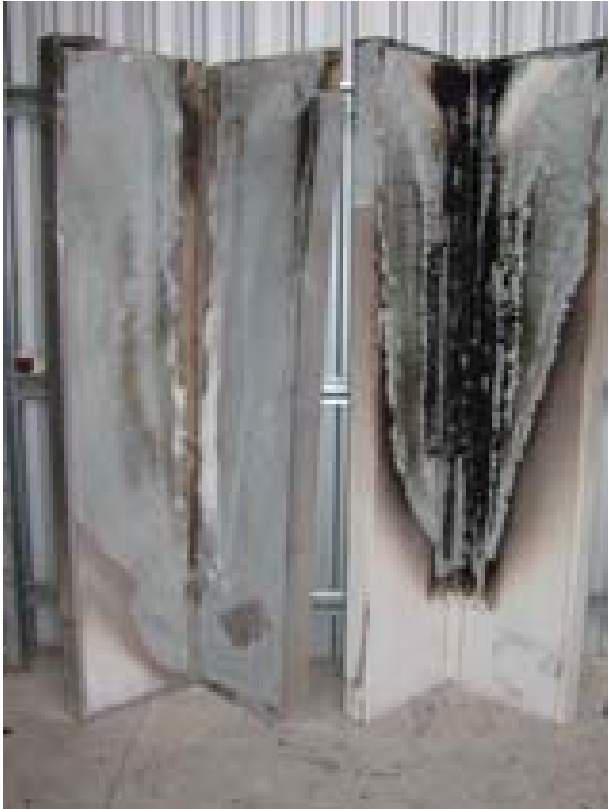
Figure 4.49: Corner joint specimens, fire exposed side, trials 4 to 5 from left to right.

The entire length (2150 mm) of the aluminium angle on the fire-exposed side above the burner had melted, and the joint had open up extensively. On the unexposed side, the aluminium angle had detached, above the burner height, by shearing or melting of the rivets. The edge capping had also opened up on the top edge and 50% down one side and was intact on the other side.

On the fire exposed side, the rivets securing the steel angle had either sheared or melted above a height of 1100 mm. On the unexposed side, the steel angle had detached, above 2000 mm height, by shearing or melting of the rivets. The edge capping had opened up only on the top edge, and had remained intact on each side.

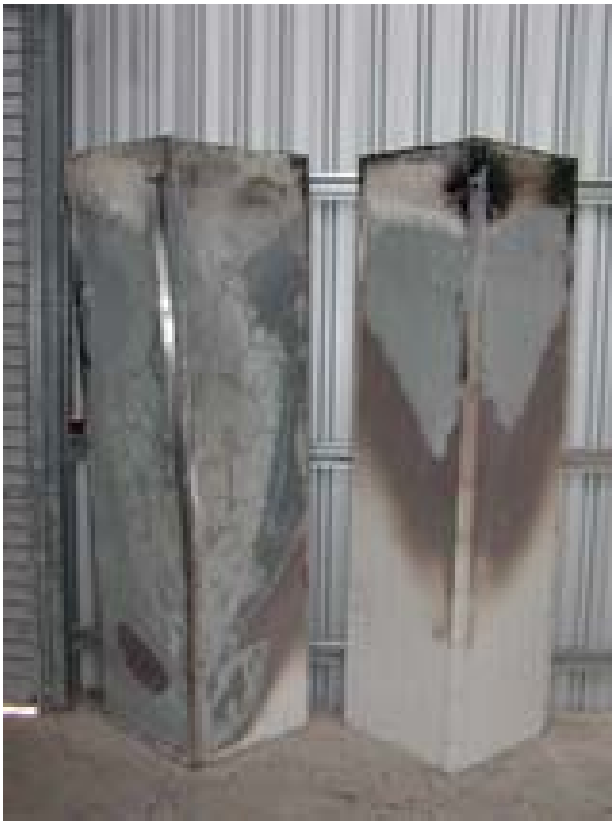
Figure 4.50: Corner joint specimens, unexposed side, trials 4 to 5 from left to right.

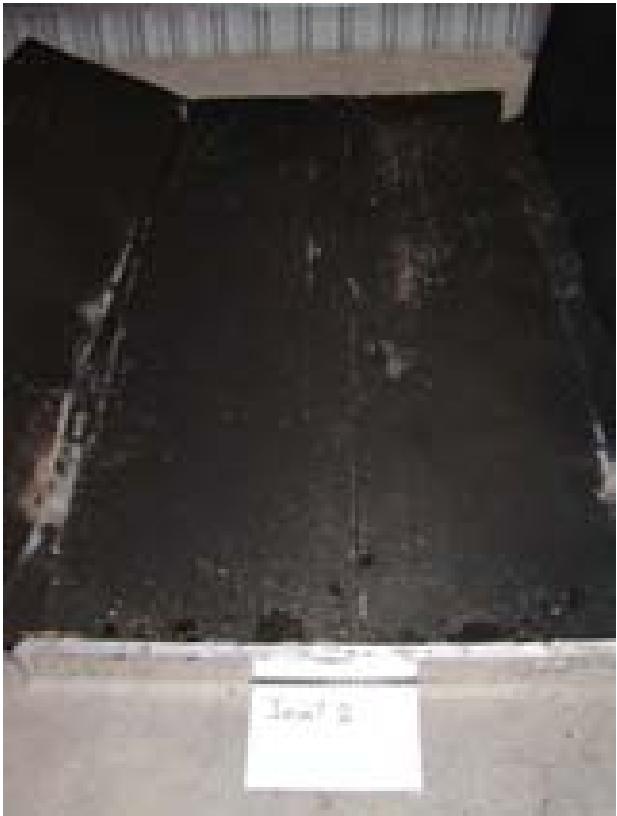
Figure 4.51: Totally consumed/melted core joint 2 panel.

Figure 4.51 and Figure 4.52 show the EPS core remaining in the post-test inspection. For joint 2 all of the EPS had melted and that which did not become involved in the flaming inside and outside of the panel remained as a solidified pool. In joint 3, where the additional rivets in the joint afforded more protection to the core a small portion of the core remained below the burner height. Considering the five joint trials there is a correlation between closer rivet spacing and more secure jointing methods in general and a reduction in the involvement of the panel cores indicated by the magnitude of additional heat generated from the burning panel and the quantity of core remaining.

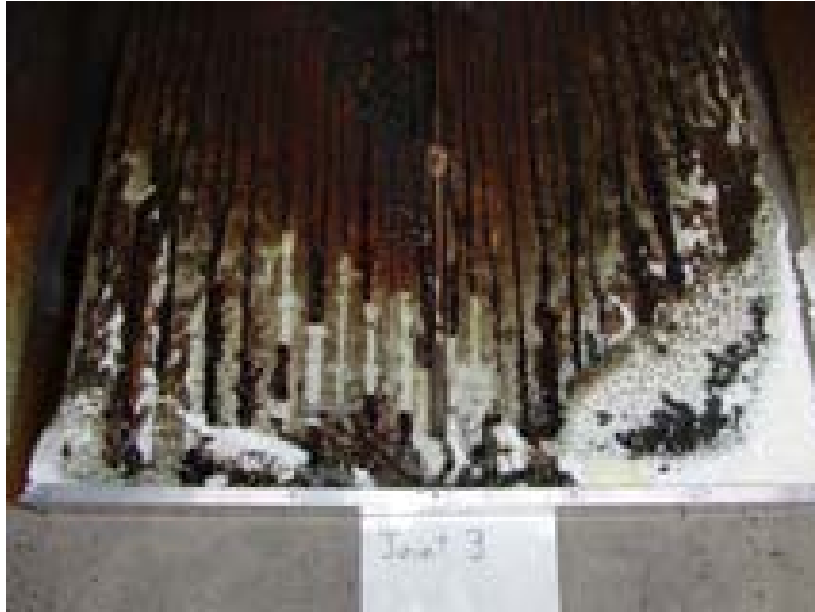
Figure 4.52: Remaining EPS core in lower portion of joint 3 panel.
