Improving the Fire Performance of Polystyrene Insulated Panel in New Zealand

BRANZ

April 2004

BRANZ Report No. FCR 9

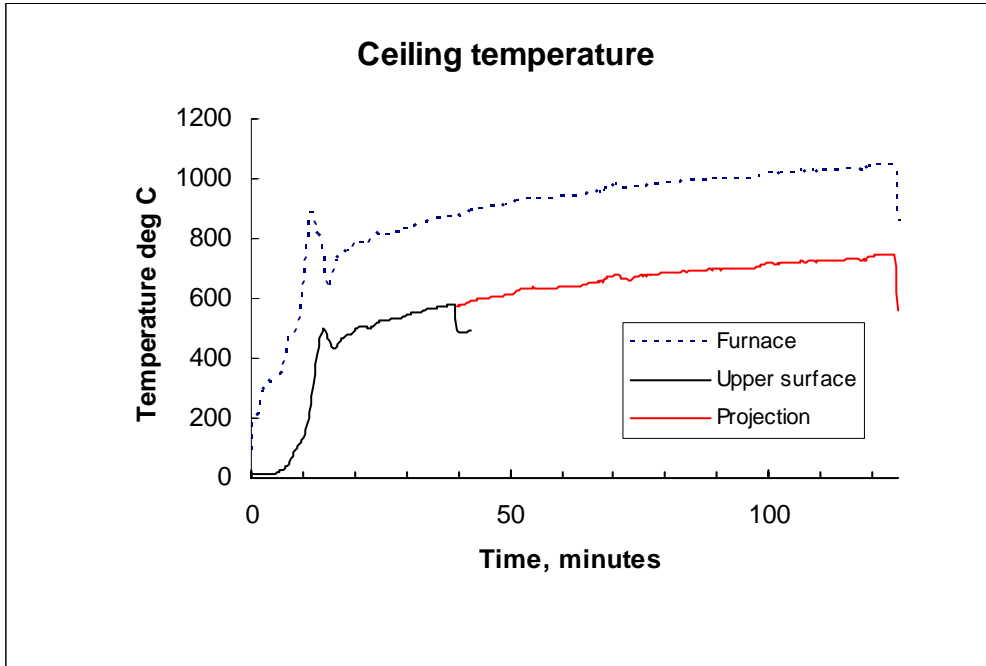
Figure 4.56: Typical temperature of ceiling and furnace.

Figure 4.56 shows the ceiling temperature on the upper surface of the ceiling and in the furnace. The temperature spike between 11 to 15 minutes is due to the involvement of the EPS core and the subsequent trough is after it had been consumed and the furnace burners restarted. Recording of the upper surface temperature was only possible to approximately 40 minutes when the thermocouple became detached from the surface, at that time the surface temperature was lagging behind the furnace temperature by approximately 300°C and the projection beyond 40 minutes is based on that. After 120 minutes, it is estimated the upper steel skin of the panel was at 700 to 750°C and the lower skin appreciably more, without any structural failure.

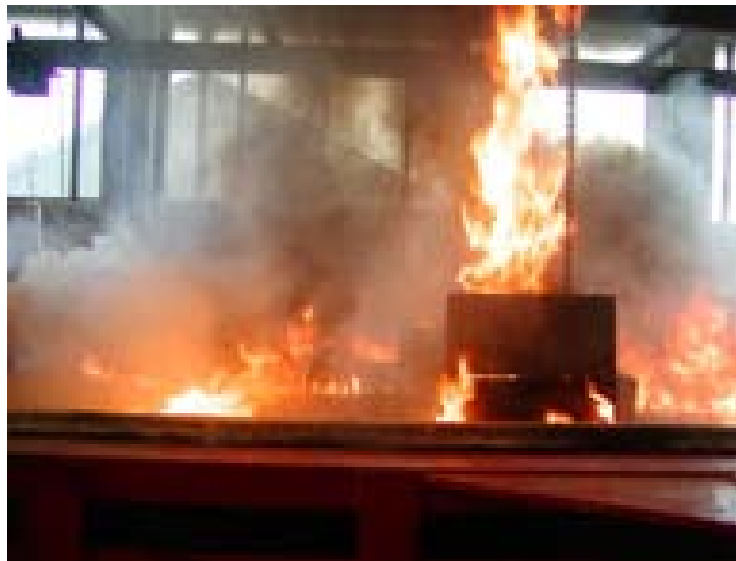
Figure 4.57: Suspended ceiling test showing flaming between 11 and 15 minutes.

Significant milestones in the tests were the melting of the plastic caps at 6 minutes, the involvement of the EPS core between 11 and 15 minutes (see Figure 4.57) requiring the furnace to be turned off to prevent a temperature overrun. Progressive opening of joints occurred from 30 minutes to 70 minutes and then some deformation (cupping) of the ceiling panel over the suspension nuts and washers. Not a single failure or pull through of a suspension point was noted or appeared likely to happen, even if the tests had continued (see Figure 4.58 and Figure 4.59). The ceilings had reached a stable condition and appeared likely to have remained attached beyond the 120 minutes of test C.

Further consideration needs to be given to what fire load or duration is likely in a ceiling space. In the furnace ceiling tests there was observed to be about 3 minutes of intense flaming (between 11 and 14 minutes into the tests) on the upper surface as the fuel load in the 100 mm thick panel burnt off, after that there was no further flaming on the upper surface. By establishing the likely fire exposure in a ceiling space for actual buildings it is very likely that this will be equivalent to less than 30 minutes exposure to an ISO standard time-temperature curve fire.

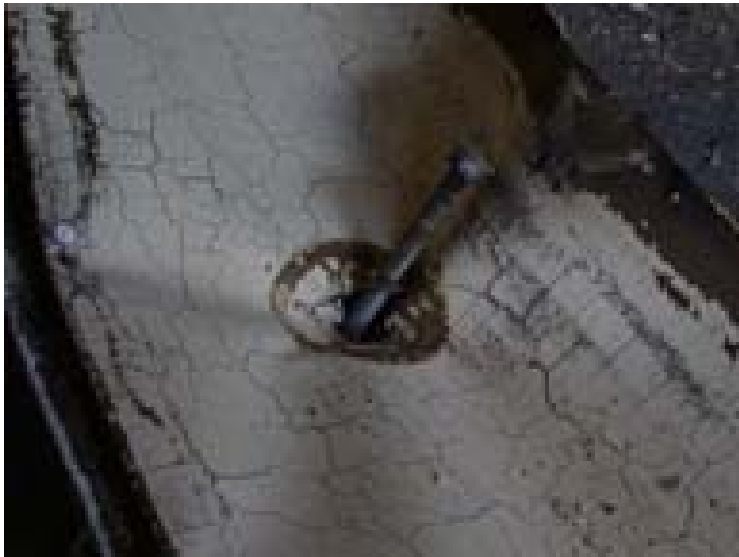
Figure 4.59: Cupping around hanger point.

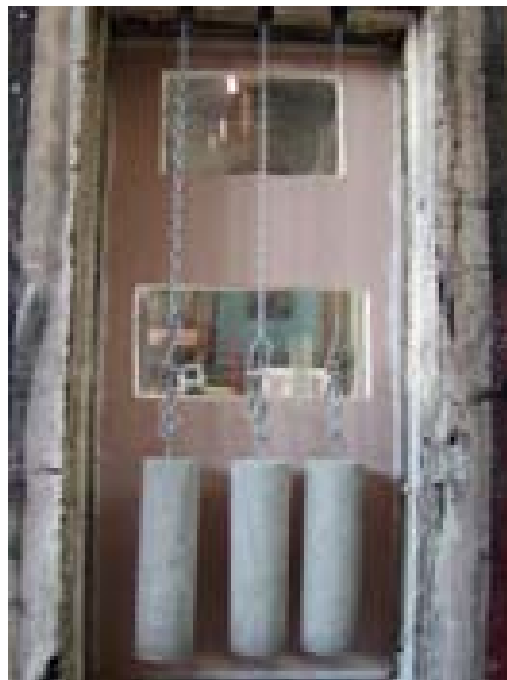
Figure 4.60: Suspension systems prior to hanger test.

Figure 4.60 and Figure 4.61 show the experimental assembly for testing the hangers, from left to right the systems are numbered 3, 2, and 1.

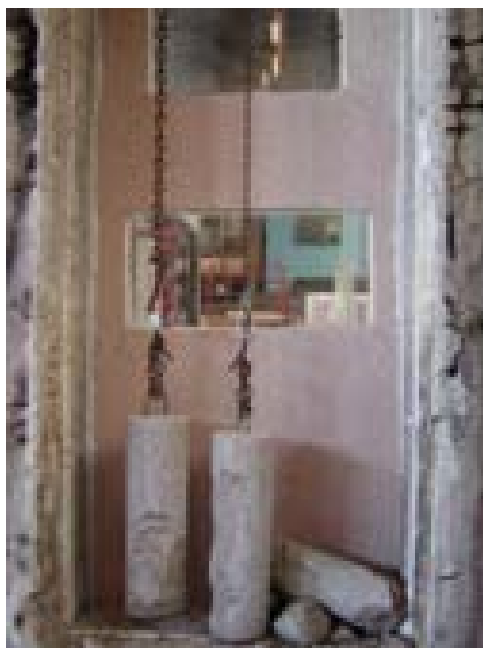
Figure 4.61: Suspension systems after 60 minutes exposure.

At 33 minutes the number 1 suspension system failed at the top connection, the steel wire snapped in the top loop rather than the copper ferrules (talurits) melting/softening or otherwise slipping, there was no visible deformation of the ferrules. It was estimated the system had stretched 228 mm. The L bracket had straightened out similarly to the number 3 L bracket in the after test photo Figure 4.61.
